## Rehabilitation of the Aluto Pilot Geothermal Power Plant – An overview

Markos Melaku<sup>1</sup> and Merga Tassew<sup>2</sup>

<sup>1</sup>Geothermal Development Associates, <sup>2</sup>Ethiopian Electric Power Corporation

**Keywords:** Aluto project, plant rehabilitation, pilot power plant, binary and combined cycle units

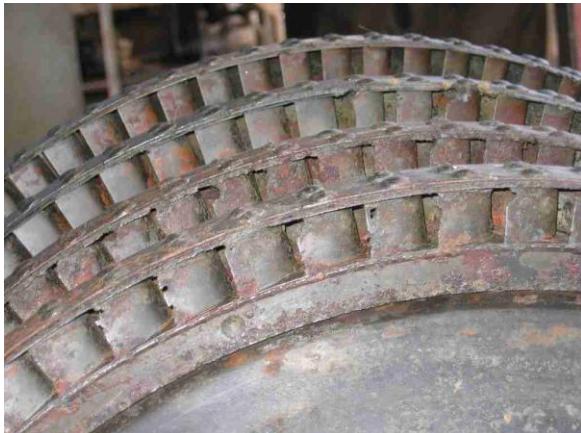
There was heavy corrosion and deposits on parts of the rotor blades (Figure 2), with severe corrosion appearing on the first and second stage. There was shroud damage to all of the stages. Additionally, the interstage drains were clogged and filled with a hard deposit. The drains were cleared of the deposition and cleaned.

There was very little scale deposited on the first stage nozzles, where it normally is found. A soft scale was found in the first stage rotating blades and it was deposited along the outer section of the blades, near the shrouds. The scale was soft and easily removed and appeared to have been dry when deposited, rather than deposited by contaminated liquid. The deposited amount was enough to significantly affect the steam flow and turbine power output.

**Figure 2 Corrosion of the turbine blades**

The steps in the rotor repair were described as follows: Cleaning and inspection using magnetic particle or other non-destructive examination methods, rotor disassembly, repair the shaft journal bearing area, repair or replace the damaged rotary steam seal section, repair turbine blades and shrouds as necessary, re-assemble rotor components and coupling in original locations, rebalance so that the final result meets or exceeds required specifications.

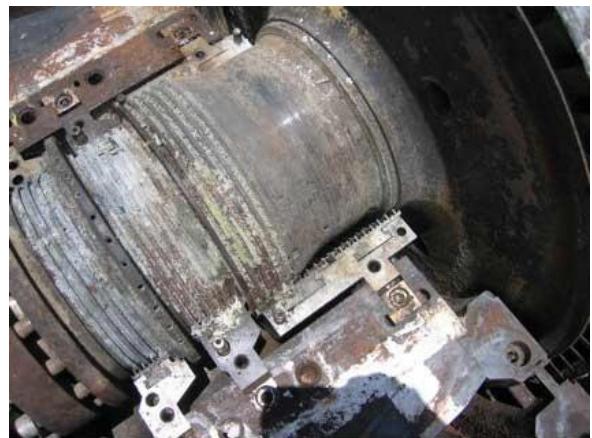
A section of the rotor labyrinth steam seal appeared to have been damaged due to wear from contact with a heavy scale deposit or a foreign object (Figure 3). However, there was no corresponding wear on the mating stationary labyrinth seal.

**Figure 3 Worn rotor labyrinth steam seal**

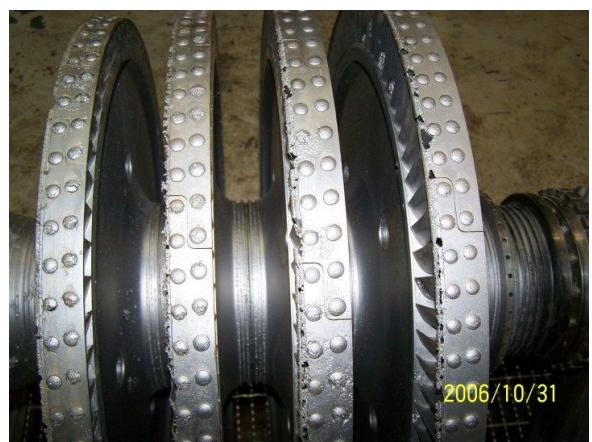
**Figure 4 Corroded shroud bands**

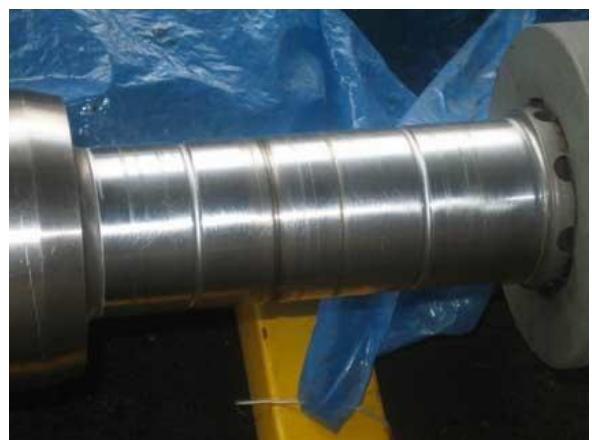
**Figure 5 Worn turbine rotor shaft**

and well-equipped facility and a strong candidate for a local repairs. However, the EA shop repairs damaged shafts by a plating process and the maximum thickness they could plate was 1 mm. Unfortunately, the scoring on the shaft was too deep to be repaired in their shop.

GDA's recommendation was that the rotor be shipped to Conhagen in Texas, USA, where identical turbines from other US geothermal plants are routinely repaired.

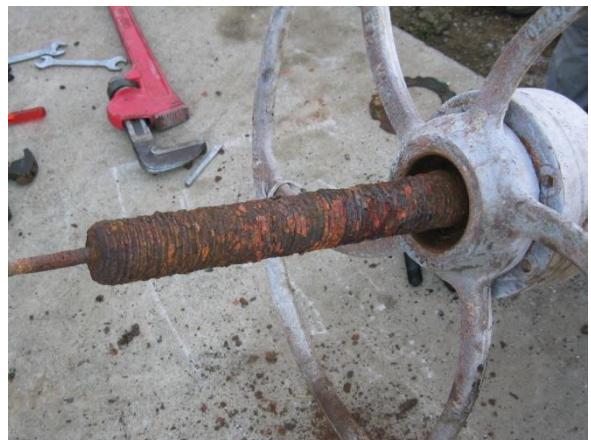
The wellhead valves at Aluto had been in service ever since the wells were drilled and completed in the early 80's. Major problems observed included, severe corrosion of the valve stem (Figure 6), corrosion and in some instances jamming of the gate-segment assembly, erosion and wear of the body-seats, damage of the valve gland and bearings. Despite these problems, the valve bodies were in very good condition. It was decided that the most cost-effective solution was to procure valve spare parts and carry out maintenance of the valves in stead of buying new wellhead valves, which has a long lead times. Accordingly, sufficient parts to service most of the 10" and 2" wellhead valves at the project site were purchased and the maintenance was carried out. After completing repair, each valve was pressure tested (Figure 7) to the applicable pressure to ensure that the repair work was satisfactory. The reconditioned valves were subsequently installed on the geothermal wells.

**Figure 6 Corroded stem of a wellhead valve**

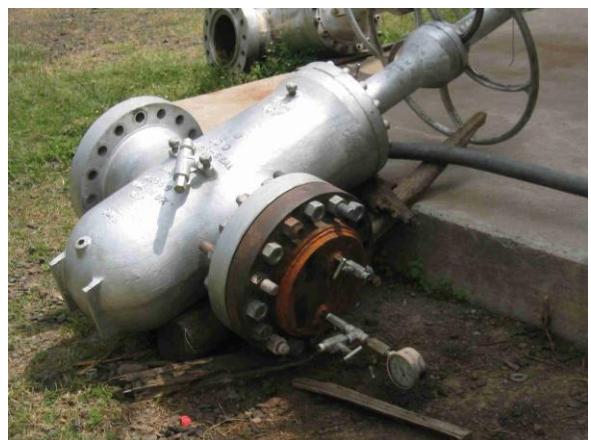
**Figure 7 Hydrostatic pressure testing of reconditioned valve**

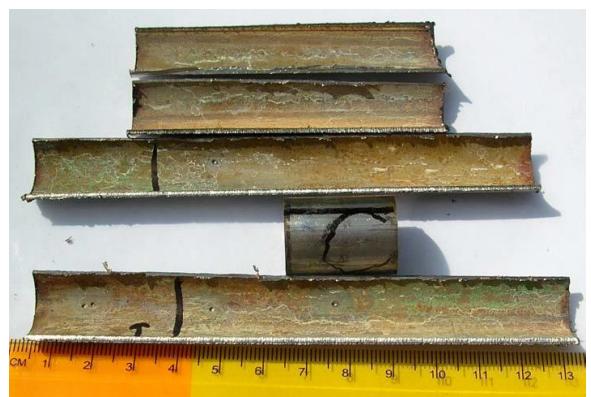
The OEC was taken out of service in 1999 due to vaporizer tube leaks. EEPCo reported a total of twenty (20) leaking tubes.

**Figure 8 Pitting corrosion of vaporizer tubes**

A tube failure analysis was carried out by Jonas, Inc. (Jonas, Inc. laboratories, Wilmington, Delaware, USA) on two leaking tubes. The major finding of this analysis was that the root cause of the pitting was the use of wrong tubing material, 316L austenitic stainless steel, which seemed to be not suitable for the chemistry of the Aluto wells. It also found that the tube leaks were caused by tube ID pitting (Figure 8), which occurred during the initial service of the heat exchanger. There may be additional pitting due to six years of unprotected layup. The pitting was more concentrated at the bottom part of the tubes where there was a liquid layer of condensed steam. It was expected that pits were present on the ID of most of the heat exchanger tubes. Jonas concluded that, with the same composition of steam and operating conditions, the pitting will continue and the heat exchanger will be unusable within a few years and, therefore, total replacement of the tubes would be necessary.

PowerChem, of Minden, Nevada, USA, carried out a second analysis. PowerChem's final report provided a number of recommendations that related to operator training in order to improve the steam quality, testing and startup procedures, etc. as well as implementation of a corrosion mitigation treatment program. The practicality/feasibility of isolating (by plugging) the failed tubes and putting the unit into operation, as a temporary solution, was extensively investigated. However, successive pressure tests on the plugged tubes proved to be unsuccessful due to discovery of more leaky tubes after each pressure test. It was then decided that the failed tubes on the vaporizer and the first two passes of the preheater would be replaced with more corrosion resistant tube material – 2205 Duplex stainless steel.
