## REHABILITATION OF THE ALUTO PILOT GEOTHERMAL POWER PLANT

**Markos Melaku and Bob Thomasson**

*Geothermal Development Associates*

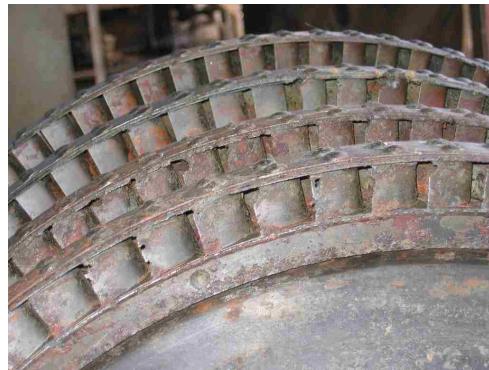
There was heavy corrosion and deposits on parts of the rotor blades (Figure 1). The interstage drains were clogged and filled with hard deposits which were later cleared of the deposition and cleaned.

There was very little scale deposited on the first stage nozzles, where it normally is found. A soft scale was found in the first stage rotating blades and it was deposited along the outer section of the blades, near the shrouds.

**Figure 1:** Corrosion of the turbine blades

The major repair work undertaken on the plant involved the work done to rectify the problems on the GCCU steam turbine. During inspection of the turbine rotor, in addition to the repairs defined in the rehabilitation contract, significant damage to the rotating blades, seal hub and shaft journal area was observed. Damages to the rotor shaft and bearing were also noted. Subsequently, a recommendation to repair the turbine blades and the hub were made to EEPSCO.

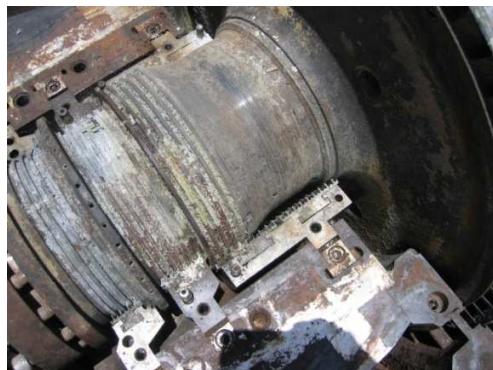
A section of the rotor labyrinth steam seal appeared to have been damaged due to wear from contact with a heavy scale deposit or a foreign object. However, there was no corresponding wear on the mating stationary labyrinth seal (Figure 2).

### Figure 2: Worn Labyrinth seal

GDA's recommendation was that the rotor be shipped to Texas, USA, where identical turbines from other US geothermal plants are routinely repaired.
