# FAILURE ANALYSIS CASE STUDY ON CONDENSER VESSELS OF GAS REMOVAL SYSTEM IN WAYANG WINDU GEOTHERMAL POWER PLANT UNIT 2

Star Energy Geothermal (Wayang Windu) Ltd

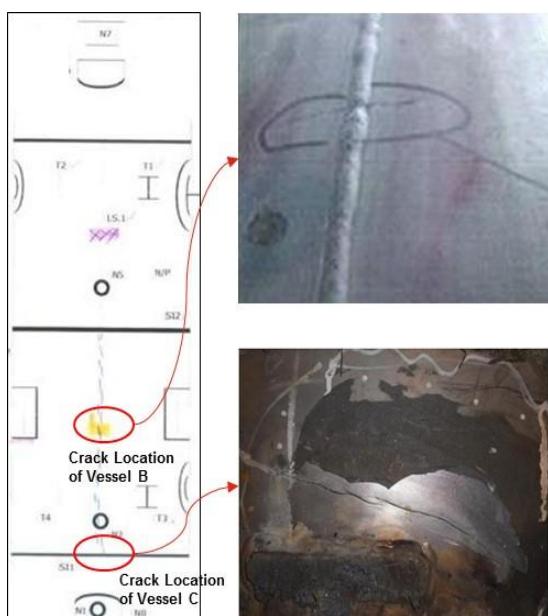
Figure 2 Crack and origin location for both examined samples.

After-condenser vessel of all Train A, B, and C experienced cracks during their operation. The number and location of cracks were various for each train. However, the cracks have similar morphology and located either on base metal or on weld metal area.

The samples, origin location, and existing crack appearance for after-condenser sample C and sample B are shown on Figure 2. Sample C is curved material sheet consisted of one through thickness crack located in base metal area adjacent to a fillet weld joint. The crack was coated on its outer surface side.

On the other hand, sample B contains one through thickness crack perpendicular to the vessel's longitudinal seam weld joint. These samples were taken as typical crack section for base metal and weld metal area, respectively.

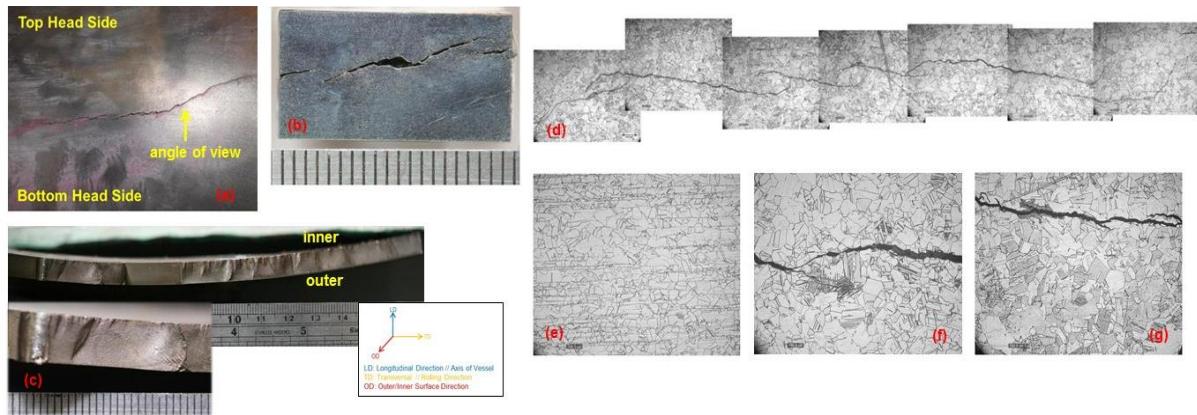
Visual examinations were carried out on both samples. Samples and crack appearance are shown on Figure 3 and Figure 4. For Sample C, the crack is adjacent to fillet weld joint for lifting lug, through thickness, and its orientation is perpendicular to axis or longitudinal direction of the vessel (Figure 3a).

Fracture surface of samples was also observed from bottom head side on longitudinal surface as presented on Figure 3c and Figure 4b. For sample C, the fracture surface appearance shows major brittle fracture with little area of plastic deformation on the edge of its internal surface.

Based on visual examination, the crack location and orientation might be associated to welding process during vessel fabrication either fillet weld for vessel C or longitudinal seam weld for vessel B. Moreover, its orientation indicates that the crack is more affected by stress on longitudinal direction instead of hoop direction.

Crack material samples were taken apart from the whole crack area. Macrophotograph of polished-etched surface shown on Figure 3b reveals that the cracks are laid separately each other. In other words, the crack propagates in stepwise, not in straight manner.

Furthermore, numerous micro cracks were observed between larger cracks. These micro cracks were then examined microscopically and presented on Figure 3d, 3f, and 3g. All of the cracks are propagated on transversal direction i.e. parallel to rolling direction of the vessel. It might be associated with the presence of ferrite stringer which is also laid parallel to the rolling direction and could predominantly be a crack initiation site [6].

Further examination of microstructure around micro cracks shows that all cracks are mostly transgranular type and have generated branching at several points as shown on Figure 3f and 3g. These branching cracks indicate high stress level involved in crack growth. It can also be observed that the crack is propagated following finer grain size or twin structure, which is confirmed by the hardness test result herein, that those structures are more brittle than the other common microstructure constituents.

Based on Table 4, hardness for base metal area of sample C are still under ASME compliances. Nonetheless, measurement on the other spots around crack area gives higher values which do not comply with the specification. Hardness at crack bank is slightly higher than base metal hardness with maximum value exceeds 217 HV (recommended maximum hardness).

Furthermore, hardness at area between cracks and at crack area with twin structures are far higher up to 256 HV. High hardness level on several local spots around crack could indicate brittleness and reduction of toughness. In other words, it indicates embrittlement process either caused by corrosive environment during operation or by welding process during vessel fabrication [5].

1. Raw material for condenser or other vessels shall be heat treated by stress relieve instead of annealing process only.
2. In addition to mechanical and metallurgical test, the material shall be corrosion tested in order to evaluate its cracking resistance in  $H_2S$  environment. Several testing method has been well established to be performed, for instances test procedure specified on NACE TM0284, and NACE TM0177.
3. Welding procedure specification and its implementation should be tightly controlled in order to avoid weld defect which may assist corrosion cracking mechanism.
4. Periodic inspection for crack detection should be performed by means of non-destructive test.

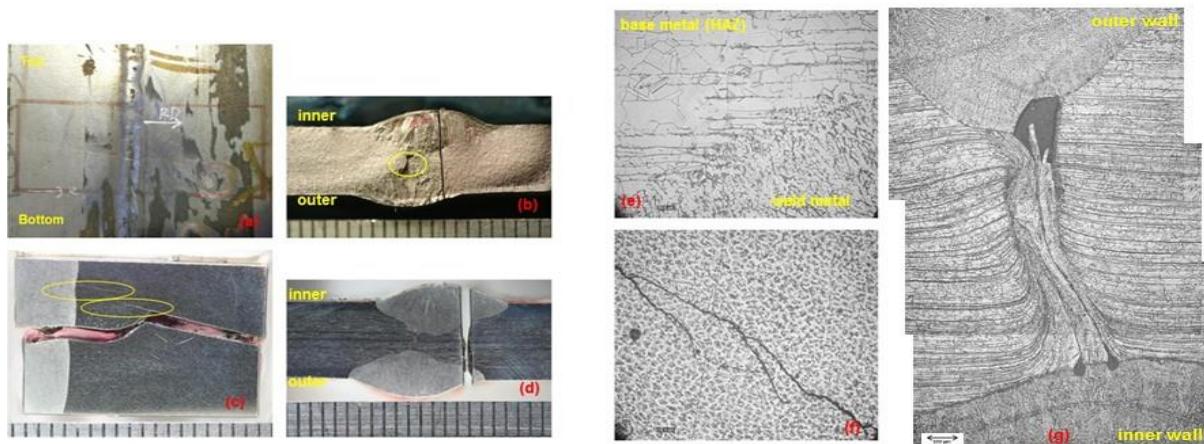
For Sample B, the crack passes through the longitudinal weld seam of the vessel, through thickness, and is laid on transversal direction of the vessel as well (Figure 4a). Additionally, there is no observable corrosion or pitting attack both around the crack and on weld seam for both samples. The welding area moreover was sound and has no visual weld defect.

Differently, the fracture surface of sample B (Figure 4b) shows two separated weld area on its inner and outer surface. It also shows various fracture appearances i.e. smooth brittle fracture on base metal area, lightly brittle fracture on weld area, and cup and cone fracture indicating ductile fracture. Apparently, a weld defect was observed in the middle of vessel's thickness between inner and outer weld area (Figure 4b and 4d). It is likely a *lack of fusion* indicating improper weld joint design.

Refer to the fracture surface appearance; cross section of vessel thickness must be subjected to inhomogeneous or localized stress pattern. Especially for vessel B, the crack might be initiated from weld defect, propagated to both sides, and terminated at cup and cone fracture site [3].

The weld sample consists of two weld metal area at inner and outer wall surface on austenitic phase base metal (Figure 4d). It can be seen that material also contains phase stringers (Figure 4e). Its distribution is more likely found around weld metal developing a banded structure, a metallurgical feature which is usually emerged due to welding process [7].

Apparently, it is also observed a crack-like weld defect which is likely *lack of fusion* pass through the thickness from both of weld root area (Figure 4b). This defect is typically developed as a result of inappropriate weld joint design and would be obviously correlated with the crack development in after-condenser B.

Microstructure around crack area on the weld metal is presented on Figure 4f. Both macro and microphotograph of crack on the sample B show some similar features with crack on sample C. The cracks are also transgranular and has generated branch indicating excessive stress level involved.

This branching crack is more likely found on weld area where typically high residual stresses are presented [5]. Stepwise micro cracks are also existed in addition to the larger one.

Hardness at crack bank of sample B are slightly higher than base metal, but it is not as high as hardness values at crack bank of sample C. In conjunction with that, hardness of weld metal is slightly higher than base metal but it is still in range with the specification. It indicates that crack growth is more influenced by high hardness constituent or structure area associated to welding process instead of weld microstructure itself.

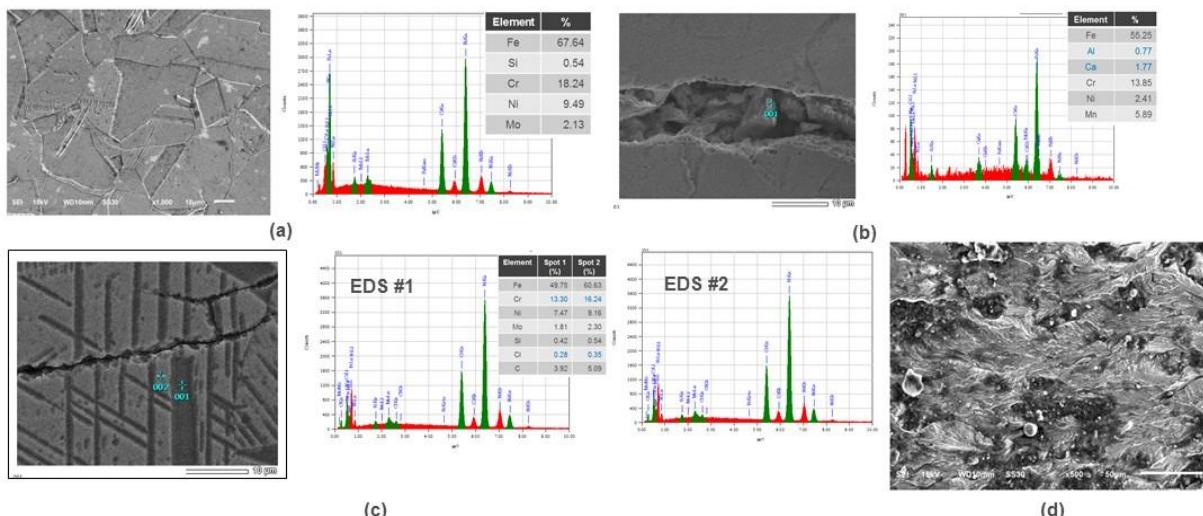
Figure 5 SEM and EDS examination result: (a) base metal overall; (b) nonmetallic inclusion on the crack path; (c) twin structure at crack vicinity (d) electron microscopy of fracture surface at weld area.

Spectroscopy result of base metal area of sample C on Table 5 gives typical result with heat analysis of raw material of after-condenser C on Table 1, except for higher Cr content on the sample up to 18.24 %. This higher Cr content can describe the presence of ferrite stringer on sample microstructure providing that Cr roles a ferrite promoter [5].

Apparently, SEM and EDS analysis on crack path has discovered calcium and aluminum content which is likely come from a nonmetallic inclusion in microstructure of stainless steel [4]. These inclusions could be the predominant initiation sites for cracking especially for those which has stepwise manner [6, 8].

Furthermore, analysis on twin structure at vicinity of the crack shows valuable information. Firstly, Cr content reduces up to 16.24 % and 13.30 % for spot #1 and spot #2, respectively. Secondly, on those Cr-reduced spot, it is observed Cl species which might also be the cause of Cr reduction process [9]. The presence of Cl is consistent with operational data verifying that steam consists of this aggressive species for stainless steel.

Fractography results by means of SEM on sample B are presented on Figure 5d. From that result, it can be observed that weld metal fracture surface is more ductile than base metal one. In addition, fractography of base metal fracture surface shows river marking which could indicate crack propagation orientation [3].

Based on those finding it can be concluded that weld metal structure has no or little influence on crack development. Instead, the *lack of fusion* defect on base metal can increase susceptibility of this material to have brittle fracture as result shown [6].
