ENVIRONMENTAL IMPACTS DURING GEOTHERMAL DEVELOPMENT: SOME EXAMPLES FROM CENTRAL AMERICA

Sue GOFF and Fraser GOFF

Los Alamos National Laboratory, Los Alamos, NM 87545 USA

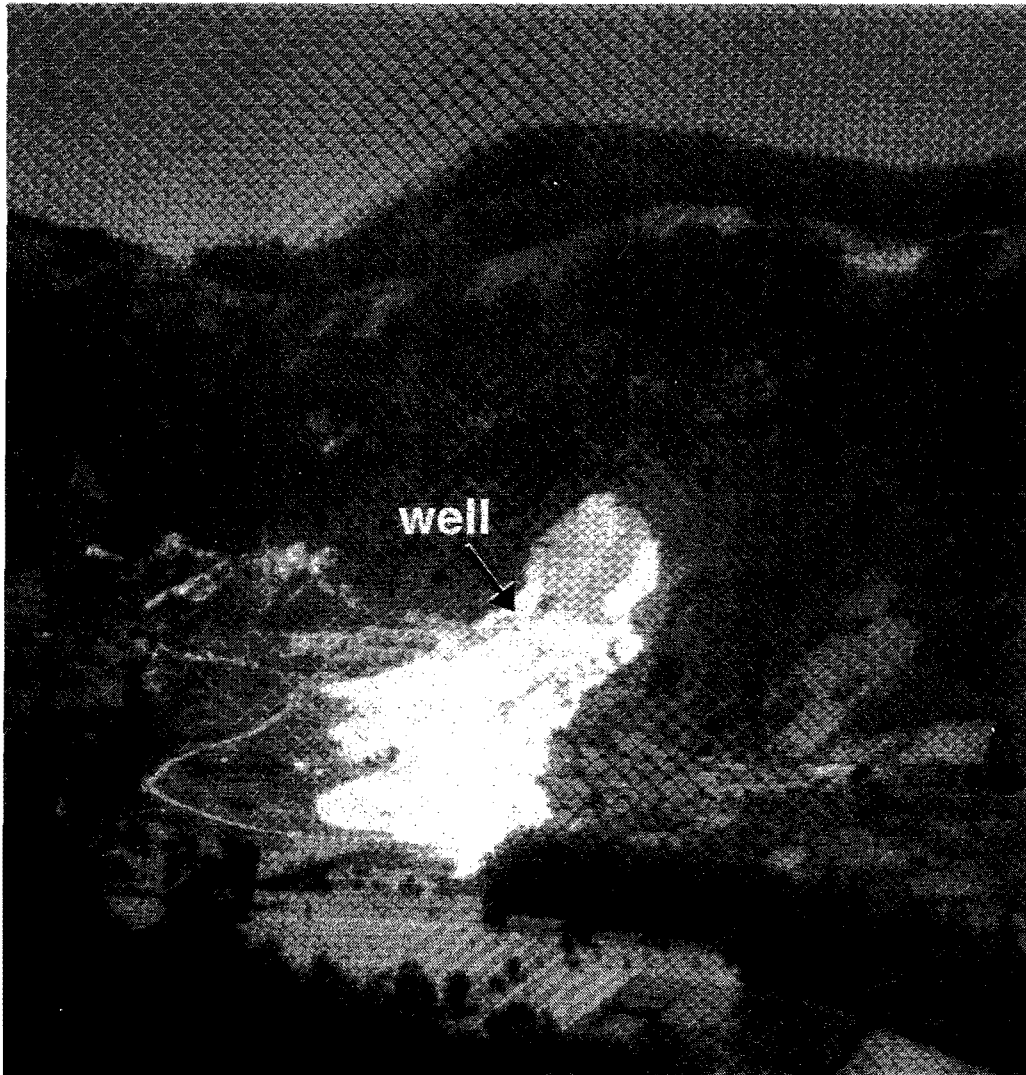
The landslide was multi-lobate in form and was nearly 800 m long, varying from 200 to 300 m in width. Thickness was estimated at three to ten meters. Twenty-three people who lived and farmed on the slopes below *la calera* were buried alive by this landslide.

Although relatively heavy vegetation and colluvium masks much of the bedrock, the landslide exposed a major trace of the Zunil fault zone (ZFZ, Figs. 1 and 2) on either side of the headwall area. The fault juxtaposes weathered to slightly altered andesite/dacite flow and flow breccia on the NW (upthrown side) against severely altered and brecciated volcanic rocks on the SE. The main fault plane is sharply defined by gouge, breccia, open cracks, and color contrast. Weak fumarolic emissions, smelling of H_2S and visible from steam, discharge from open cracks along isolated locations on the main fault trace. Alteration consists mainly of kaolinite with minor Fe-oxides, silica minerals, and various sulfates formed by oxidation of acidic gases rising from the underlying geothermal system (reservoir temperature $\leq 300^\circ C$) and by oxidation of disseminated pyrite in the host rocks. Oxidation of sulfur forms natural sulfuric acid.

The landslide displayed a classic circular failure mode and had an estimated volume of $800,000 \text{ m}^3$ (Flynn et al., 1991). The slide consisted of one main lobe of white- to green-colored, highly fluidized volcanic breccia that moved downslope rapidly as a mudflow. Two to four smaller subsidiary lobes, less fluidized than the first, followed the initial lobe. These landslide lobes damaged and buried the well ZCQ-4. A small crater roughly 15 m in diameter

soon developed a few meters downslope of the well. The crater apparently formed when debris that had buried the damaged well were forcibly ejected by a mixture of hot water and steam that escaped from the well. As the crater formed, a radial blanket of fine-grained mud up to several centimeters thick was deposited around the crater. It is likely that a post-slide blast was interpreted as an exploding geothermal well by some of the early observers.

Fig. 2: Photo looking west at the catastrophic landslide that killed 23 people on January 5, 1991 at the Zunil I geothermal field, Guatemala. The area is heavily cultivated from terraced fields. Because of its fluidized character, many local inhabitants mistakenly thought the slide was a white lava flow. Note steam near headwall of slide from damaged well ZCQ-4.

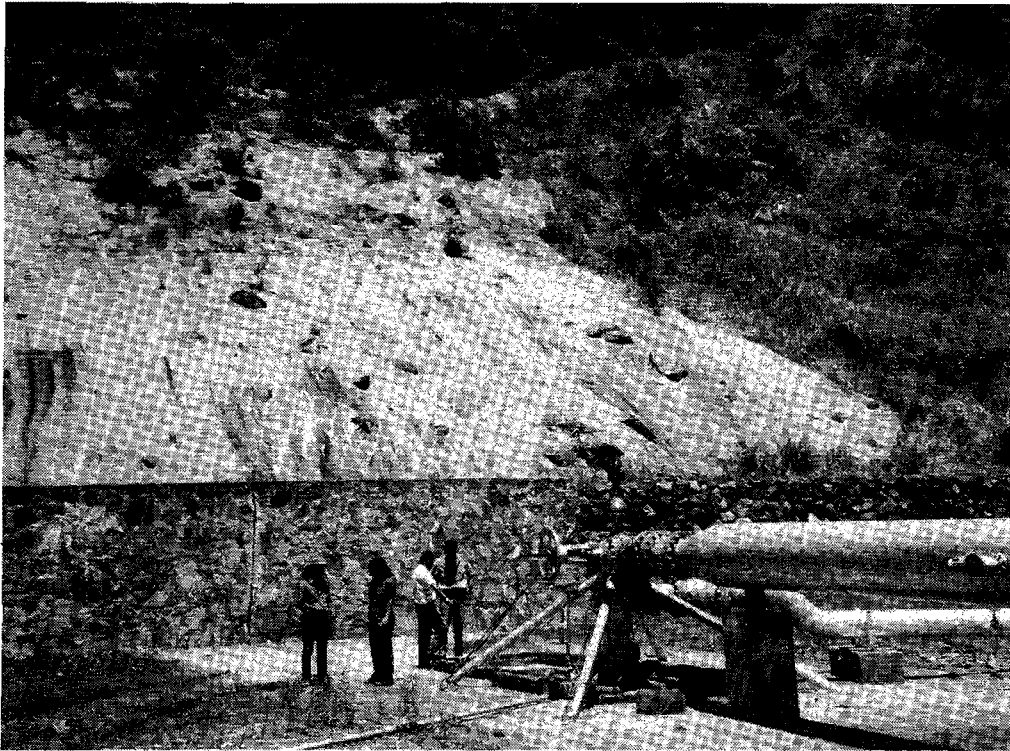
El Salvador is a small country with impressive geothermal resources (Fig. 3). One of the most noticeable characteristics of the Berlin geothermal field is the steep topography and presence of a large landslide complex. Local zones of fumarolic activity and hydrothermal alteration occur in the complex. Several areas within the complex displaying past or present creep were shown to the authors during a visit in 1994. Of major concern, the most productive well in the field at that time (TR-2) was located at the base of an obvious headwall scarp near the top of the slide complex (Fig. 4). The ground surrounding the TR-2 was riddled with cracks (which grouting could not stabilize), the paved road just above the headwall scarp displayed arcuate subsidence cracks, and the casing of the well was leaking steam due to damage caused by creeping ground. Access roads, project headquarters, and the small binary power plant of the field were all located in the slide complex several hundred meters below

Fig. 4: Photo of well TR-2 showing grouted slope, Berlin geothermal field, El Salvador. The grout did not prevent continued ground cracking and other “creep” phenomena in the landslide encompassing the well.

The Zunil catastrophe shows that it is not immediately obvious where and when slope failures will occur. A recommendation was given to the El Salvadorian Electric Utility (CEL) that summarized the parallels between Zunil and Berlin and suggested that CEL implement work to monitor the slides, re-evaluate the landslide hazard with respect to infrastructure, and to possibly abandon well TR-2 after redrilling of a replacement well(s) from stable ground (Goff, 1994).

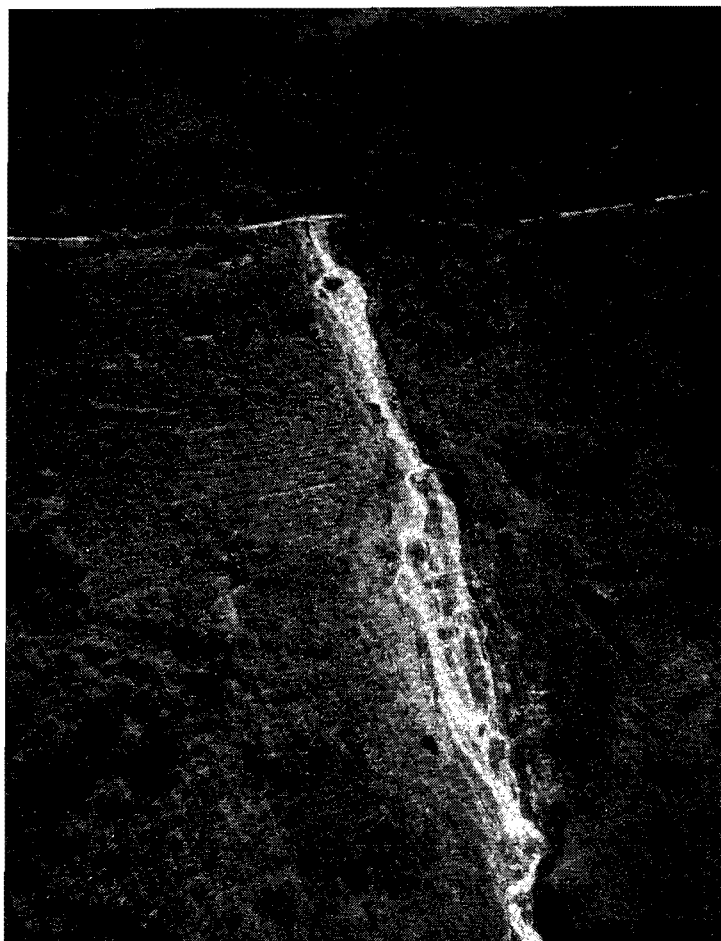
The Ahuachapán geothermal field is one of the world's first liquid-dominated geothermal reservoirs to produce electric power and is a geothermal success story of the 1960's and 1970's. Because initial efforts to drill and manage reinjection wells were unsuccessful, an 82-km-long canal (“canaleta”) was constructed to remove geothermal brine from the power plant and dump it in the ocean. The canal traverses many kilometers of rugged terrain along its journey to the ocean and has been used since 1978. It generally carries 0.35 m³/s of waste brine. When examined in summer 1994, no waste brine was reaching the ocean because of major leaks along the canal. The largest leak occurred only 2 to 3 km from the Ahuachapán power plant (Fig. 5) and allowed geothermal brine to cascade down a steep slope into the Río San Rafael, which drains into the Río Paz (the local boarder between Guatemala and El Salvador). Analysis of the fluid cascading into the Río San Rafael (45°C) showed that it far exceeded U.S. Environmental Protection Agency (EPA) limits for As, B, and Cl (about 9, 110, and 7620 ppm, respectively). For example, As levels in the waste brine were about 175 times higher than EPA limits and the waste would need to be diluted with about 225,000 tons/hr of essentially pure water to bring concentration levels down to EPA limits (Goff, 1994).

Since local residents wash their clothes and domestic animals drink in the Río San Rafael, the leaking canaleta is a rather toxic example of an environmental hazard. In addition, the canal is so long that it is impossible to patrol; thus, many sections of the canal roof have been removed by nearby inhabitants to construct buildings. Animals and people have fallen into the hot waste brine and have died by drowning or from burns. Future drilling and wise use of reinjection wells is the only solution that will permanently remove this hazard from the local scene.

Fig. 5: Photo of waste geothermal fluid leaking from the canaleta near Ahuachapán geothermal field, summer 1994. This fluid contained 9 ppm As as well as high concentrations of other constituents.

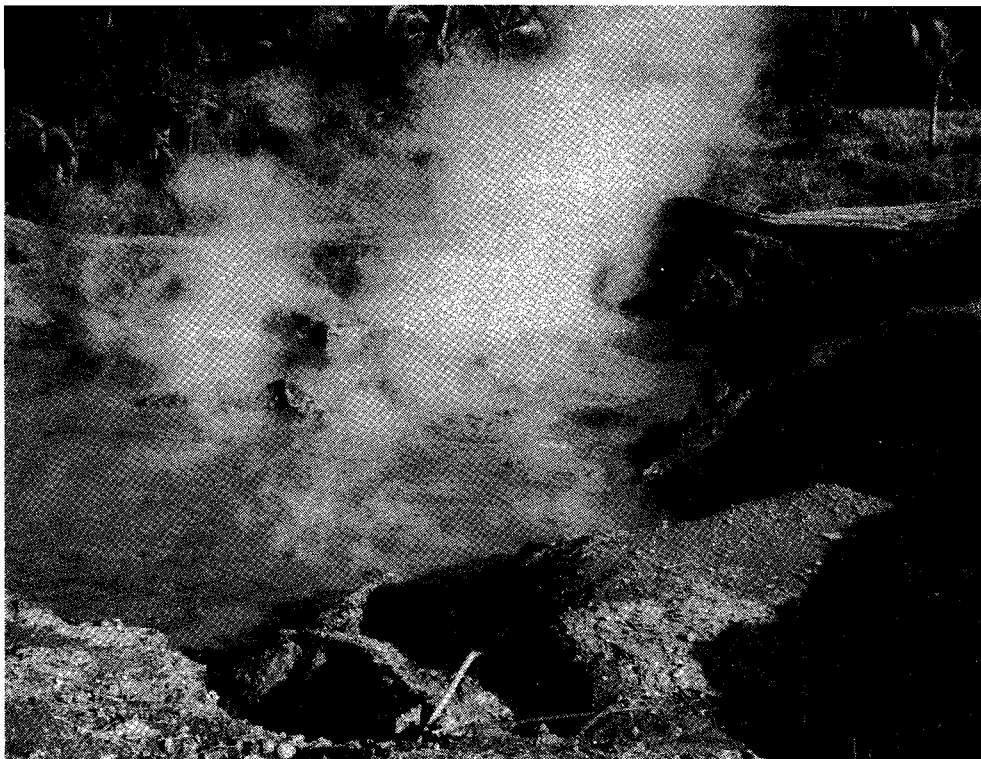
Hydrothermal (phreatic) explosions are relatively common phenomena in and near fumarole areas of high-temperature geothermal systems. At 0300 hrs on October 13, 1990, a tragic hydrothermal explosion occurred at the fumarole area named Agua Shuca which killed 25 people who lived in a small village near the margin of the boiling mud pools (Bruno et al., 1992). The site (Fig. 6) is located on the SW side of the Ahuachapán geothermal field. A similar explosion had occurred at Agua Shuca probably in 1868 and at an earlier but unknown time at La Labor fumarole in the NW part of the geothermal field. The latter explosion is inferred by the presence of a 200-m-diameter crater that is 20 to 25 m deep. The Agua Shuca eruption of 1990 enlarged the pre-existing 25-m-diameter crater to one that was over 40 m in diameter and over 5 m deep. The volume of ejected material was 1600 m³. People in the surrounding houses died or suffered injuries in their sleep from a "violent rainfall of boiling water, mud, altered soil, and rocks . . ." (Bruno et al., 1992).

Fig. 6: Photo of the Agua Shuca explosion crater, Ahuachapán area. The explosion of this feature about four years earlier killed and injured many people who lived on its edge. In the summer of 1994, the crater was a muddy, boiling cauldron.

Although several explanations for the explosion are evaluated by Bruno et al. (1992), no firm conclusions were reached. All inhabitants were removed from the immediate margins of the fumarole areas and the existing buildings were destroyed. A monitoring program that incorporates chemical, temperature, heat flow, shallow seismic, and survey measurements of the fumarole areas might forecast future explosions.

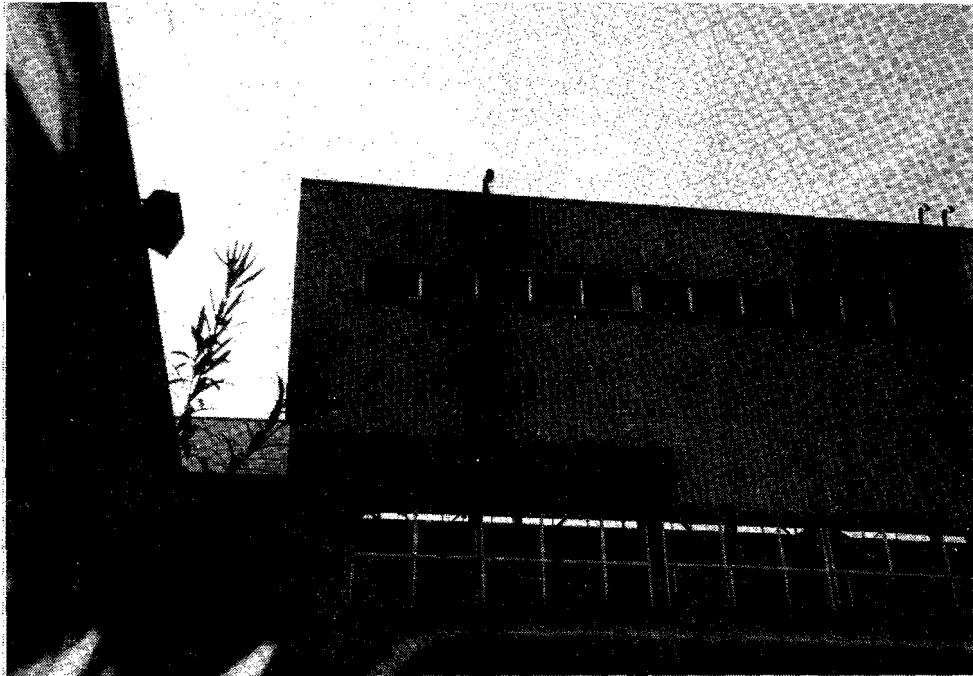
Evaluation of noncondensable gas data from the Ahuachapán geothermal field shows that H_2S is the only gas constituent in recovery operations that seriously impacts air quality (Dennis et al., 1990). During a tour of the Ahuachapán site on June 28, 1994, the odor of H_2S was strong both inside and outside the power plant. At that time, a small ejector pipe discharged noncondensable gases 1 to 2 m above the roof of the power plant and roughly 15 m above ground level (Fig. 7). The power plant has a small chemistry laboratory used to monitor water quality in different areas of plant operations, but in 1994 there was no in-house capability to measure gas compositions nor was there on-site portable H_2S measuring equipment.

An evaluation of the H_2S problem at the power plant by ELC (1994) used fluid production and composition data and a meteorological code to calculate probable air quality without heed to real air quality measurements. Among other conclusions, ELC stated that in the worst case situation, H_2S concentrations in air will exceed "strict" American air quality limits but will never exceed Italian limits. The U.S. Occupational Safety and Health (OSHA) ceiling level for H_2S is 14 mg/m^3 but an ambient air quality standard of 0.042 mg/m^3 is used in California (Goff, 1994).

Fig. 7: Stack at Ahuachapán power plant emitting non-condensable gases including lethal H_2S , summer 1994.

Because H_2S is an insidious poisonous gas, a credible accident scenario should be developed for the power plant. Several kinds of reliable monitoring equipment are available that have reasonable cost ($\leq \$10,000$ depending on type of device). When appropriate data are collected, a suitable abatement scheme can be planned. Occupational health standards of H_2S levels in air vary from country to country but to prevent adverse health problems, levels should be low enough to protect the very young, the very old, and the infirm.
