DETERMINATION OF CASING CONDITION USING MECHANICAL AND ELECTRIC LOGS

P. F. Bixley

Ministry of Works and Development, Geothermal Projects Office,
Wairakei

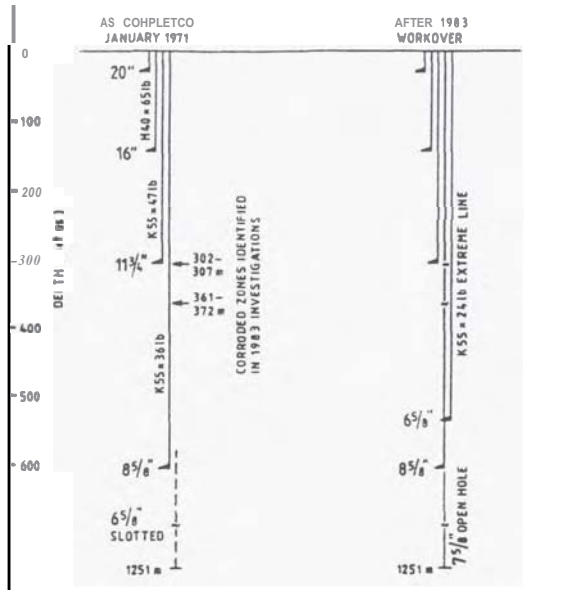
figure 1. BR25 well details before and after the 1983 workover.

The BR25 well details before and after the December 1983 workover to repair the production casing are shown on figure 1. The first indication of a problem was an Otis caliper run in May 1983 which showed severe damage over length 18 (361-373m) and moderate deformation on length 23 (296-309m). A Kinley survey in September confirmed the Otis survey that damage was confined to two lengths only (figure 2). Two cross-sections taken off the Kinley record are shown on figure 3.

After casing investigations had been completed, the bottom plug was drilled out and the 6-5/8 inch slotted liner removed. After placing a drillable plug at 600m a 6-5/8 inch extreme line casing was run and cemented to 540m.

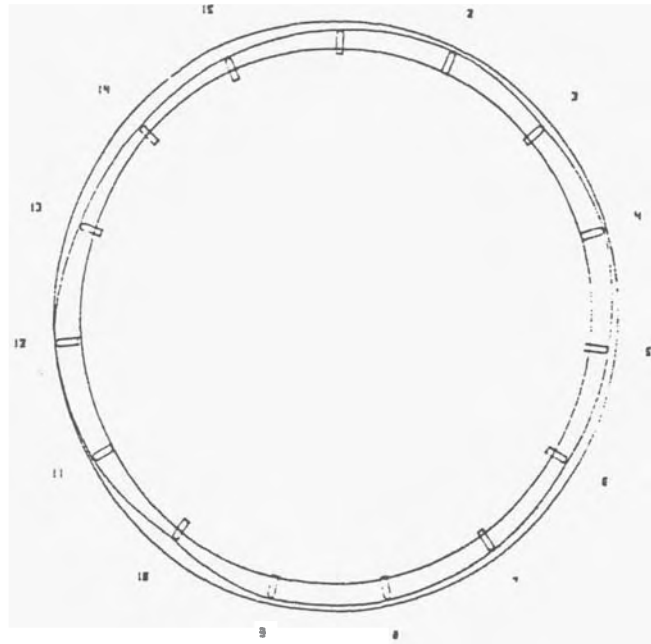
figure 3. Casing cross-section at 370m depth. The two concentric circles represent original casing ID and OD, and the irregular line the measured ID from the Kinley survey.
