TURBINE WASHING TO REMOVE NOZZLE DEPOSITION AT WAIRAKEI

C. J. MORRIS & L. G. BACON

Contact Geothermal, Wairakei

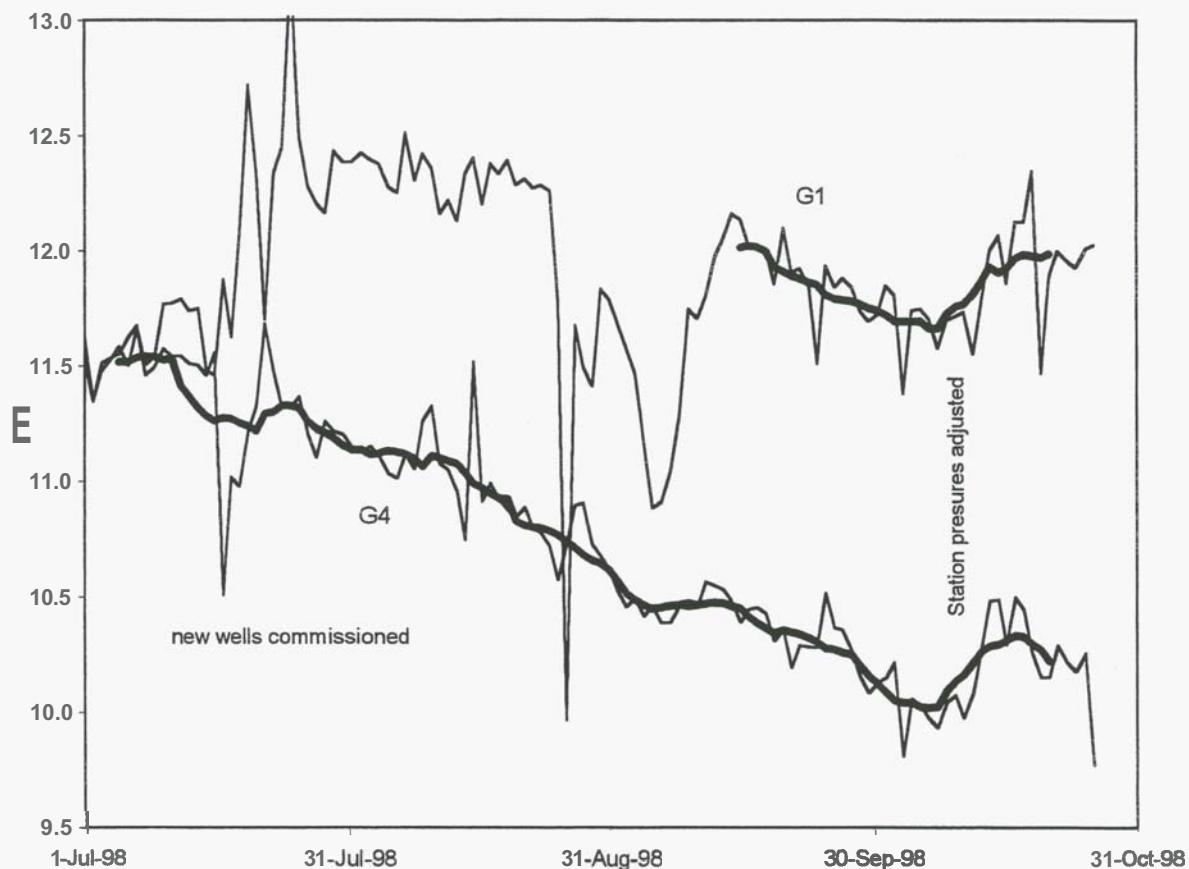
Figure 1. Turbine output decline from deposition associated with new wells

line was interconnected with the western borefield wells. Under the old flow regime, the western borefield **steam** which was wet, flowed into R line at A10. When the new wells were connected, the R line **steam** flowed into the lines from the western borefield. This change in flow regime meant that as the **steam's** velocity increased, the **dryness** of the **steam** increased. The IP turbines started to clog up the day the new wells were commissioned. G4 is thought to have declined in output first because its machine nozzles were already partially clogged. Within 3 months, one of the turbines had a 20% decline in output. Figure 1 shows the effect of the well commissioning and output decrease. The figures shown are the average generation for the day so are affected by other station and machine activities. Trend lines have been added to remove these day to day fluctuations.

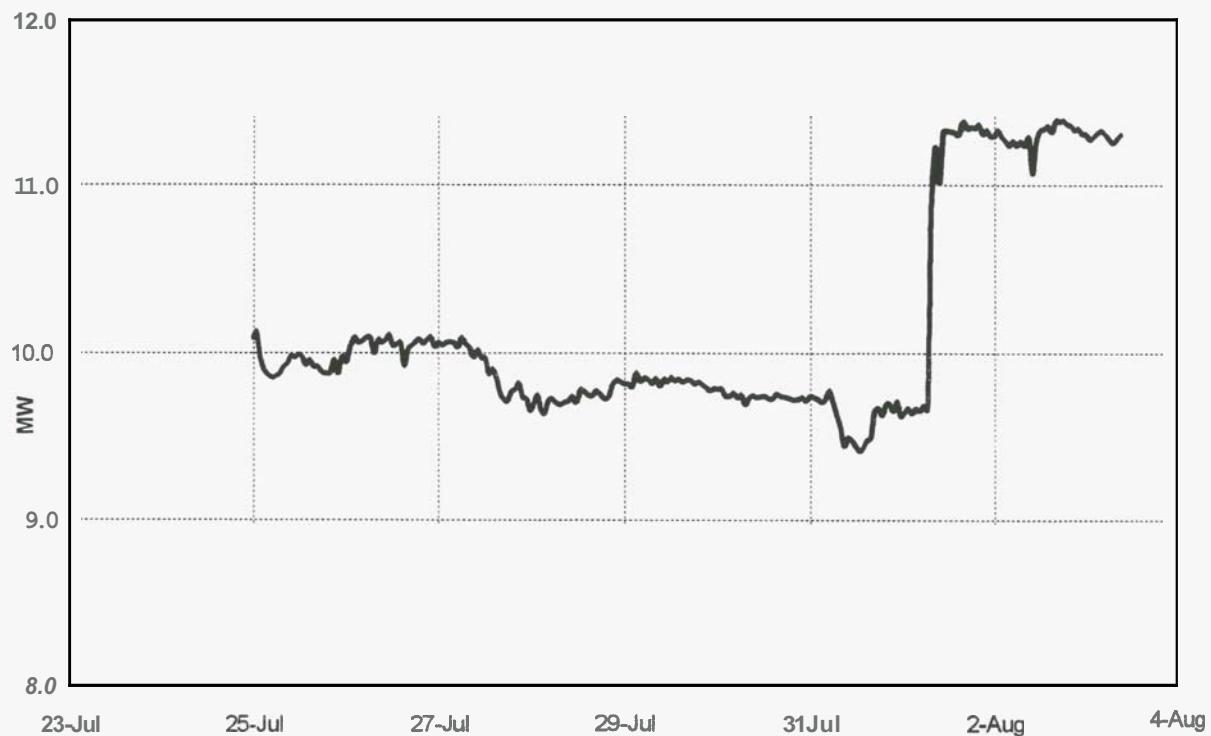
Figure 2

Turbine generation during a turbine wash
