WAYANG WINDU POWER STATION TURBINE ROTOR REPAIR REVIEW

Alan C. Robinson, Scott G. Baigent & H. Brett Houston*

Progen Ltd, 2/829 Heaphy Terrace, Hamilton, New Zealand 3140

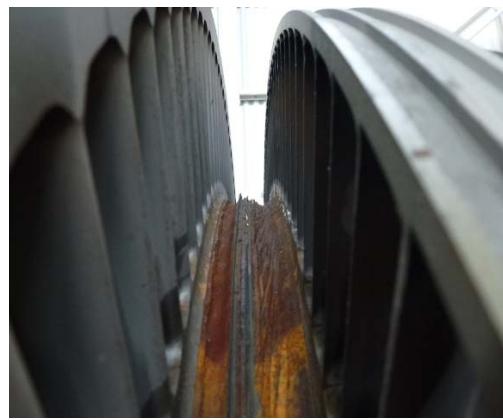
The major erosion damage to the rotor is located on the rotor body between each of the reaction stages. Several of the seal "J" strips in these sections have been eliminated through the erosion of the parent metal surrounding the caulking groove. An example of this erosion at interstage 3 is shown in Figure 3.

Figure 3 - Erosion at Interstage 3

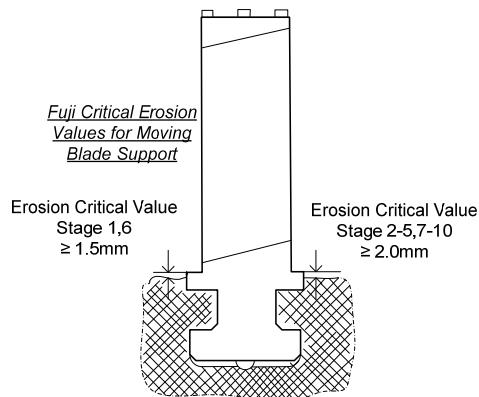
The erosion has encroached into the blade support slot at almost all blade locations. Note that the OEM (Fuji) has indicated that the blade support shoulder is critical to the security of the blades.

The erosion of the blade support shoulders is most noticeable in the middle reaction stages of each of the flows. This shoulder erosion has progressed since the 2009 overhaul to the point where stages 2-4 and stage 8 were outside the tolerances specified by the OEM (Fuji) as shown in Figure 4.

Figure 4 - Erosion at blade support slots

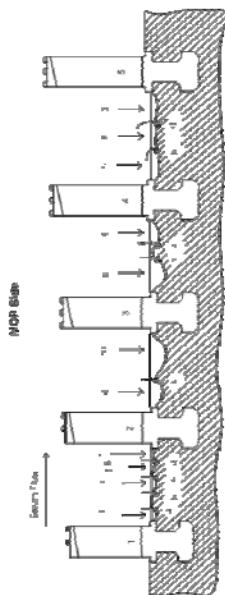
The erosion of the seal areas of the main oil pump (MOP) end section is noticeably more advanced than that of the generator end as shown in Figures 5 and 6. Of the 18 seal strips that were originally installed at each end of the rotor, only 9 remain in the MOP end whilst 16 remain in the generator end.

Figure 5 – MOP side erosion

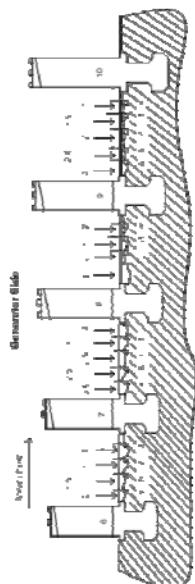
A notable point with the generator end is that almost all of the caulking grooves had now been fully exposed on the upstream side. As a result there was a high potential for the seal strip caulking being dislodged in the near future should the rotor be returned to service in its current condition. It was also likely that a number of the adjacent strips may also be dislodged and results in major consequential damage to the blading components.

Figure 6 – Generator side erosion

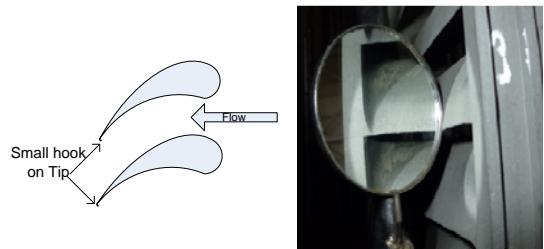
Closer inspection revealed that the trailing edge of the blades have a slight hook curving into the port of the blade. The edges of the blades are mostly thinned to a fine knife-edge which has weakened the stability of the exit of the port. The slightly ragged trailing edge can be seen in the Figure 7.

Figure 7 - Blade tip trailing edge erosion

The hook shape has been formed from the deflection of the fine edge by either the grit-blast cleaning of the blades or the steam/water droplet and (at times) deposit laden media passing through the stages. The formation of this edge was not able to be checked prior to the blast cleaning of the rotor so the actual "as found" shape of the trailing edge could not be confirmed

Most of the blades exhibited some erosion on the pressure faces. This erosion is limited to the inner and outer radial extremities of the port. The blade in Figure 7 shows a slight curve on the outer end of the trailing edge indicating the erosion. This curve is replicated on the inner edge of the port wall as well.
