Surface Analysis of Carbon Steel and Corrosion-Resistant Alloys Exposed to Acid- SO_4^{\pm} Chloride Type Geothermal Fluid

James Nogara^{1*} and Sadiq J. Zarrouk^{2†}

Keywords: corrosion, geothermal fluid, CRA, surface analysis, Acid sulphate, low-pH, ESEM-EDS, XRD

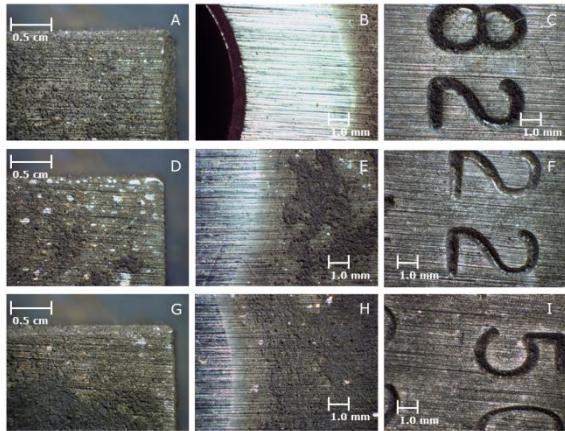
It was observed that all of the CRA's were covered with a scale in the section exposed to the fluid consisting of gray to dark brown resinous grains. The thickness of the scale varied across the surfaces of the coupons but generally covered most of the exposed surface. In the section covered by the insulating spacers, the scale was visibly absent and

the luster and surface texture of the CRA's in these areas were almost similar to their appearance before exposure to the fluid. Thicker scale deposits were observed to form inside the stencil marks and towards the center of the coupons. When the scale was chipped-off from the surface of the CRA, the appearance of the exposed metal surface was similar to the original color, luster and texture (original grinding scratches).

Figure 5. Images of the corrosion coupons after exposure to acid-SO₄ chloride geothermal fluid for 32 days viewed from the photomicroscope. A-C: images of Alloy 825 samples taken at the corner of the coupon (A), near the bolt hole which was shielded by insulating spacer (B) and near the stenciled coupon name (C). D-F are images of DSS 2205 while G-I, showed images taken from DSS 2507.

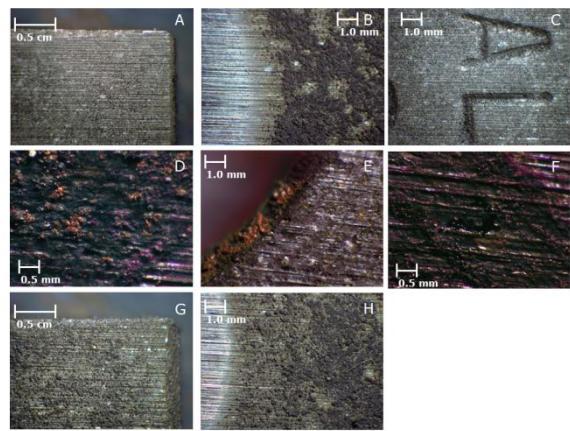
This resinous scale was also present in both K55 and L80 coupons but only in the exposed areas of the coupons. The color of the K55 coupon (Figure 7, D-F) turned reddish black while the L80 coupon (Figure 6, G-I) turned dark gray to black. The section of the coupons covered by the insulating spacers has also been transformed in color and in texture but different from the exposed surface. Corrosion damage was visible across the surface of both carbon steel coupons. The grinding marks had been eroded to some degree and corrosion craters were visible in K55 (Figure 6, D). Corrosion damage appeared to be more pronounced in the section covered by the insulating washer. Formations of rust tubercles were also evident around the rim of the K55 coupon hole. Numerous microscopic pits were observed in the L80 coupon surface. The corrosion damage in the L80 coupon covered by the insulating spacer was similar to that observed in the K55 coupon. Parts of the stencil marks in the K55 coupon were no longer visible because of corrosion damage in contrast to L80 where the marks were still readable.

Figure 7. Images of the corrosion coupons after exposure to acid-SO₄ chloride geothermal fluid for 32 days viewed from the photomicroscope. A-C: images of AL6XN sample taken at the corner of the coupon (A), near the bolt hole which was shielded by insulating spacer (B) and near the stenciled coupon name (C). Second row (D-F) are images of carbon steel K55 while third row (G-H) showed images taken from Alloy 625.

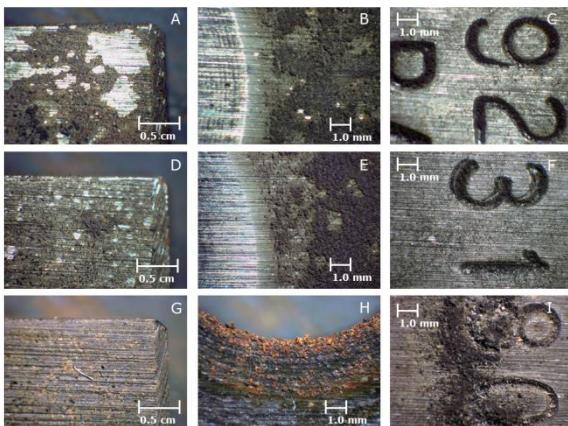
The absence of the resinous scale in the shielded areas of both carbon steel coupons was similar to that observed in the CRA's. In contrast, 'rusting' had occurred in the carbon steel coupons whereas; the CRA's appeared to be unchanged. In terms of severity of corrosion damage, the K55 coupon appeared to be more affected than the L80 coupon in the shielded area. The K55 coupon 'rusted' appearance was observed in both shielded and exposed areas, but the damage is more pronounced in the former. There was also a marked difference in the type of corrosion damage incurred by the L80 sample between shielded and exposed surfaces. The corrosion damage in the shielded surface was more uniform corrosion (rusting) while numerous small pits were observed on the exposed surface. Clearly, there was crevice corrosion effect observed for both carbon steel coupons.

It appears that the CRA coupons were immune to this type of corrosion in this fluid environment, with the exception of Alloy-59. There were a few rare pitting sites observed in the creviced surface of the Alloy-59 coupon. It should be pointed out again that underneath the scales that deposited in the exposed surface of the CRA's, the metal were essentially free of corrosion damage.

Figure 6. Images of the corrosion coupons after exposure to acid-SO₄ chloride geothermal fluid for 32 days viewed from the photomicroscope. A-C: images of Alloy 59 samples taken at the corner of the coupon (A), near the bolt hole which was shielded by insulating spacer (B) and near the stenciled coupon name (C). Photos D-F are images of Alloy 31, while G-I showed images taken from carbon steel L80 – Type 1.

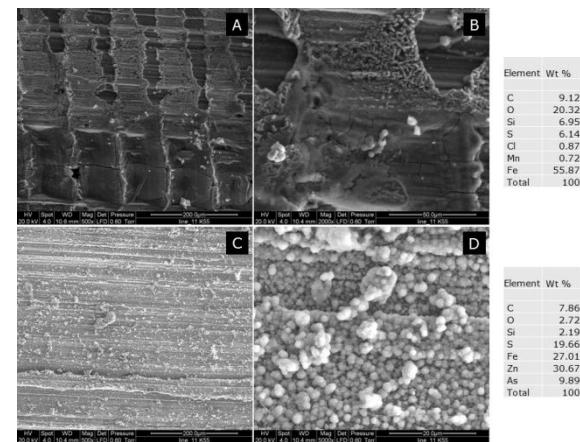
With regards to the carbon steel coupons, the appearance of the shielded (creviced) surfaces when viewed at high magnification were very different from the original metal before exposure to the acid fluid from the well (Figures 9 and 10). The grinding marks were considerably eroded and to some extent no longer visible. The surface appeared to show a paste-like mass with 'sandy' texture. 'Cotton-ball'-like globules were also observed forming from the mass. At 5000 \times magnification (Figure 9, B), some micro-crystals can be observed to grow from this mass of material. The form of these crystals when viewed at high magnification appeared to be isolated hexagonal plates (Figure 13, right image) in the L80 coupon and orthorhombic prisms in K55 coupon (Figure 13, left image). The color contrast between the hexagonal plates and the orthorhombic prisms indicate a difference in molecular mass. Crystal formation habit was also different for both as the hexagonal plates appeared as individual isolated crystals while the prisms form as continuous clusters.

In the exposed surface area of the carbon steel coupons, cubic crystals covered the surface similar to that observed in the CRA coupons. The result of the EDS analysis of the exposed area of the coupons also indicate the presence of large quantities of zinc and sulfur at the same abundance as that detected from the CRA's. Zinc composition by weight ranged from 30.67% – 44.88%, while sulfur was from 18.11% – 19.66%. The Zn/S molar ratio was 0.76 for K55 and 1.35 for the L80 coupon. Contrastingly, in the shielded area of the coupons, zinc was not detected by the EDS, but sulfur was present. Interestingly, the level of oxygen detected (>20% by weight) was unusually high in both coupons in contrast to the CRA's. Formation of iron oxides may explain this abundance of oxygen.

Figure 8. Surface SEM-EDS scan of the surface of K55 carbon steel coupon. Top row shows micrographs of the coupon taken from the area shielded (creviced) by the insulating spacer at low magnification (A) and high magnification (B). Bottom rows are micrographs of the area of the coupon exposed to the fluid viewed at low magnification (C) and high magnification (D). Elemental analysis results of the surface scan are shown in tables in the extreme right.

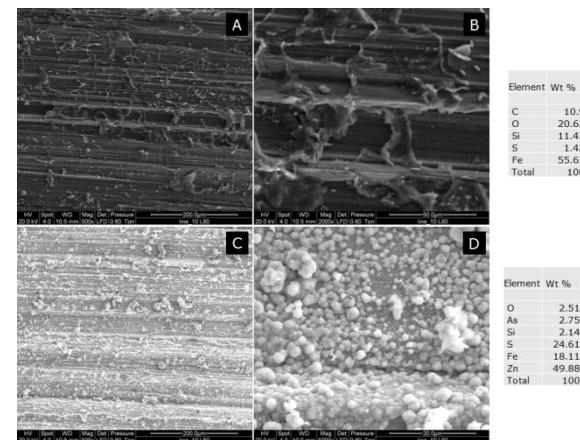
Figure 9. Surface SEM-EDS scan of the surface of L80-Type 1 carbon steel coupon. Top row shows micrographs of the coupon taken from the area shielded (creviced) by the insulating spacer at low magnification (A) and high magnification (B). Bottom rows are micrographs of the area of the coupon exposed to the fluid viewed at low magnification (C) and high magnification (D). Elemental analysis results of the surface scan are shown in tables in the extreme right.

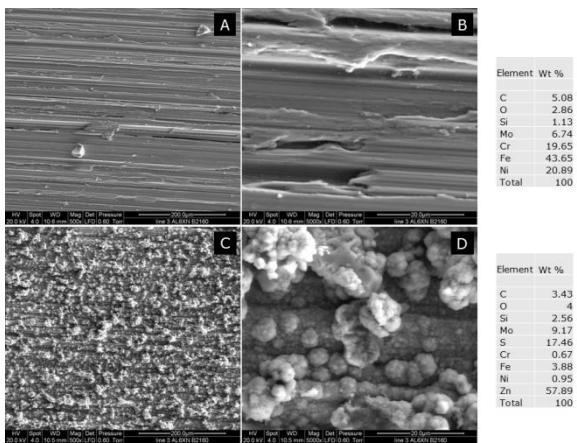
The SEM images of the CRA's show clearly that the surfaces of the coupons shielded by the insulating spacers were not covered by scale deposits. The original striation marks caused by grinding with 120-grit abrasives were visible without any deposition or crystalline corrosion product. In contrast, the exposed surfaces of the CRA coupons were partially or completely coated with scale and corrosion product. At high magnifications, the scale consisted of fine crystalline grains that appeared to aggregate to larger crystal structures. The shape of the crystals appeared primarily cubic but with slightly curved faces. There is also clear-cut distinction in the surface elemental analysis results between the shielded and exposed surfaces. As an example, in the AL6XN coupon (Figure 11), the elemental composition EDS scan of the surface essentially mirrored the composition of alloy as specified

Figure 10. Surface SEM-EDS scan of the surface of AL6XN coupon. Top row shows micrographs of the coupon taken from the area shielded (creviced) by the insulating spacer at low magnification (A) and high magnification (B). Bottom rows are micrographs of the area of the coupon exposed to the fluid viewed at low magnification (C) and high magnification (D). Elemental analysis results of the surface scan are shown in tables in the extreme right.

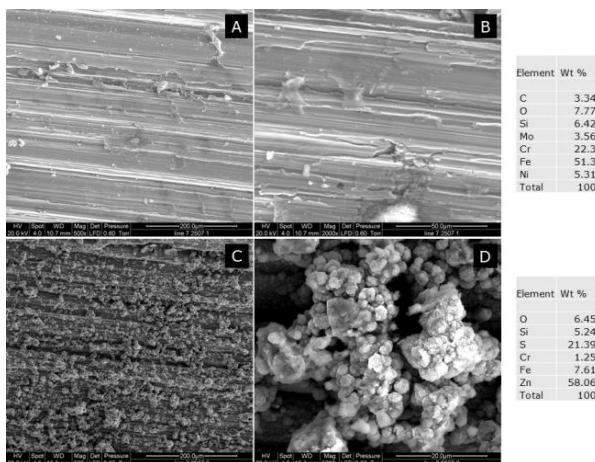
Figure 11. Surface SEM-EDS scan of the surface of DSS 2507 coupon. Top row shows micrographs of the coupon taken from the area shielded (creviced) by the insulating spacer at low magnification (A) and high magnification (B). Bottom rows are micrographs of the area of the coupon exposed to the fluid viewed at low magnification (C) and high magnification (D). Elemental analysis results of the surface scan are shown in tables in the extreme right.

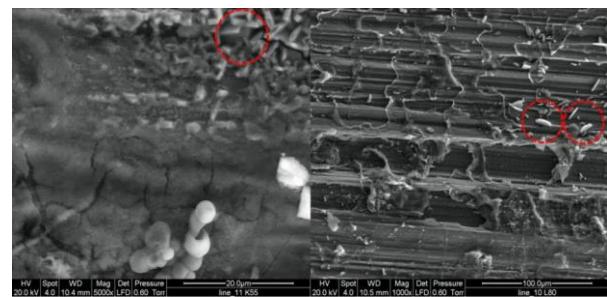
In Figure 12, B microscopic damage was observed on the surface of DSS 2507 at the shielded surface of the coupon.

This could be an initiation site for pitting corrosion based on the shape of the damage. The damage appeared to be a circular depression about 25 μm in diameter. Note that this damage was not visible from the optical microscopy inspection.

Figure 12. Growth of larger orthorhombic prisms (possibly goethite) from an amorphous mass of iron oxides in the creviced surface of the K55 coupon (Left). Isolated hexagonal plate crystals (possibly troilite) are observed to form in the corroded surface of in the crevice of the L80 – Type 1 coupon (Right).

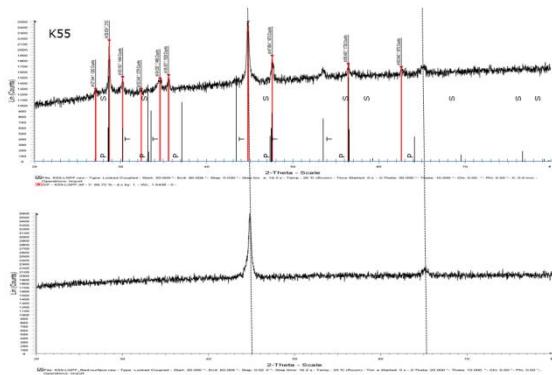
Based on the EDS analysis results, the XRD from the shielded area of the carbon steel coupons should yield a different set of diffractograms owing to the absence of zinc and the abundance of iron and oxygen. In the scale that formed on the exposed surface, XRD analyses gave poor match with respect to iron oxides including: magnetite ($Fe^{2+}Fe_2^{3+}O_4$), hematite (Fe_2O_3) and maghemite ($Fe_2^{3+}O_3$) and iron oxy-hydroxides: lepidochrocite $\gamma-Fe^{3+}O(OH)$, goethite ($\alpha-Fe^{3+}O(OH)$) and akaganeite ($\beta-Fe^{3+}O(OH,Cl)$). Iron carbonate siderite ($FeCO_3$) similarly did not produce good match in terms of diffraction peaks. It is possible that the diffraction patterns of these minerals were masked by

the sulfides owing to their relatively trace amounts within the bulk scale composition.

Figure 13. X-Ray diffractograms of carbon steel K55. Pattern of characteristic radiation peaks of the substrate metal (Bottom) and the scaled surface (Top). Also shown in the scaled surface diffractogram are the diffraction pattern of sphalerite (S), troilite (T), and pyrrhotite (P).

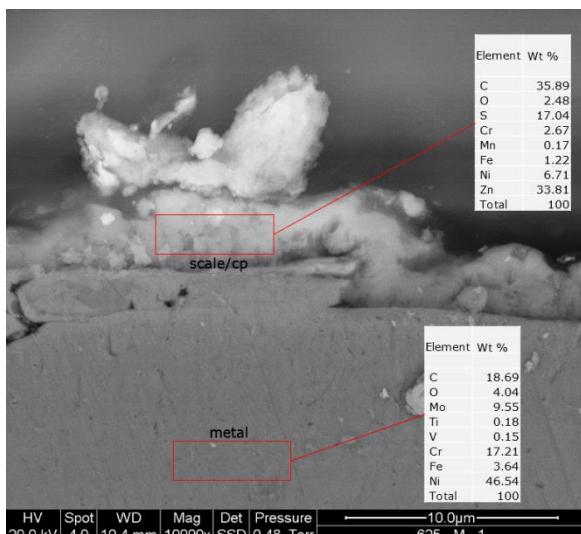
There was no observable damage or defect to the metal surface underlying the scale such as pitting or cracking in the Alloy-625 coupon (Figure 15). The same is true for Alloy-31, AL6XN and DSS 2205. Some form of pitting was observed on the surface of duplex stainless steel 2507 (Figure 16). This was also observed in both optical microscope and surface SEM scans within the shielded area of the coupon. In Figure 16, a pit is visible on the left side of the image. The pit formed under a scale of sulfides that were about 10 μm thick. Some isolated small pits were likewise observed in Alloy 825 but because of its rarity, this needs to be further verified with future tests. It was

Figure 14. Micrograph of the Alloys 625 with sulfide scale as viewed from the cross-section. The EDS elemental analysis result is shown for both scale and metal to contrast the chemical composition. The scan area is represented by the red rectangle.

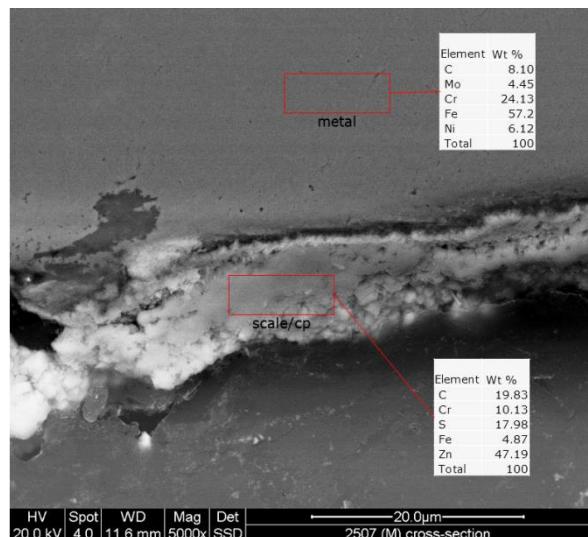
expected that DSS 2507 would be less prone to pitting damage compared to DSS 2205 because of the higher PRE number. In this experiment, 2205 appears to be immune while 2507 showed rare occurrence of pitting corrosion and visible metal damage.

Figure 15. Micrograph of the DSS 2507 with sulfide scale as viewed from the cross-section. The EDS elemental analysis result is shown for both scale and metal to contrast the chemical composition. The scan areas are represented by the red rectangles. A corrosion pit is clearly visible on the left side of the image.

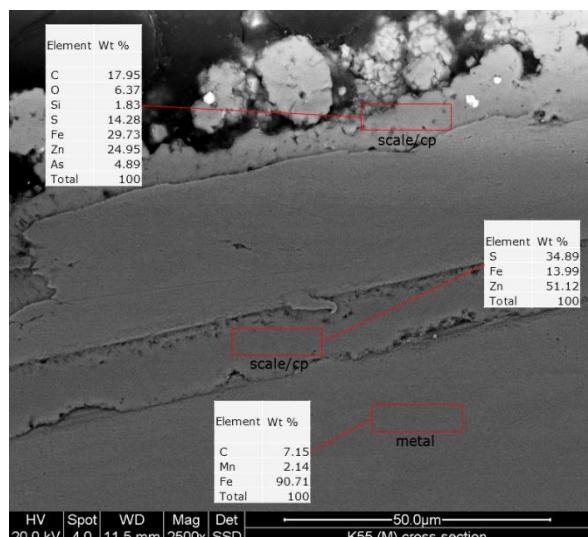
In carbon steel samples, deep pits formed ($> 10 \mu\text{m}$ deep) and interestingly, the pits propagated perpendicular to the pit hole underneath the metal surface. This resulted to formation of sulfide scale underneath a layer of metal. As can be observed in the K55 cross-section (Figure 16), there were alternating layers of metal and scale formed near the surface. The shape of the pit can be clearly seen in the L80 coupon cross section (Figure 17). In the image, a pit with a diameter of about 5 μm formed on the surface of the metal. The pit penetrated to a depth of about 10 μm and hereafter propagated laterally underneath a layer of metal. From there it appears that the deep pit that formed is subsequently plugged by sulfide scales. This explains the observed alternating scale – metal layers as viewed from the cross-section.

Figure 16. Micrograph of the carbon steel K55 with sulfide scale as viewed from the cross-section. The EDS elemental analysis result is shown for both scale and metal to contrast the chemical composition. The scan areas are represented by the red rectangles. Interlayering of metal and sulfide scale is shown in the image.

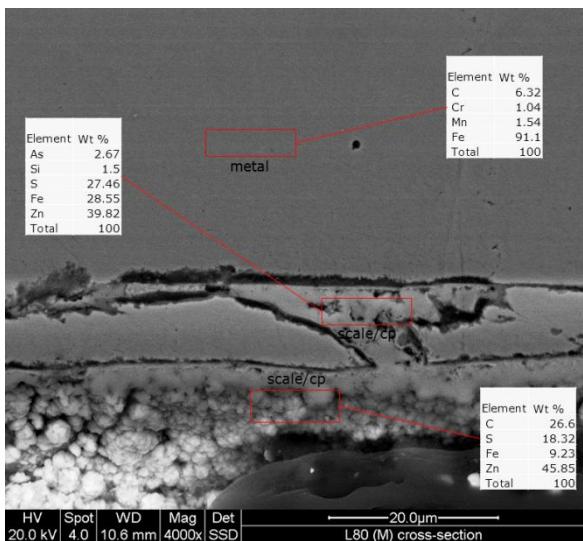
Figure 17. Micrograph of the L80 carbon steel with sulfide scale as viewed from the cross-section. The EDS elemental analysis result is shown for both scale and metal to contrast the chemical composition. The scan areas are represented by the red rectangles.
