FLATNESS SURVEY AND CORRECTION OF TURBINE-GENERATOR ALIGNMENT USING LASER MEASUREMENT TECHNIQUES

Michael A. Robinson¹ and H. Brett Houston²

^{1, 2} ProGen Ltd, 2/829 Heaphy Terrace, Hamilton, New Zealand 3240

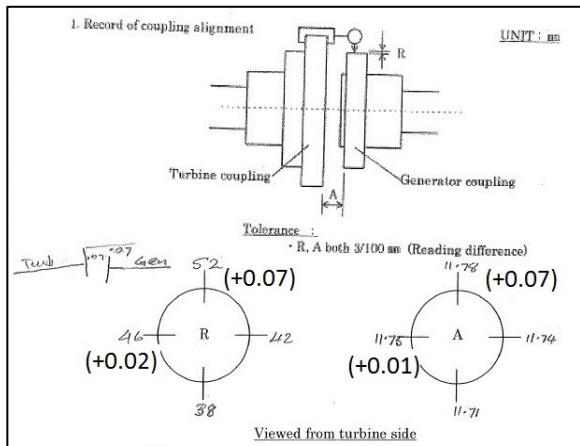
Figure 2: As-Found Shaft Alignment³

As-found shaft alignment measurements showed that: the turbine coupling hub was higher than the generator hub by 0.07mm, and the coupling gap was open at the top by 0.07mm; against targets of 0.00mm. The coupling gap figures, regarded alone, would seem to indicate that either the front of the turbine or the rear of the generator should be raised by approximately 0.5mm to correct this gap. Lifting the front of the turbine would partially correct the height offset of the turbine coupling hub; whereas lifting the rear bearing of the generator would exacerbate that issue, and require lifting both front and rear generator bearings significantly.

Previous inspection records showed that realignment of the TG had been conducted during past overhaul work, so these measurements were only be used for an indication of the as-found state of the unit. Calculations for final shaft alignment adjustments were based on measurements conducted after the turbine casing had been shimmed.

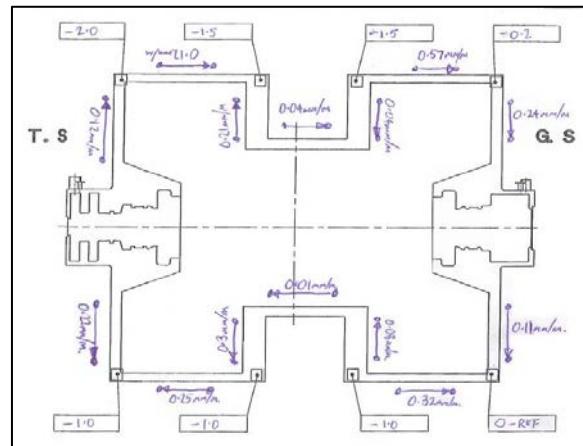
Figure 3: Optical and Spirit Level Measurements (3)

The measurements taken with the optical level indicated that the left front corner of the casing was lower than the right rear by about 2mm. Spirit level measurements showed that the area of #1 bearing could be even lower.

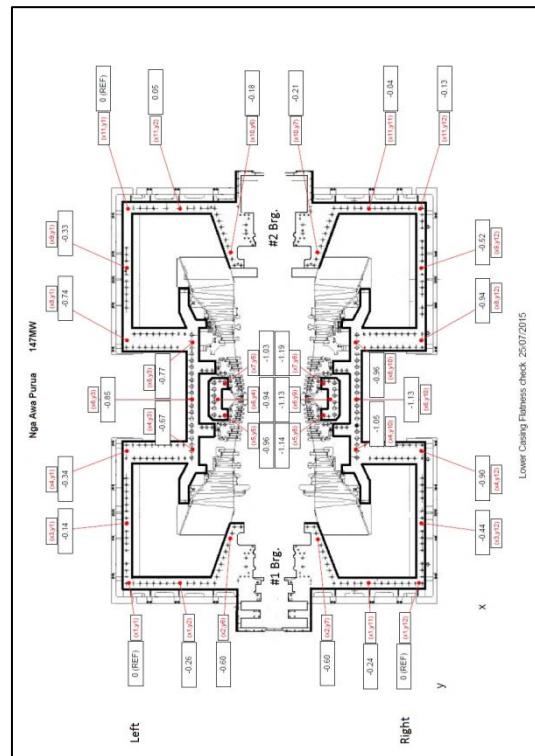
Figure 4: As-Found Lower Casing Flatness³

The measurements showed that a general bow shaped depression existed along the length of the casing. The maximum depression was in the region of the centre right of the casing with approximately 1.2mm maximum magnitude.

There was also a depression along the width of the front of the casing in the region of the #1 bearing, with approximately 0.6mm maximum magnitude.

The current method used to set the diaphragm heights is to adjust them level with the half joint face of the casings. This method assumes that the casing is flat and level. So, considering that the internal seal clearances are in the order of 0.3 – 0.4mm, it is clear that with a depression of up to 1.2mm along the length of the casings there was a high risk of diaphragm seal contact with the rotor.

It was decided that the turbine lower casing would be shifted nearer to true level, and that the depressions would be flattened out simultaneously. This would be achieved by lifting the left front of the turbine by about 2mm, and the right front by about 1mm. The rear corners would not be disturbed.

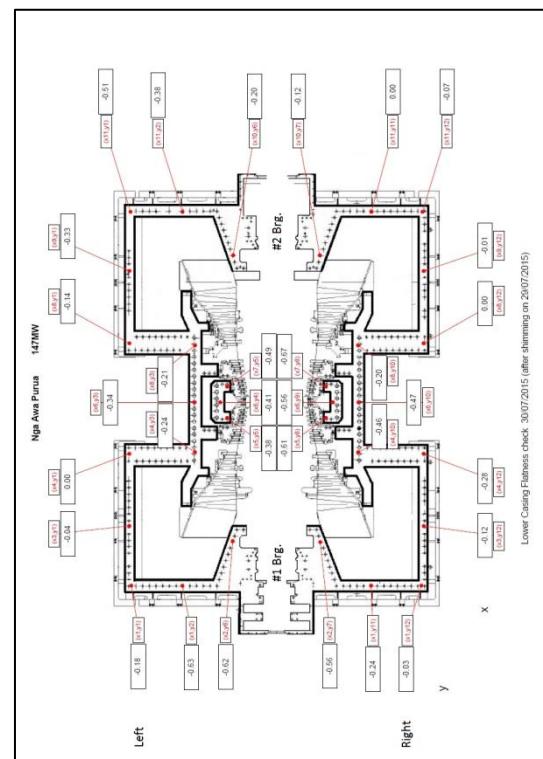
Figure 6: As-Left Lower Casing Flatness³

The results presented in Figure 6 are displayed as 'all negative'. The highest points have changed: from three of the corners previously; to two points near the middle of the sides, and one point near the right rear corner. It can be seen that there is less variation in the measurements; i.e. the turbine casing is flatter. Due to time pressure only one attempt at flattening the casing was made. Given at least one more shim alteration, it would have been possible to flatten the casing even further; potentially to within 0.3mm variance.

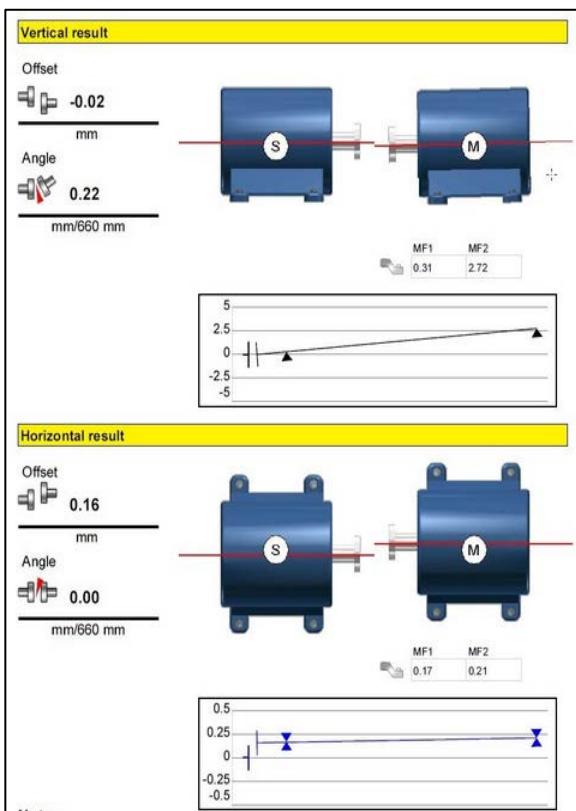
Figure 7: Shaft Alignment after Casing Shimming³

Initial results showed that the coupling gap was open at the bottom by 0.22mm. This is consistent with records showing that the generator had been raised significantly at the rear; probably unwittingly accounting for the turbine casing subsiding at the front.

Since the turbine casing was by this time relatively level, it was planned to lower the rear of the generator by about 2.7mm to correct the alignment.

Adjustments were made to the generator in the vertical and horizontal directions, bringing the alignment back within tolerance.

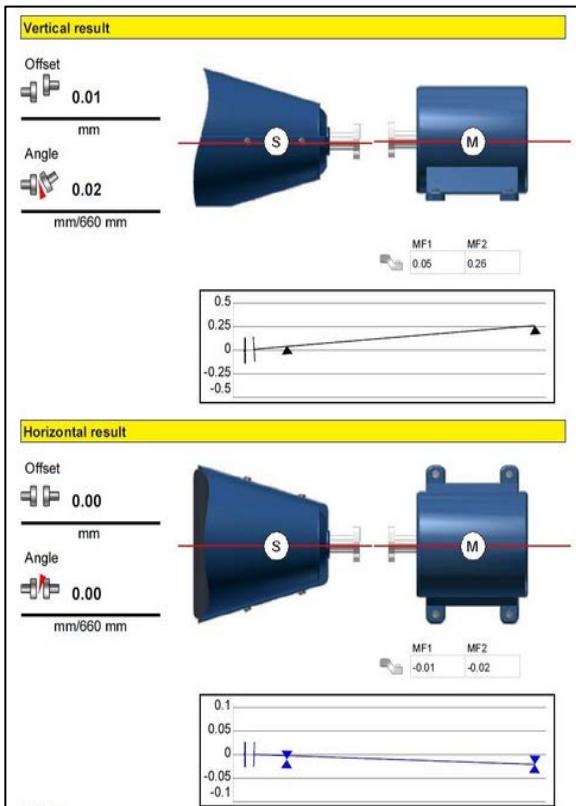
Figure 8: As-Left Shaft Alignment³

It is interesting to note that: based on the as-found alignment results, the rear of the generator could have been lifted by approximately 0.5mm to correct the shaft alignment as it was at that time. This action would have addressed only a

symptom of the plinth movement that had been occurring. The final approach taken has been to address the issues at a slightly deeper level; where the root cause of the misalignment has been tracked back, and an effective and efficient solution implemented.
