# WAYANG WINDU GEOTHERMAL POWER STATION – REINSTATEMENT OF LANDSLIDE DAMAGED GEOTHERMAL FLUID SUPPLY PIPELINES

Sanjay Banerjee<sup>1</sup>, John Cranston<sup>1</sup>, Wilis Wirawan<sup>2</sup> and David Burns<sup>1</sup>

Wayang Windu geothermal power station, located in hilly terrain about 40 km south of Bandung, West Java, Indonesia, delivers 227 MW of electricity into West Java transmission grid.

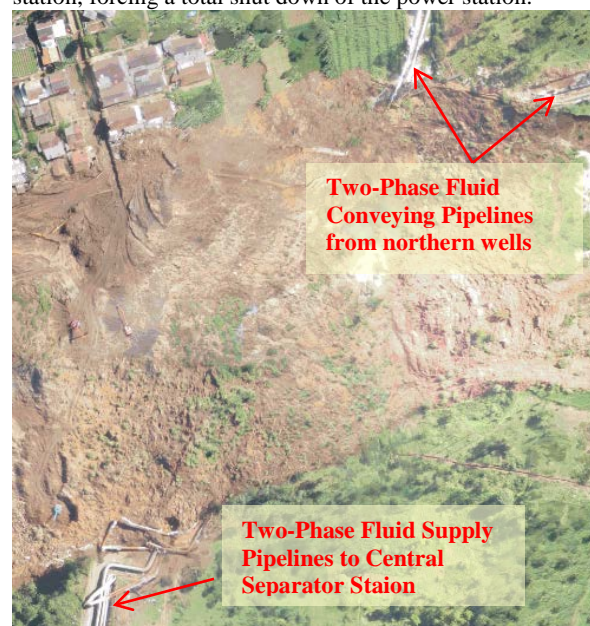
A major landslide (Figure 1) occurred upslope of Margamukti village, Cibitung Residency on the afternoon of 5<sup>th</sup> May 2015. The landslide, possibly triggered by heavy rain over the previous few days, occurred rapidly and without much prior warning. It had a severe impact on the local community. The village population had to be evacuated and subsequently relocated to an alternative settlement area.

Figure 1: Part of Landslide Debris Field

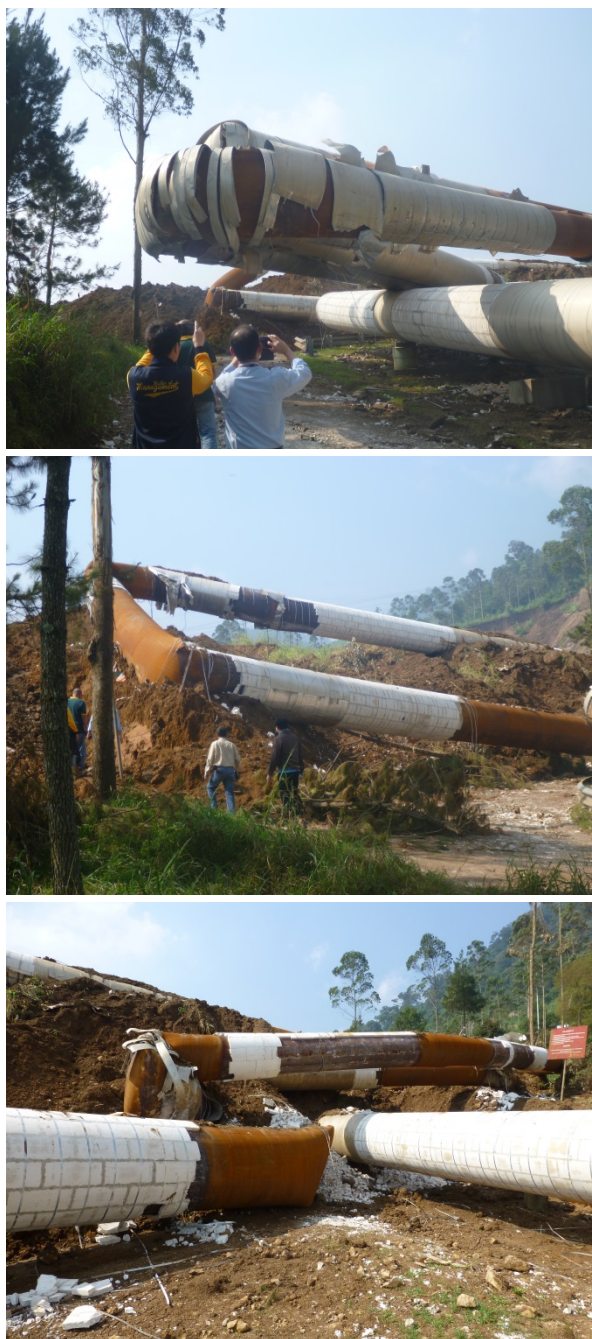
The length of the landslide from its crown to the toe of the debris flow is about 800m. The landslide destroyed about 400m length of 3 major production pipelines (Figure 2) conveying geothermal two-phase fluids to the separator station, forcing a total shut down of the power station.

**Figure 2: Pipelines Damaged by Landslide**

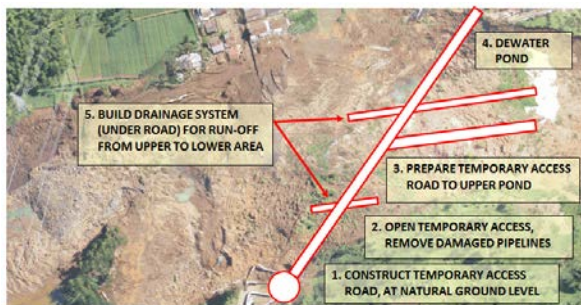
**Figure 3: Step-by-step pre-construction works plan**

- Draining of the landslide pond located below the headscarp since water infiltration in that area could destabilize the slide debris;
- Reshaping of the headscarp and upper part of the debris to improve the slope stability safety factor to an acceptable value;
- Daily monitoring of the landslide to provide warning of any ground movement;

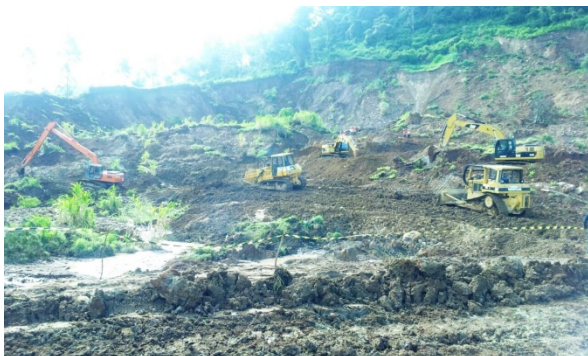
**Figure 4: Clean-up of debris on the upper landslide area**

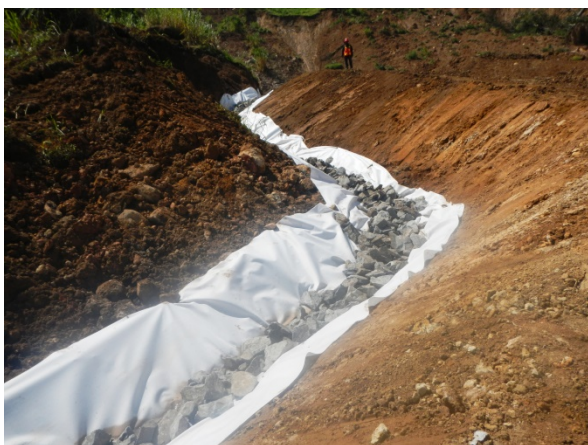
**Figure 5: Temporary drainage from the upper pond**

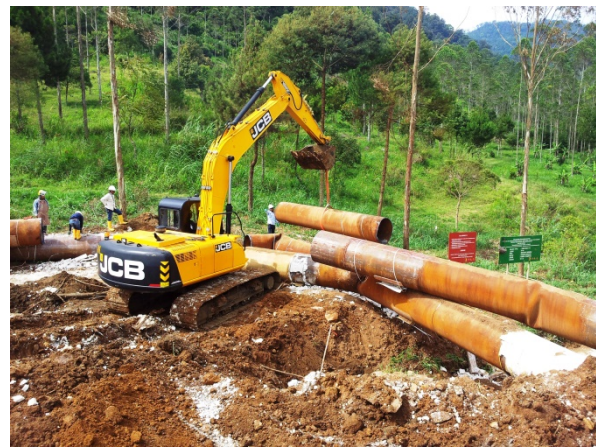
**Figure 6: Damaged pipeline removal**

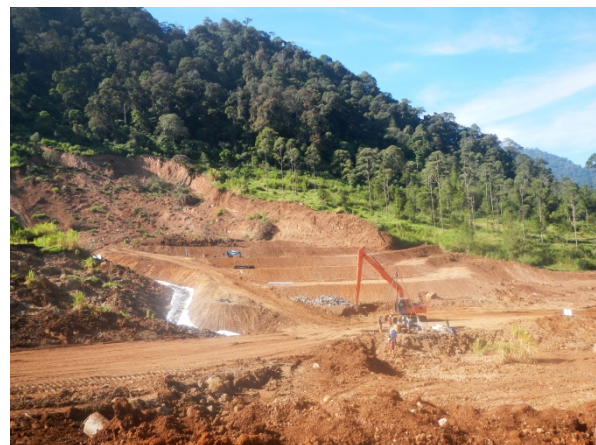
**Figure 7: Reshaping to stabilize the upper part of debris**

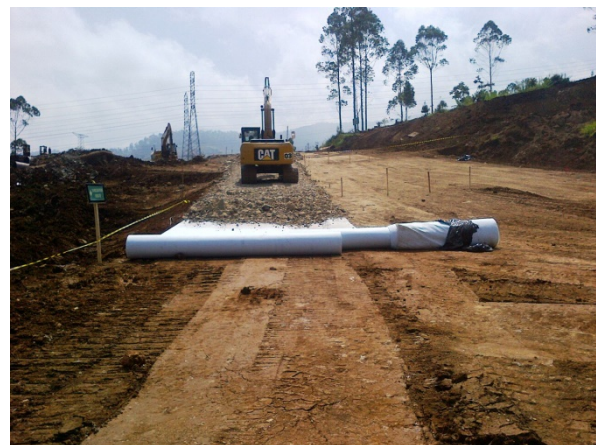
**Figure 8: Access road preparation**

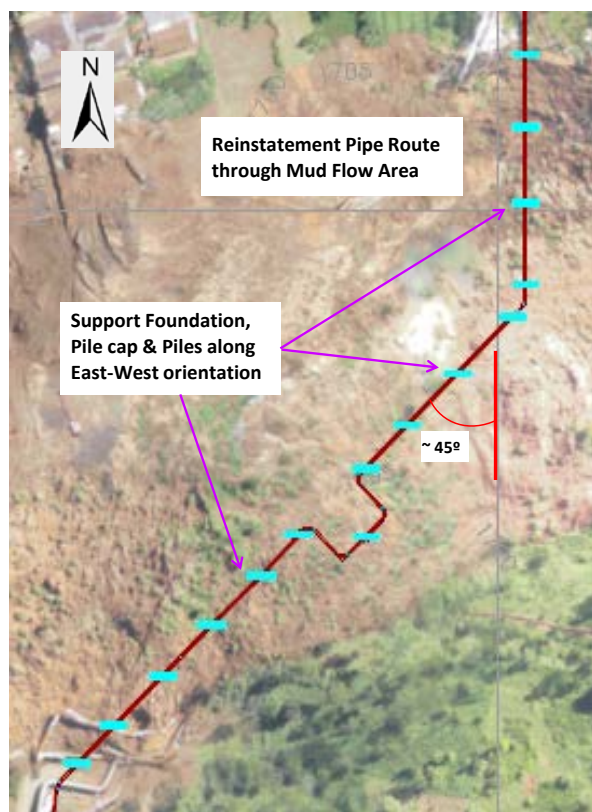
The basis for PT GEC selecting this pile system on debris was: a) the thickness of unconsolidated failure debris being about 10m; b) the debris may continue to move, which would impose lateral loads on the pile system. Consequently, the long axis of the pile caps was oriented parallel to the general direction of any future debris flow. This meant that for a total of 11 pile caps, the pipe supports were at an angle of 45° to the pipeline axes (Figure 9).

**Figure 9: Orientation of Pipe Supports**

PT GEC hypothesised that the movement in the debris may continue and therefore recommended that the axis of piled foundations in landslide debris be oriented parallel to potential ground movement, for a so called “knife effect” (Figure 9). PT GEC calculated that the ground movement would require part of the resistance of each foundation system, with the remainder being available to resist above-ground loads, such as pipe operational loads and seismic loads in their various combinations. Pile reinforcement consisted of 36xD32 axial bars with D13x200 hoops reducing to 16xD32 (D13x200) hoops over the bottom 7m and 12m respectively for the 25m deep and 35m deep piles.

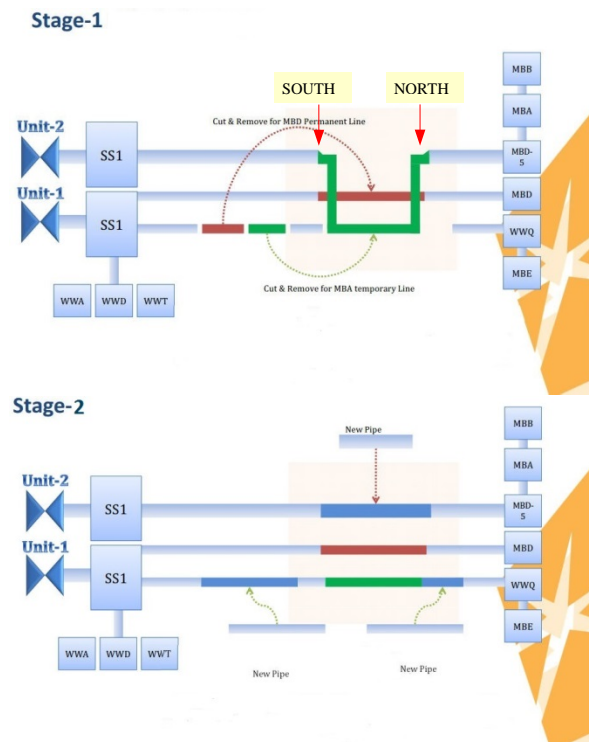
Figure 11: Reinstatement Stages – Schematic Diagram

In Stage-1 (also known as "temporary piping" stage), only the 2 x NPS 36" reinstatement pipelines would be installed, i.e., excluding the NPS 48" reinstatement pipeline. The NPS 48" line installation was to be carried out in Stage-2 (also known as "permanent piping" stage) of the project.

The NPS 36" pipes required to install the Stage-1 pipelines were reclaimed from the existing fluid conveying pipeline from the comparatively less productive wells on wellpads WWQ/MBE. In Stage-1, the NPS 48" pipeline conveying fluids from the more productive wells on wellpads MBA, MBB and MBD was connected, at North and South ends, to the NPS 36" reinstatement pipeline that was designed for eventually transporting fluids from the WWQ/MBE wells. Thereby, on completion of Stage-1, the power station could be restarted on part-load using fluid from wellpads MBA, MBB & MBD only (i.e., without fluid from WWQ & MBE).

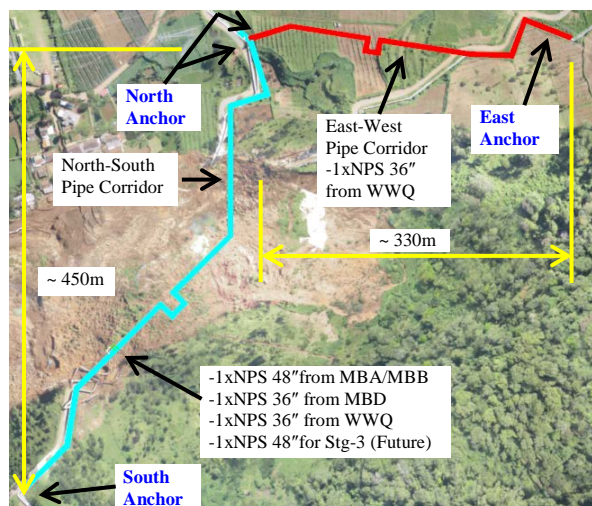
The Project Owner carried out extensive field inspections to check the integrity of existing pipes, supports and foundations outside the landslide area. Based on the field check results, the extent of reinstatement piping design and installation was identified for sections of pipelines within 3 existing anchors – known as “North”, “South” and “East” anchors, as shown in Figure-12.

Figure 12: Reinstatement Piping Design Limits

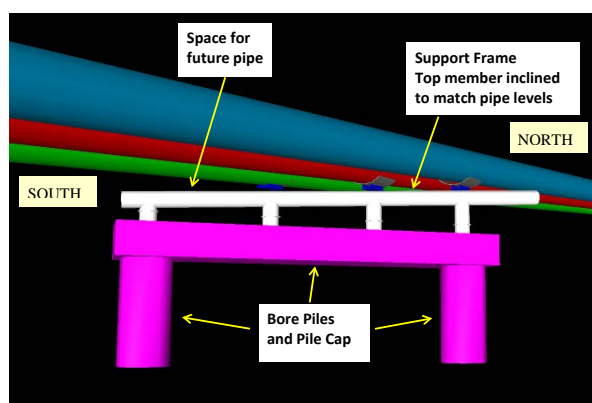
As outlined in the previous sections, the reinstatement pipelines through the landslide area were routed at an angle of about 45° to the north-south direction. The three parallel pipelines ran with a uniform fall in the direction of flow. The undersides of the 3 parallel pipelines were levelled at any plane square to the pipe axes, and therefore it became necessary that the top member of the support structure frame would have to be sloped to support adjacent pipelines resting at slightly different levels (gradually increasing/ decreasing from one outer pipe to the other). The profile of the support frame top member was accurately designed and fabricated to suit the varying levels of adjacent pipes (Figure 15).

Figure 15: Model of support frame at 45° to pipe axes

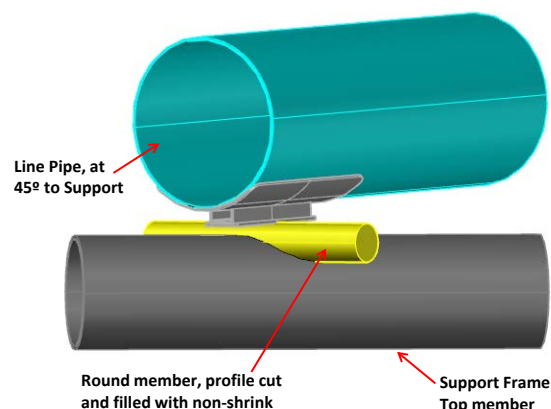
Figure 16: Special Bracket - 3D Design Model

In order to ensure that the contact line of the pipe shoe and steel structure remain square to each other, to allow the pipelines to undergo thermal expansion, special brackets (Figures 16, 17) were designed to be used with the special support frames detailed above (Figure 15).

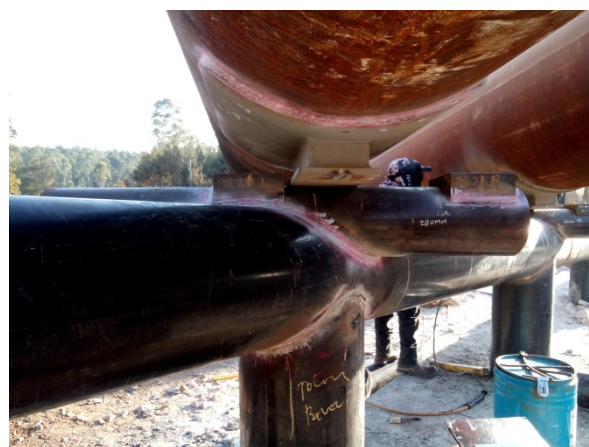
Figure 17: Special Bracket – Field Construction

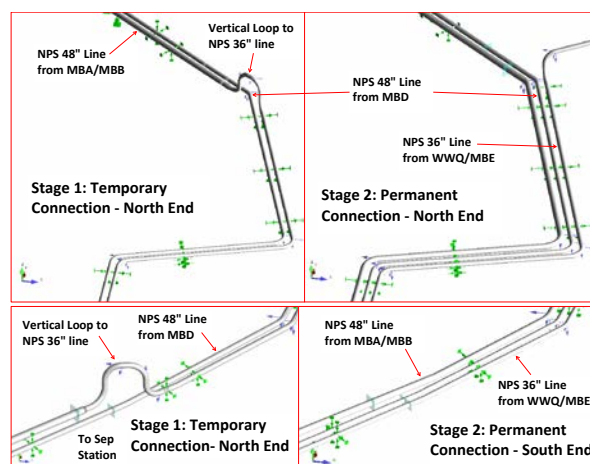
Figure 18: Reinstatement Pipe tie-ins

The temporary pipe connections for Stage-1 used vertical loops to cross-over the adjacent pipe and connect with the outer pipe. The design of the pipelines and supports was suitable for operations both during Stage-1 (temporary) as well as Stage-2 (permanent) pipeline reinstatements.

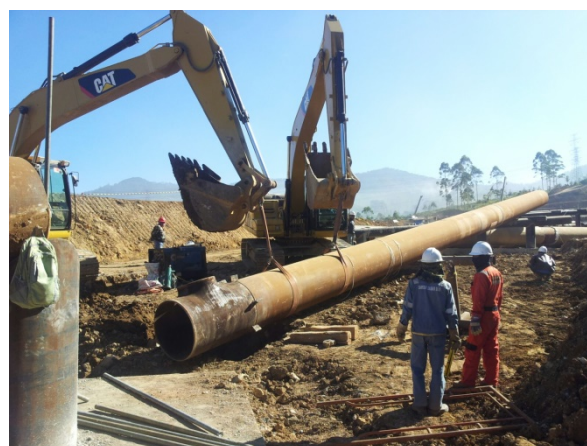
Figure 20: Lifting of pipe spool onto supports

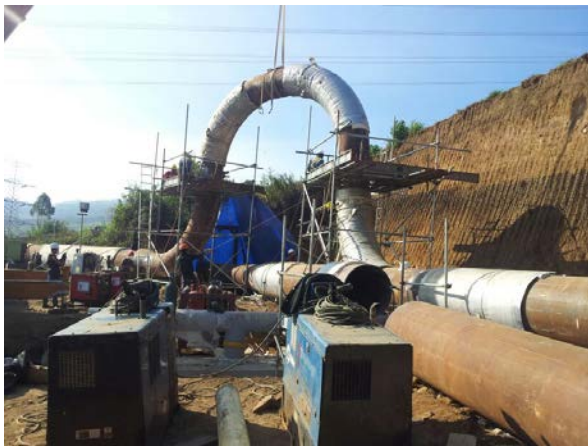
**Figure 21: Fitting vertical loop (in Stage-1)**

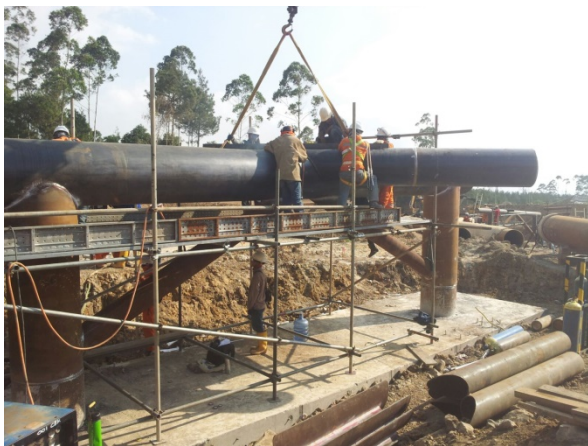
**Figure 22: Construction of support frame LS-15**

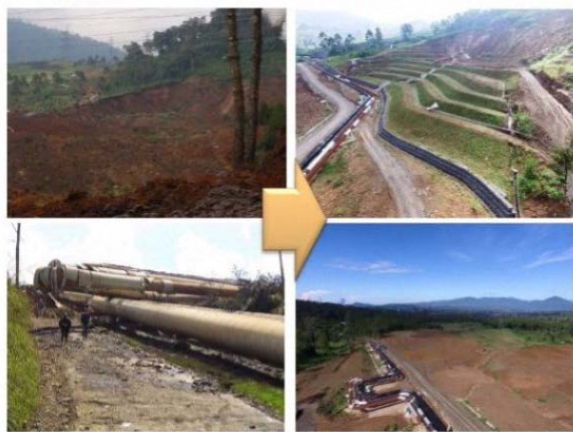
**Figure 23: Before and after Reinstatement Project**
