FAILURE ANALYSIS AND MITIGATION OF CORROSION ON CONDENSATE REINJECTION PIPELINE IN WAYANG WINDU GEOTHERMAL POWER PLANT

Gian Ganjar Zatnika¹, Stefanus Wisanto¹, Aryo Wityasmoro¹, Djamaludin Kurniadi¹, Amri Zein¹

¹Star Energy Geothermal (Wayang Windu) Ltd., Pangalengan, Bandung, West Java, Indonesia.

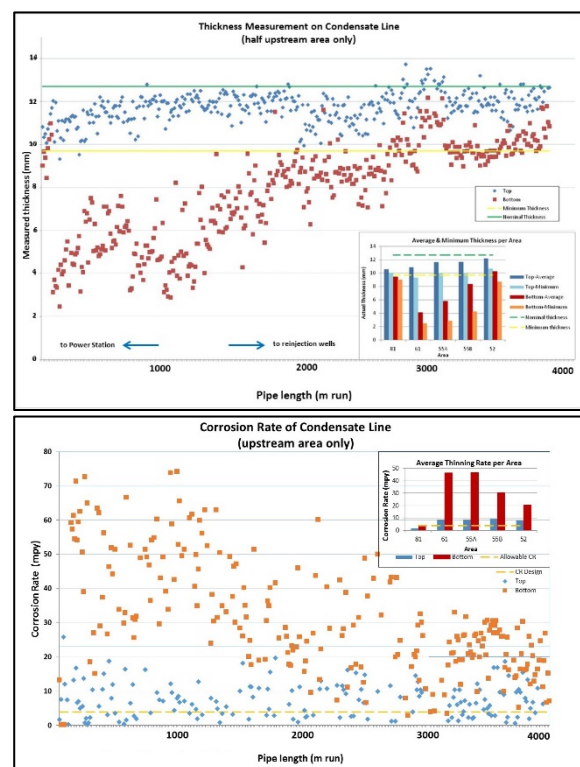
The leaks of condensate pipeline took place in the first downhill area along the pipeline and has not occurred in its downstream area. Therefore, thickness data and mapping were mainly investigated in this upstream area. Pipe thickness distribution mapping of this area is shown on Figure 3.

the Bottom position, Figure 3 also shows that thickness in the upstream area was lower than thickness in the downstream area. It can be seen that the average thickness for this area reached 4.8 mm. As was confirmed by field observation, that area was the most possible locations for the leak occurrence.

This 16" API 5L Grade B pipeline possesses design pressure of 28.1 bar, so it would have minimum allowable thickness about 6 mm (ASME, 2009). Therefore, the thickness mapping result shows that numerous pipe sections have thickness below MAT. In spite of that, the inspection was conducted by spot measurement so that the monitoring result did not provide the best estimation for leak occurrences. As a consequence, the leak still might be occurred at pipe section with higher thickness data, particularly if localized corrosion took place.

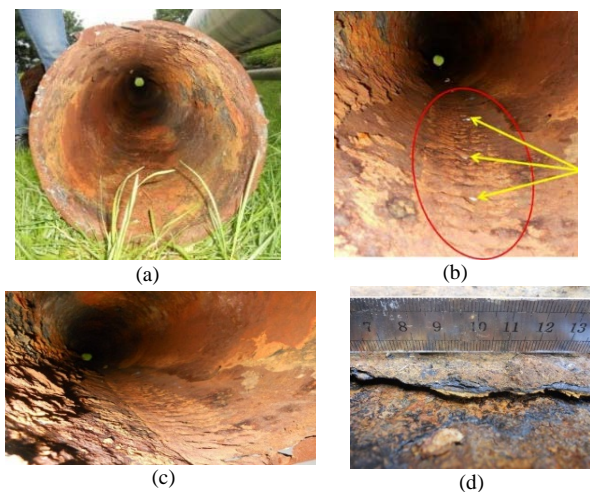
Figure 4 Visual observation on pipe internal corrosion

Fig	Finding / Features	Indication / Cause
4a	Uniform corrosion on all internal surface	General corrosion due to oxygen corrosion
4b	Directional metal loss pattern	Erosion
4b	Wavy corroded surface	Flow-induced corrosion
4b	Localized leaking point	Oxygen corrosion
4c	Elongated tubercle	Oxygen corrosion
4d	Tubercle layers	Oxygen corrosion (tuberculation)

Observation on some corroded pipes along the pipelines delivered several typical finding. There were a number of similar features on the pipes such as uniform corrosion, tubercle or stratified corrosion product, and directional metal loss pattern. Uniform corrosion on pipe draining water is

one of typical features of oxygen corrosion. Simultaneously, corrosion product characterization by XRD also confirmed this. This evidence was strengthened by tubercle finding (Fig. 4c and 4d) which is typical for oxygen corrosion products.

On the other hand, directional metal loss found indicates that thinning was also assisted by erosion mechanism instead of corrosion only. Numerous dents due to erosion were clearly shown. Another evidence of corrosion erosion process is shown by a tubercle which is induced by flow direction namely elongated tubercle (Nalco, 1993).

In addition, there was a wavy corroded surface that indicates typical process of oxygen corrosion: form a cathodic-anodic pattern where localized corrosion is rapidly occurred in anodic area that could eventually become a leaking point. Briefly, all these finding strengthen the presumption that root cause was flow induced oxygen corrosion.

Field observation and laboratory analysis delivered conclusion that the failures were caused by flow-induced oxygen corrosion. The oxygen corrosion were proved by: (1) corrosion product of iron oxides and iron hydroxides; (2) extremely high dissolved oxygen in the fluid up to 1.18 ppm; and (3) oxygen corrosion features such as tubercle growth, and localized leak pattern. Moreover, erosion thanks to high flow rate and pipe geometry has been proved by field observation of flow regime and typical erosion features such as dent, wavy corroded surface, and directional metal loss pattern on corroded pipe surfaces.

Partial pipe spool repair was taken as short term mitigation program. Repair processes were conducted by patching, pipe lamination with fiber reinforced plastic (FRP) coating, pipe replacement with newly pipes, and pipe rotation such that the thicker part of the pipe is positioned on the top. These processes were decided based on the latest thickness inspection data and resources availability. The thickness data were utilized for corrosion rate and remaining life assessment to determine priority of pipe spool replacement and the suitable repair method.

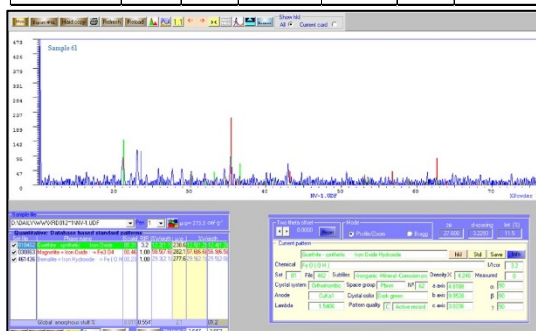
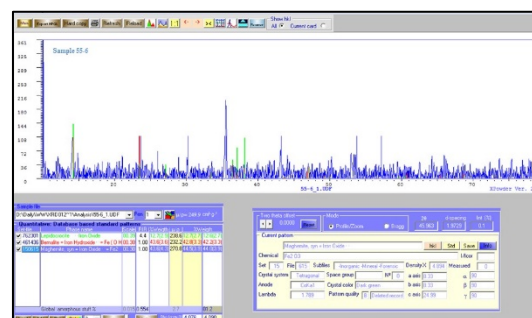
Figure 5 XRD test results

Chemical characterization of corrosion product of the pipes were conducted by X-Ray Diffraction (XRD) method. The results were then processed qualitatively by Automatic Powder Diffraction (APD) and quantitatively using X Powder™ analysis. Diffractogram of XRD test result for all samples are presented on Figure 5. Those XRD analysis results are summarized on Table 4.

Despite minor difference associated with software database, both results revealed that all specimens consist of various iron oxide (magnetite and maghemite) and hydroxide (iron (III) hydroxide, goethite, lepidocrocite, and akaganeite). Moreover, all diffractograms of test specimens did not present diffraction pattern of other possibility compound such as iron carbonate (siderite) or iron sulfide (pyrite) although condensate fluid also contains CO_3^{2-} and SO_4^{2-} ion. Those verified that the pipeline encountered oxygen corrosion due to contact with oxygenated condensate fluid. Indeed, any other corrosion mechanism such as CO_2 or H_2S corrosion was not evidently found.

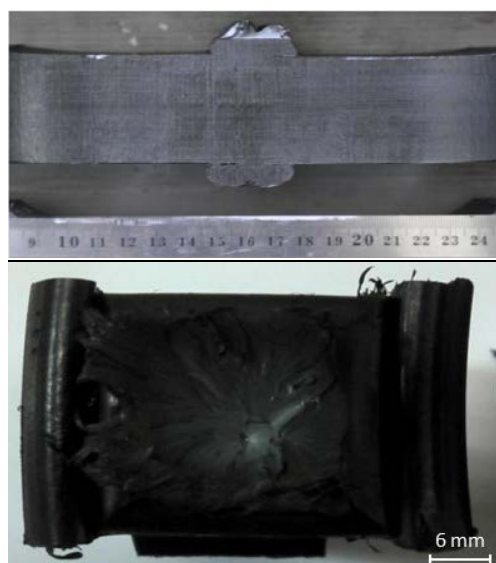
Figure 10 Fractography of butt fusion joint

Macroscopic examination reveals difference solidification orientation between fusion area and base material. It indicates melt flow orientation during bead up pressure step in butt welding process. This solidification process leaves tiny gap in welding area which is not melted during heating and pressurizing. These features, however, may not influence the pipe strength. The HDPE tensile test specimen experienced large plastic deformation during tensile tests until the ductile fracture occurred. The weld joint area remained solid as the failure occurred at base material. Butt fusion parameters used were then qualified for pipe installation.
