STRESS CORROSION CRACKING IN METAL ALLOYS EXPOSED TO ACID-SO₄²⁻ CHLORIDE TYPE GEOTHERMAL FLUIDS

Katrina B. Dacillo^{1*} and Sadiq J. Zarrouk^{2‡}

Keywords: *stress corrosion cracking (SCC), acid sulphate, low-pH, corrosion resistant alloys (CRA)*

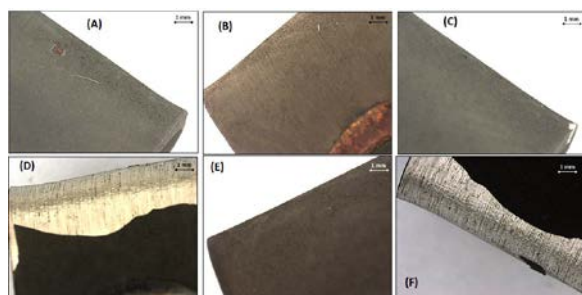
The convex side of the U-bend coupons (Figure 4) was also examined and no visible signs of cracking were found on any of the samples. Some of the black scales were chipped off from the surface of the 5923 HMO, Ti-Gr12 and 904L CRA samples but the exposed areas of the base metal did not appear to have suffered any corrosion. In contrast, the scales on the J55 carbon steel coupon were generally intact but a small area where scales were removed was corroded. Attempts to examine the concave portion of the U-bend coupons revealed that a small exposed area on the J55 sample showed the presence of black discoloration on the base metal, which could have only resulted from a reaction with the test fluids. Similar observations were not found near the concave sections of the L80 and CRA samples. No visual evidence of cracking was likewise detected.

Figure 4. Images of the convex section of the uncleaned U-bend samples: (A) J55, (B) L80 Type-1, (C) 5923 HMO, (D) Ti Gr12, (E) 2507, (F) 904L.

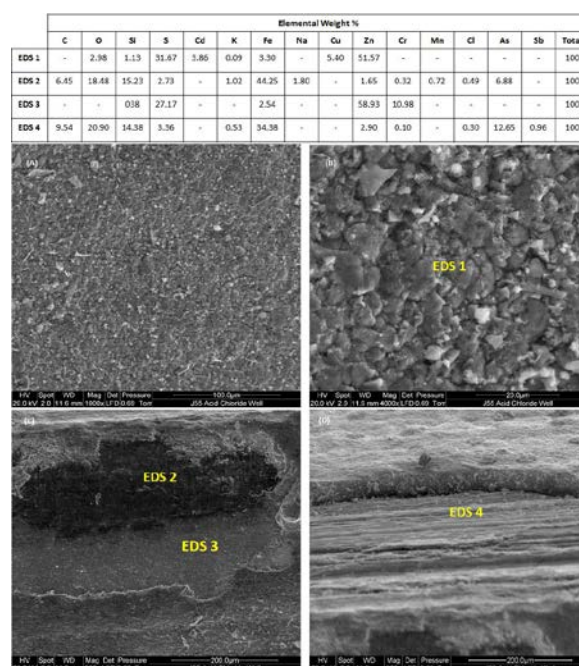
crystalline morphology in irregular sizes at 4000× magnification (Figure 4, B). Elemental analysis from EDS indicated that the scale formed was mainly composed of 40–54% by weight zinc (Zn) and 23–32% by weight sulfur (S) (Figure 4, EDS 1). The calculated Zn/S mole ratio of 0.79–0.97 indicated an almost 1:1 ratio for Zn and S atoms typical of sphalerite mineral (ZnS).

The small area of exposed surface with black discoloration found on the J55 alloy was irregularly shaped with an estimated area of 500µm × 183µm. Based on EDS analysis, this was mainly composed of 44% iron (Fe), 18% O, 15% silicon (Si) and 6% C (Figure 4, EDS 2). These weight percentages translate to a Fe to O mole ratio of 1:1.5, which if reduced further can give the molecular formula for iron oxide (Fe₂O₃). A Si/C mole ratio of 1.0 was likewise obtained, which suggests the presence of silicon carbide (SiC). The surrounding area of the blackened surface was made of 59% by weight Zn and 27% by weight S (Figure 4, EDS 3).

Figure 5. SEM-EDS scans on the surface of the convex section of the uncleaned J55 carbon steel U-bend sample. Images shown include surface scale at (A)1000× and (B) 4000× magnifications, (C) exposed base metal surface w/ black discoloration, (D) other sections of the base metal uncovered by flaked off scales.

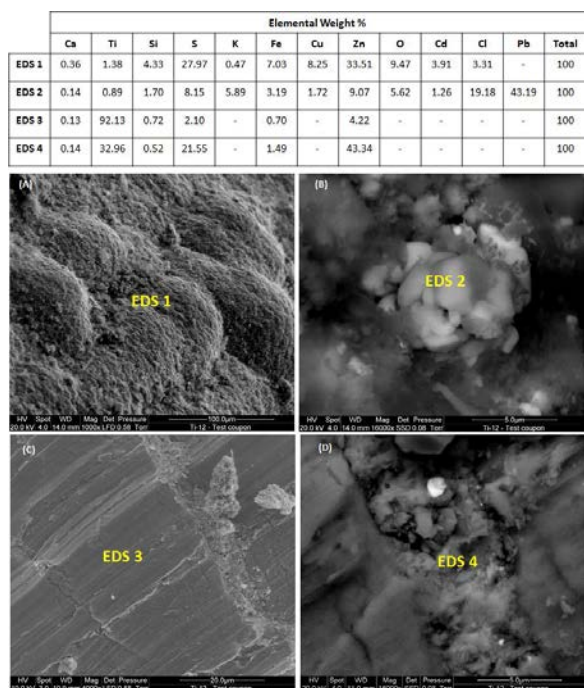
the chemical make-up of the metal before the exposure test (Table 1). However, cracking was observed on the base metal surface of the Ti-Gr 12 alloy (Figure 5, C). Some scales also appeared to be embedded inside the cracks, which were identified by EDS (Figure 5, D, EDS 4) to be mainly composed of 43% by weight Zn and 22% by weight S with a Zn/S mole ratio of 0.98. The bare Ti-Gr 12 metal surface (Figure 5, C, EDS 3) was mainly composed of 92% by weight Ti, but signatures of Zn and S were also present at weight percentages below 5%. The 904L base metal also showed seemingly branching lines on its exposed surface but no cracks with embedded scales similar to that observed in Ti-Gr12 alloys were detected. The weight percentages of major components in the 904L bare metal post-exposure to XM-02 fluids (i.e. 50% Fe, 22% Cr, 22% Ni) were also still comparable to pre-exposure conditions (Table 1) but a signature of scales composed of 46% by weight Zn and 18% by weight S was also detected.

Figure 6. SEM-EDS scans on the surface of the convex section of the uncleaned Ti-Gr 12 U-bend sample: (A) scales on the surface with globular morphology at 1000 \times magnification, (B) round white crystalline agglomerate distributed on the scale at 16000 \times magnification, (C) base metal surface exposed by flaked-off scales with crack lines and (D) scales embedded in the cracks at 16000 \times magnification.

SEM-EDS analysis of the Ti-Gr12 sample indicated sphalerite growth in the crack. Signs of pitting were also found around the crack. It is possible that the layer of titanium oxide film formed on the Ti-Gr12 surface was not stable enough given the reducing nature of the acid-SO₄²⁻ chloride geothermal fluids of well XM-02. A poor oxide layer can leave the metal susceptible to localized corrosion such as pitting particularly in areas with broken passive film. Note that pitting is often a pre-cursor to crack growth. It is also possible that stress accumulated by sphalerite scale deposition destabilized the titanium oxide layer to allow cracks to propagate by the cyclic process of film rupture, dissolution and film repair.

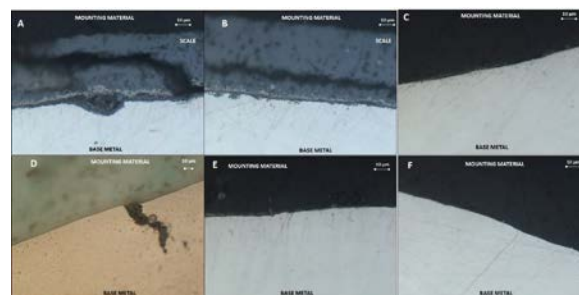
Inspection of the section 1 cross-sectional specimens from the U-bend samples found a crack on the Ti-Gr12 alloy (Figure 7, D). The crack had a maximum width of 18 μ m and progressed to a maximum depth of 72 μ m from the convex surface of the U-bend coupon. No cracks were found on the section 1 specimens of all other samples. However, a pit of 25 μ m wide and 12.5 μ m deep was observed on the J55 carbon steel sample (Figure 7, A). The pit, which was also found on the convex surface of the sample where tensile stresses are prominent, can potentially serve as a crack initiation site on the metal.

Figure 7. Metallurgical inspection of section 1 cross-sectional specimens using light optical

microscope: (A) pint on J55, (B) L80 Type 1, (C) 5923 HMO, (D) crack on Ti-Gr 12, (E) 904L.

The evidence for the cracking in Ti-Gr12 was found both in the uncleaned and cleaned U-bend sample. The size of the crack suggested that it was still in between the crack initiation Stage 1 and steady-state crack propagation Stage 2. It can be inferred that Ti-Gr12 did not fail by SCC after 35 days exposure to acid-SO₄²⁻ chloride fluids but the potential to fail via SCC if exposed continuously to well XM-02 fluids in the future is possible. Note that Ti alloys rely heavily on the integrity of the titanium oxide film for corrosion resistance. However, once destabilized, corrosion damage can occur very rapidly (Thomas, 2003). The high affinity of titanium metal to oxygen can promote re-healing of the titanium oxide film. This is the reason why it is the choice material for oxidizing environments but not for reducing media. Reducing acids (e.g. hydrochloric, sulfuric, etc) often cause general corrosion on titanium alloys, the degree of which is dependent on the concentration and temperature of the media (Houser, 2010). Alloying elements such as Ni, Mo, palladium (Pd) and ruthenium (Ru) are often added to titanium to increase resistance to reducing acids.

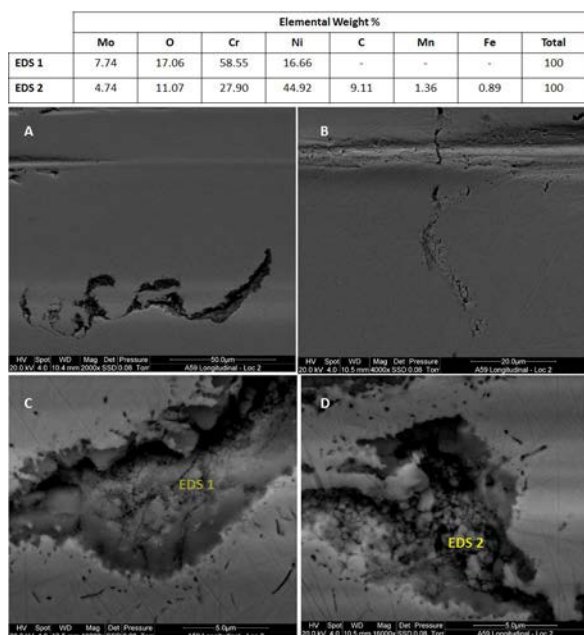
The cracks found on the 5923 HMO and Ti-Gr12 specimens were subjected to SEM-EDS inspection. In the 5923 HMO Section 2 specimen (Figure 8), the cracks traversing the convex plane were greater than 100µm in length and had crack widths above 5µm. Pitting marks found around and within the cracks indicated that the cracks might have initiated from pits on the surface. EDS analysis performed on the crack internals showed enrichment of chromium in the metal from a pre-exposure value of 22.8% by weight to a post-exposure level of 28–59% by weight. Cr is one of the trace elements naturally found in geothermal fluids. Nearly all of the Cr remains in the geothermal brine after separation because it is a non-volatile substance. In the operating field of well XM-02, Cr levels of 10.5 µg/kg were detected on the acid SO₄-Cl fluids of an adjacent well. The EDS analyses also revealed significant depletion in the Ni and Mo contents of the metal after exposure to XM-02 fluids. The absence of Zn and S indicated that surface scale components did not embed further into the crack. Elemental C and oxygen were also present at weight percentages of 9% and 11–17%, respectively. A Cr to oxygen mole ratio of 1:1.5 was calculated, which can be further reduced to the molecular formula for chromium (III) oxide (Cr₂O₃).

Figure 8. SEM-EDS scans on the cracks found on 5923 HMO sample. Images of the crack at (A) 2000×, (B) 4000× and 16000× (C, D) magnifications are shown.

Recognizable cracks were only found on CRA samples 5923 HMO and Ti-Gr 12. The poor performance of 5923 HMO was anticipated based on pitting on the surface of the 5923HMO flat coupons previously observed by Nogara and Zarrouk (2015). SEM images of the crack showed pitting within the edges of the crack suggesting that pits might have served as crack initiation sites. EDS analysis of the crack interior showed depletion of Ni and Mo content and enrichment of C compared to the original composition of 5923 HMO before exposure. Note that in nickel-base alloys, carbon is known to precipitate carbides with Ni and Mo which can weaken grain boundaries and enhance SCC (Jones, 2003). The carbides can either be formed during the solidification process (primary) or result from thermal exposure while in service (secondary). The precipitation of secondary carbides depends on the amount of carbon in solution, exposure temperature and time at temperature (Davis, 2001). It is possible that 5923 HMO exposure to acid-SO₄²⁻ chloride fluids promoted secondary carbide precipitation. With the depletion of Mo, an element typically added to improve resistance to a non-oxidizing acid environment (Davis, 2001) such as that of well XM-02 fluids, localized corrosion such as pitting and SCC were enhanced.

- The 5923 HMO nickel base CRA acquired a crack on the surface. This was caused by secondary carbide precipitation based on depletion of Mo and Ni and enrichment of C within the crack. The crack likely grew from pits observed within and around the crack. Nogara and Zarrouk (2015) did report very rare pitting which could imitate SCC.

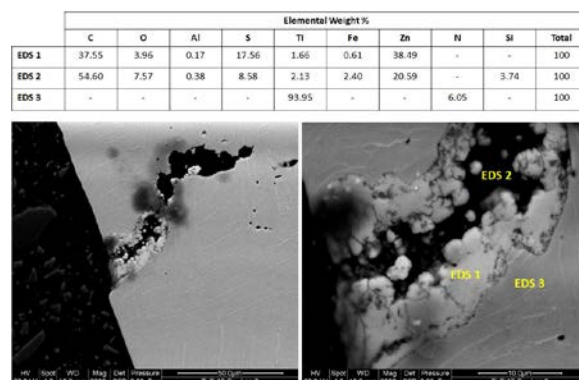
Figure 9 shows the SEM-EDS results of the crack found on the surface of the Section 1 cross-sectional specimen from Ti-Gr12. Pitting marks were also observed around the crack but these were not as prominent as the ones found in the 5923 HMO sample. EDS analyses confirmed earlier results of scales growing into the crack because the edges of almost the entire crack length were composed of whitish materials with 21–38% by weight Zn and 9–18% S. The calculated Zn/S mole ratio of 1.0 to 1.15 was typical for sphalerite. Elemental signatures of C and oxygen atoms at weight percentages of 38–55% and 4–8%, respectively, were also detected.

Figure 9. SEM-EDS scans on the cracks found on 5923 HMO sample. Images of the cracks at 2000× (left) and 8000× (right) magnifications.

- The Ti-Gr12 titanium base CRA sustained a crack on the base metal surface. The reducing nature of the fluid and the accumulated stress brought about by sphalerite precipitation destabilized the protective titanium oxide film. The crack possibly propagated either from pits found around the crack or through the cyclic process of film rupture, dissolution and film repair based on the growth of sphalerite scales in the crack. This is an interesting observation since it is the first time Ti-Gr12 has been reported to be tested in this low pH fluid environment. Caution is advised when considering Ti-Gr12 in such environment.
