WAIRAKEI - STILL GOING AFTER ALL THESE YEARS

Chris Morris

Wairakei Power Station, PB 2001, Taupo 3352, New Zealand

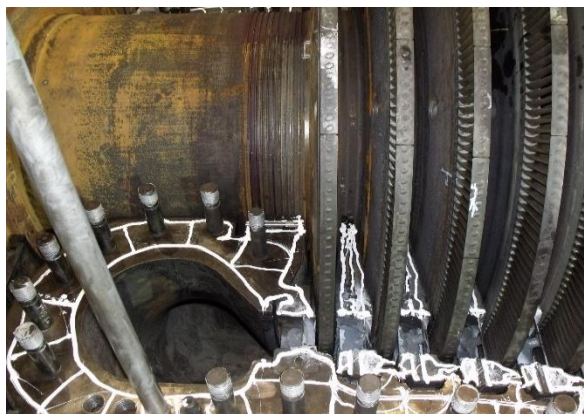
The turbine casings were a combination of cast iron and fabricated low carbon steel components. For the most part, there has been little or no erosion and no corrosion on the cast iron. However, where there is damage, it is very hard to repair. Ceramic fillers have been used extensively to keep the mating faces flat and square. The use of flexible sealing compounds on the halfjoints have stopped a lot of leakage and wash erosion problems (Figure 4).

Figure 4: IP casing half-joint just before assembly showing sealing compound to stop leaks.

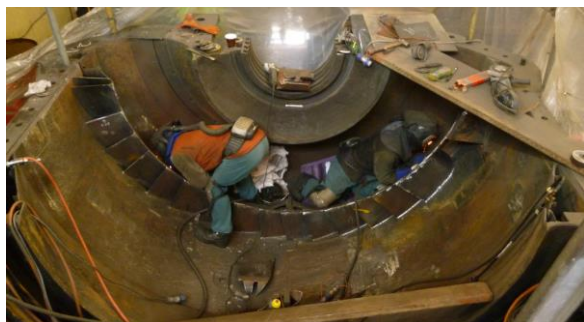
The steel exhaust casings, particularly the IP sections, have had extensive erosion damage. Major weld repairs have had to be done most surveys – an example shown as Figure 5. These have generally been by overlay, though components like turning vanes and watershed plates are regularly replaced. Going to thicker turning vanes made of a harder steel has extended life without losing performance. Protective metal spray has not worked. There appears to be micro cracks forming through the spray during operation. That has allowed the metal loss in the underlying material to continue, and then allowing pieces of the sprayed coating to break off into the cavity as they are unsupported.

Figure 5: Replacing turning vanes in MPLP casing

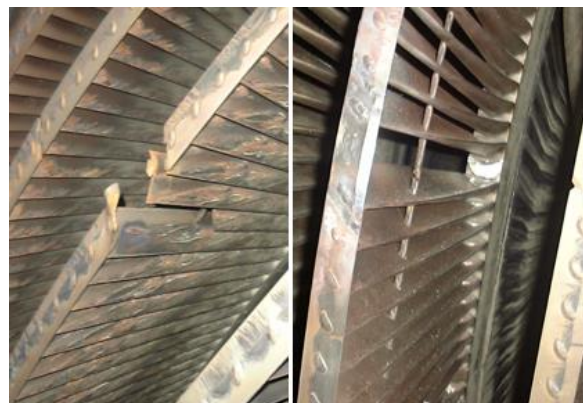
The last five stages of the MP blades have been replaced after about 200,000 operating hours. LP3 to LP5 had cracking occurring in the lacing tube hole. Figure 6 shows one of these failures. LP6 & LP7 had leading edge erosion – at worst, about 30mm from a 100mm wide last stage blade. There was an early failure of the banding on the Stage 7 blades from poor tenon design. This was fixed by arc welding the banding onto the blade, then doing the heat treatment in a molten lead bath. This solution worked. It is still done nowadays on newly installed blades, but using TIG to minimise heat input, and flexible ceramic heat pads do the heat treatment.

Figure 6: Blading failure and subsequent repair to get back in service till rotor can be rebladed. Blade on opposite side was cropped to keep it in balance.

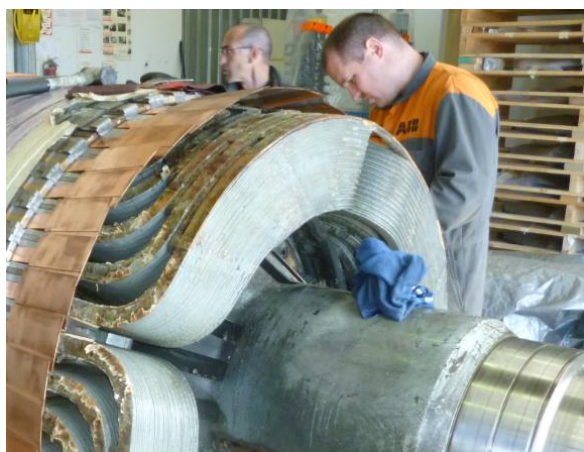
The early voltage regulation system was by thyatron valves. These were not reliable and there were many losses of excitation. To minimise the risk of damage, the generator rotors were built with a heavy segmented copper amortisseur under each ferritic endring. Figure 7 shows this. These did a very good job of stopping arc damage in the shrink area of the ring and rotors during pole slip and phase imbalance incidents. In the late 80s, a programme was started to inspect all the rotor endrings in line with best practice. Most were found to have some arc pits from historic asynchronous motoring, pole slip and cracks forming in the rough machining around the bayonet teeth. For the most part, these were able to be dressed out. Replacement rings were fitted where the damage was beyond recoverable limits. The blanks were forged in Europe, then machined and fitted locally. The rings are now inspected every second survey.

Figure 7: 30MW generator rotor being worked on during endring inspection. Segmented amortisseur and original mica insulation visible.

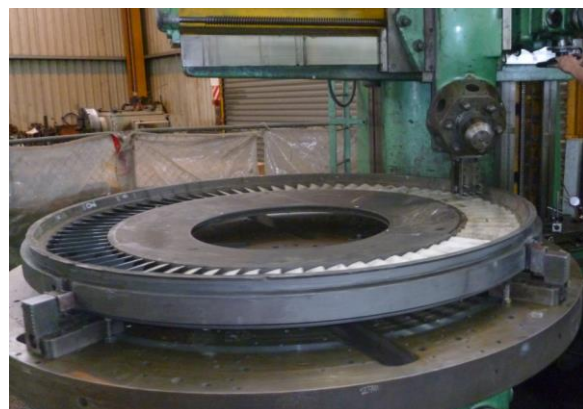
The wash damage on the trailing rings was initially addressed by retrofitting stainless steel inserts. These then had nickel cover welds. Modern practice has been to apply protective metal spray on the eroded surfaces. This has managed to halt further erosion (Figure 8). The tapped lift eye holes have been replaced by stainless steel inserts. These give a lot more security during crane lifts.

Figure 8: Machining a diaphragm after repairs and metalspray to ensure correct clearances are maintained.

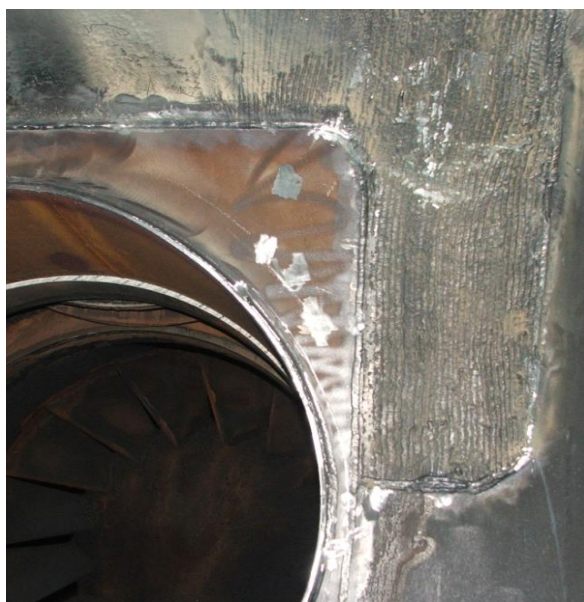
present. This made them very susceptible to water droplet erosion, particularly downstream of the IP turbine exhausts; the exhaust legs, LP manifold, in-line Howden separators and LP inlet legs. As well as the direct impingement damage, particularly on the turning vanes in the exhaust legs and Howdens, there was ditching occurring on the seam welds.

Figure 9: Full wall replacement and overlay weld repairs in LP manifold.

Repair continues to be an ongoing maintenance activity. For minor damage, this is just overlay weld repair, but full wall patch replacement is done on the larger areas like in Figure 9. Historically, stainless steel overlay or ceramic coatings were used, but it is now done using just parent metal. The Howdens and legs were replaced in the 90s mid-life refit.
