RESTORING WELLBORE INTEGRITY IN A COLD BRINE AND CONDENSATE INJECTOR, MAK-BAN GEOTHERMAL FIELD, PHILIPPINES

Ng, N. J. U.¹, Alvarez, R.R.¹, Guevarra-Segura, I.F.¹ and Torres, A.C.¹

¹Philippine Geothermal Production Company, Inc., 14/F 6750 Ayala Avenue, Makati City 1226, Philippines

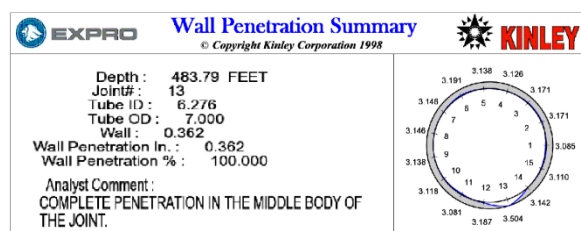
Following the installation of a hangdown liner in 1987, CIC surveys were consistently run into Bul-25 – a total of 10 runs from 1988 to 2005 showing that the hangdown liner was in reasonable condition but also showing signs of corrosion. When the CIC survey was run in 2011, a casing hole was found at 483 ft MD (147.2 m MD). See Figure 5, Figure 6 and Figure 7.

Because the depth is above 1000 ft MD (304.8 m MD), the finding is a cause for concern, despite the well operating at vacuum wellhead pressure as it could still build up pressure under shut-in conditions. Additionally, 16 joints of liner were found to be in BMAT condition due to corrosion, and this further reinforced that Bul-25 will need to undergo a workover in order to preserve its mechanical integrity. Its severely corroded hangdown liner is to be replaced with either a secondary tieback or a new hangdown casing to further extend the life of the 9 5/8 in (245 mm) casing. The use of a more exotic material that will be resistant to oxygen corrosion like titanium was also evaluated but was not economical and is also susceptible to H₂S embrittlement.

Figure 5: A cross section of the hangdown liner showing the casing hole found on Bul-25.

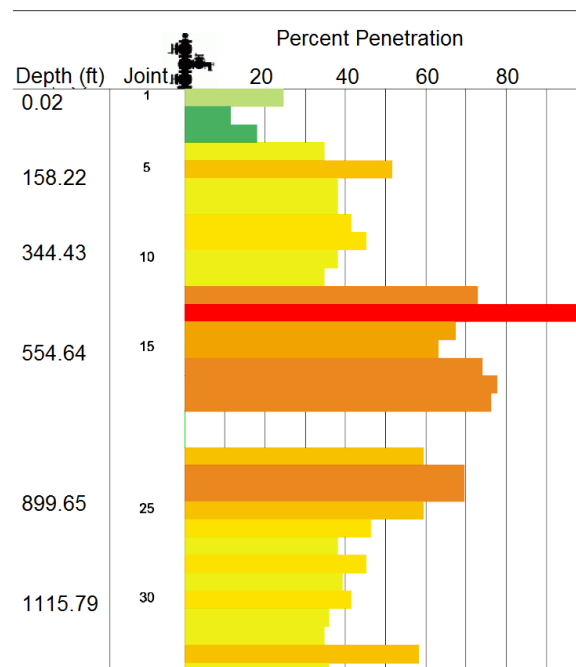
Figure 6. The penetration profile of Bul-25.

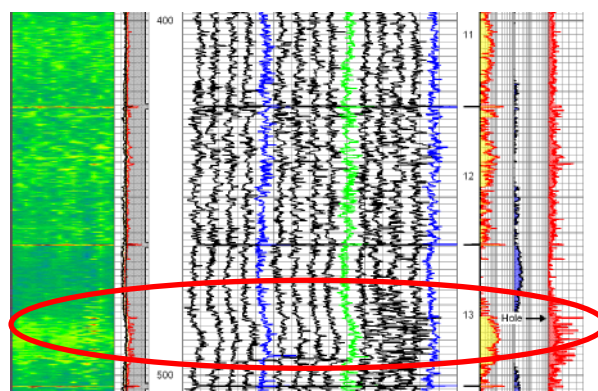
Figure 7. Raw CIC data showing the casing hole at 483 ft MD (147.2 m MD), with deformations surrounding the area.

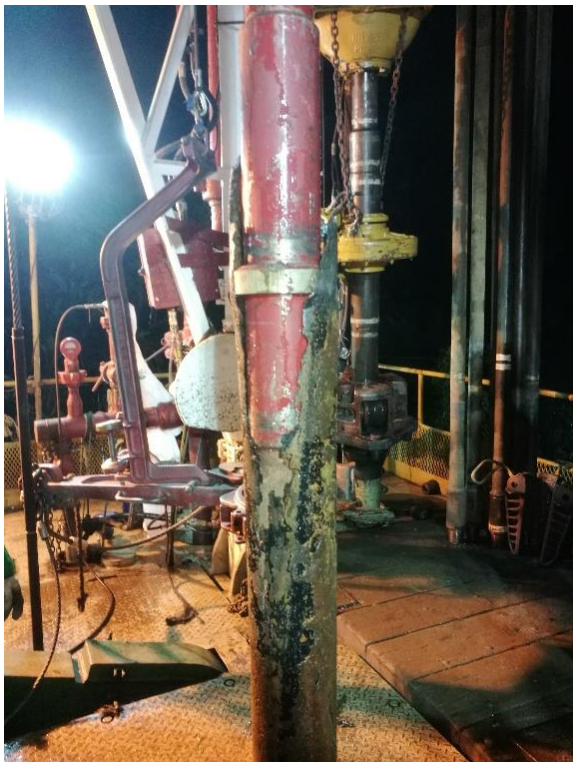
pull out of the remainder of the casing and, as stated in its 2011 CIC results, the hangdown liner was in poor condition (see Figure 8) and was extracted in small sections because of this. Also, following this finding, it was decided to run a secondary tieback, with the assumption that the production casing is also likely to be corroded.

Figure 8: A section of Bul-25's hangdown liner showing extensive corrosion.

A total of 2110 ft (643 m) of hangdown liner was successfully extracted from the wellbore. Aside from the depths stated above, it was also observed that general corrosion was present throughout the whole hangdown liner. The original casing behind the former hangdown was cleaned out before running and cementing the secondary tieback casing.

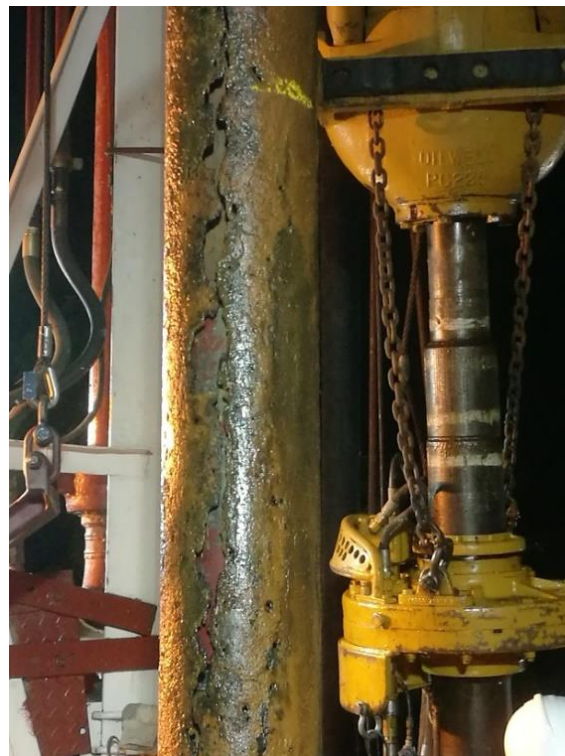
It is also worth noting that findings in the 2011 CIC survey align with the actual condition of the hangdown liner. Seen in **Error! Reference source not found.** are streaks of corrosion and areas of pittings found along the liner, which is also seen in the caliper reading shown in **Error! Reference source not found.**

Figure 9: A section of liner approximately located at 800 ft MD (243.8 m MD) showing streaks of corrosion and pittings.

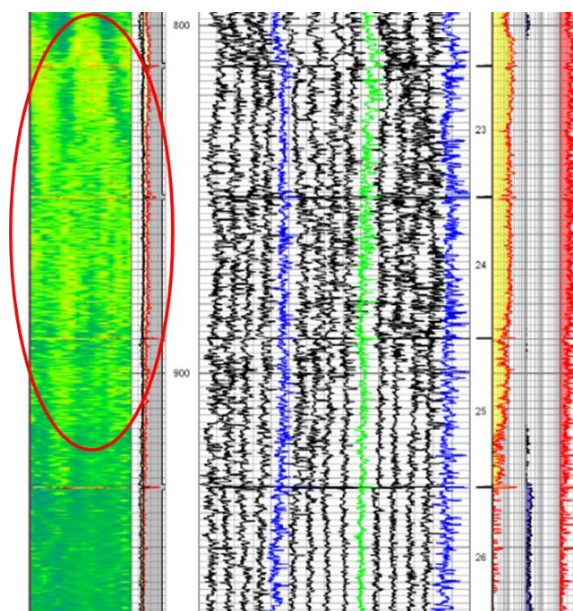
Figure 10: The readings at 800 to 900 ft MD (244 to 275 m MD) from the 2011 CIC survey.

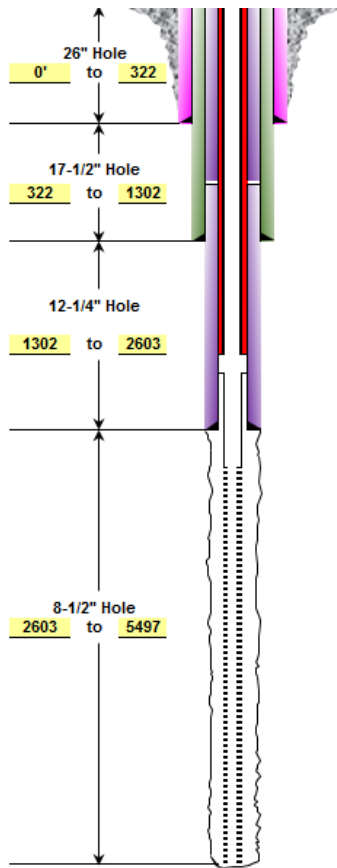
Figure 11: The wellbore schematic of Bul-25 (depths in ft) after the work-over (marked in red is the new secondary tieback).

The secondary tieback casing included 51 joints of 7 in (178 mm) 29 pounds per foot (ppf) K-55 casing and 4 joints of 7 in (178 mm) 29 ppf L-80 which were ran and cemented to 2073 ft MD (641 m MD). These will serve as the permanent replacement for the hangdown liner (**Error! Reference source not found.**).
