TE MIHI GEOTHERMAL POWER STATION – STEAM TURBINE GENERATOR PEDESTAL DEFLECTION

Dugald Morrison¹

¹Contact Energy Geothermal Resources and Development, Brandon Street Wellington, New Zealand

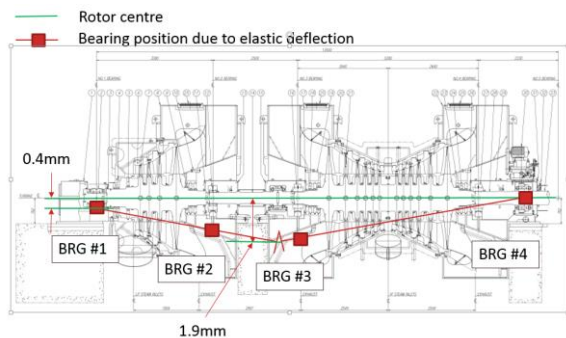
The LP turbine is supported at the No 2 bearing and the IP turbine is supported at the No 3 bearing. (Refer Figure 1) The No 2 and No 3 bearings are supported on a transverse beam (east – west with 8m span). The transverse beam is supported by 14m longitudinal beams between the column supports. Each of these beams contribute to the overall mid span STG deflection.

Deflection of the STG foundation support will affect the position of each bearing and cause rotor misalignment. A conceptual image of the change of the bearing position due to elastic deflection from vacuum loading only is shown in Figure 1. Plastic deflection from concrete creep shrinkage has contributed an additional 3.6mm.

Figure 1: Modelled bearing position change due to elastic deflection from vacuum loading.

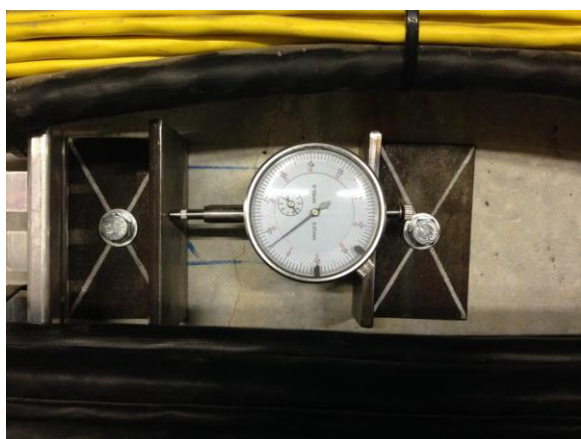
Following the first outage STG realignment, an inspection of the underside pedestal longitudinal beam identified similar cracking on both Units. A symmetrical pattern of crack spacing was observed indicative of beam deflection with a crack spacing of approx 400mm adjacent to the columns increasing to approximately 200mm mid span.

Dial gauge monitoring of crack width (Figure 3) before and after outage showed that these cracks closed when the Unit was removed from service (vacuum released) and opened again on return to service, i.e. cracking is related to beam deflection from vacuum loading and not a result of concrete creep shrinkage.

Figure 3: Unit 1 longitudinal beam crack monitoring.

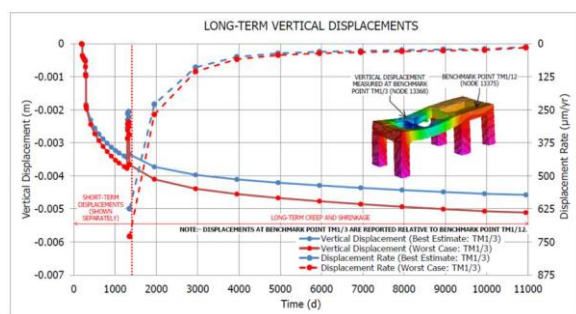
BECA was engaged by CE in 2015 for the initial assessment of long term creep and shrinkage of the STG pedestal (Figure 4). The predicted permanent displacement due to creep and shrinkage properties at the No.3 bearing benchmark. The operational rate of displacement rate was estimated to be approximately 0.17mm/year, becoming asymptotic over time. Observed displacements were slightly greater than the predicted displacement.

Figure 4: Initial assessment of long term displacements from concrete creep shrinkage.

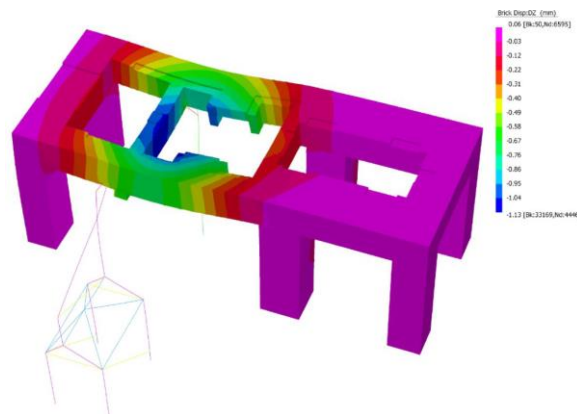
Modelling of the existing pedestal estimated that deflection of the longitudinal beam would be approx. 1.0mm at BM3 using standard concrete properties. Following the pedestal dynamic testing, the model was revised for coefficients of stiffness of 40% of the gross stiffness. This increased the analytical estimate of deflection at BM3 to 1.5mm

Figure 5: Elastic deflection under vacuum load with new RHS and wide trussed column supports.

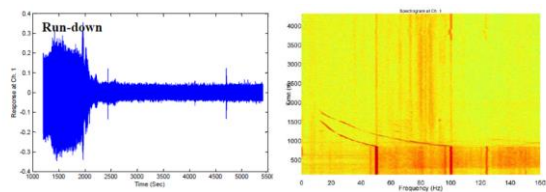
Figure 8: Recorded acceleration and frequency spectrogram during sequence 2: Run-down

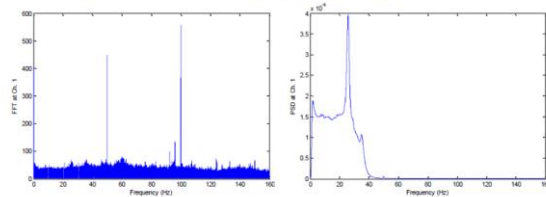
Figure 15: Fast Fourier Transform (left) and filtered power spectral density (right) of device #29 (Ch. 1, Z direction) which is located at the operational level during run-down sequence.

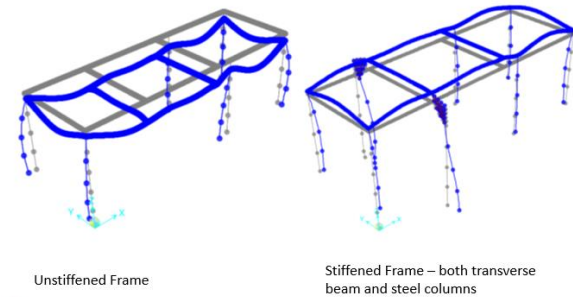
Figure 8: Dynamic response – 1st modal shape.

The initial theoretical model, using expected concrete properties, required the gross flexural stiffness to be reduced to 20 – 30% of their initial value (original assessment using standard concrete properties) to obtain a close match for the dominant frequencies derived from the vibration analysis. The revised displacement assessment is shown in Table 1.

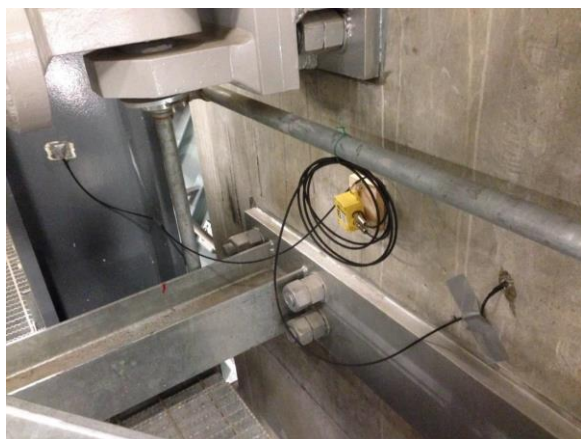
Figure 9: Thermocouple monitoring installation of Concrete and steel columns.

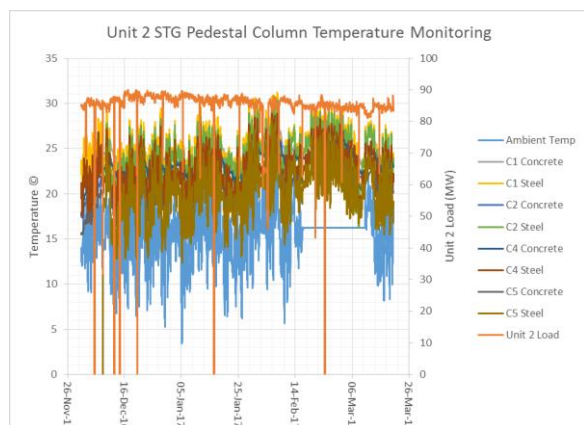
Temperature monitoring (Figure 10) indicated that both steel and concrete columns are sensitive to ambient temperature variation.

- The concrete column follows the daily ambient max / min with a typical 6.5 hour offset and temperature range is typically 10% of the daily ambient temperature variation
- The steel column follows the daily ambient max / min with a typical 3.5 hour offset and temperature range is typically 54% of the daily ambient temperature variation

Figure 10: STG pedestal temperature monitoring.

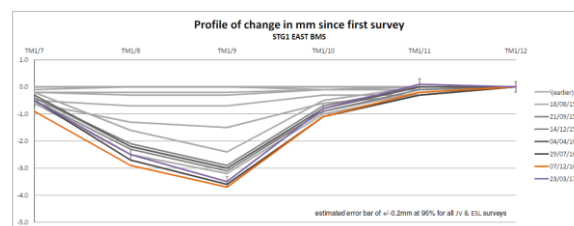
Benchmarks were installed in the pedestal table during construction adjacent to each STG pedestal. Initially optical survey levels (Figure 11) were used to monitor bearing benchmarks using the #6 bearing (northeast generator outboard) benchmark as the reference point.

Figure 11: Optical deflection survey monitoring.

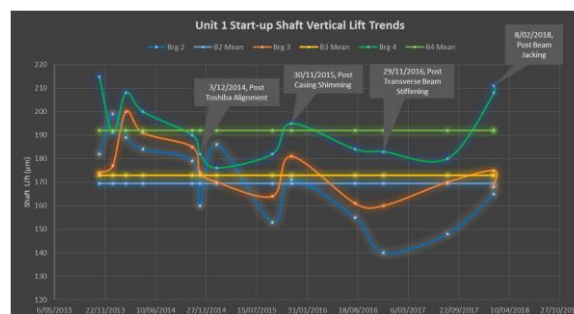
Figure 12: Historical Unit 1 start-up shaft vertical lift trends (bearings 2,3 & 4 with mean values).

The vibration assessment has shown increasing constraint in the vertical plane over time due to increasing plastic deflection, in the form of reduced shaft lifts and vibration amplitudes. Following each outage, STG realignment, and the casing shimming works in 2015, there was reduced constraint in the form of increased shaft lifts and vibration amplitudes. These degraded over time with the ongoing plastic deflection indicating light rubbing present in vibration data; with evidence in the form of variability in amplitudes, orbit position, and orbit shapes.

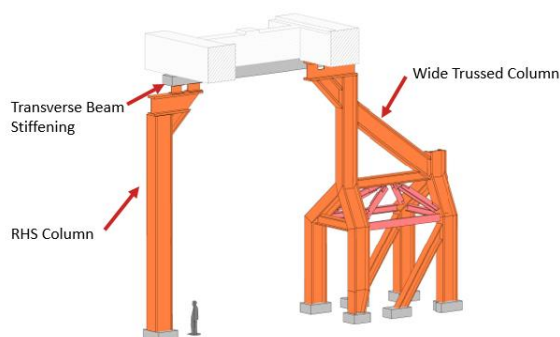
Figure 13: STG pedestal stiffening structural elements.

Two vertical columns were designed (Figure 13). The west side allows for a single fabricated RHS box section column to be installed by relocating lubricating oil and other service pipework to provide a void. The east side was achieved by use of a wide trussed column so as to bridge the CW pipe work (Figure 14). Multiple iterations were required to finalise the design.

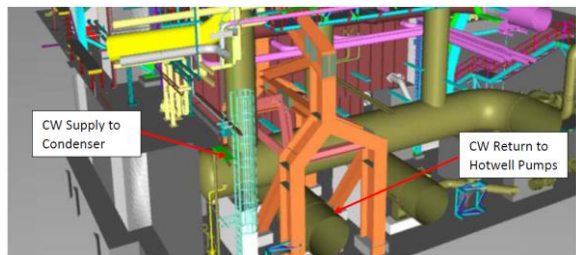
Figure 14: Wide Trussed Column Straddling CW Pipework.

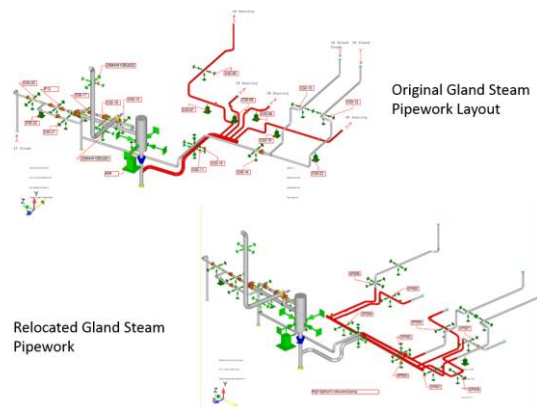
The following Figures 15 & 16 illustrate clash / interference and the relocation of the gland steam pipework were required on the east side to provide the construction space for the wide trussed column installation.

Figure 15: Gland steam pipework modification.

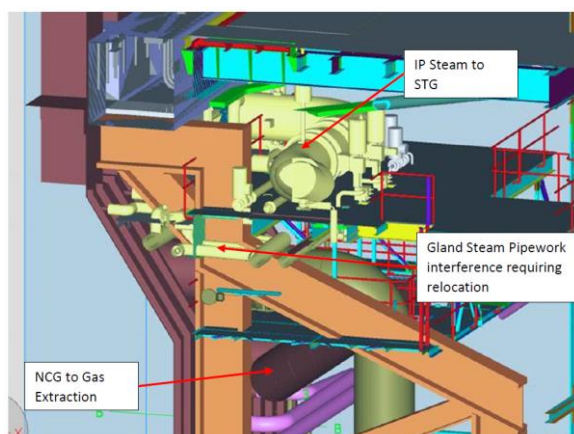
Figure 16: Wide trussed column showing interference with the original gland steam pipework.

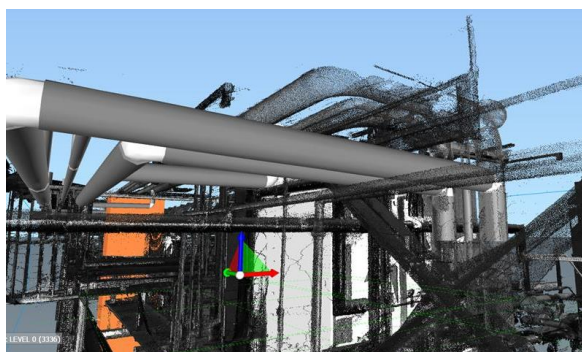
Figure 17: Relocated lube oil pipework with point cloud location of original services.

The use of point cloud survey of the original equipment installation (Figure 17) provided a high degree of confidence for the design and installation of the both services and structure.

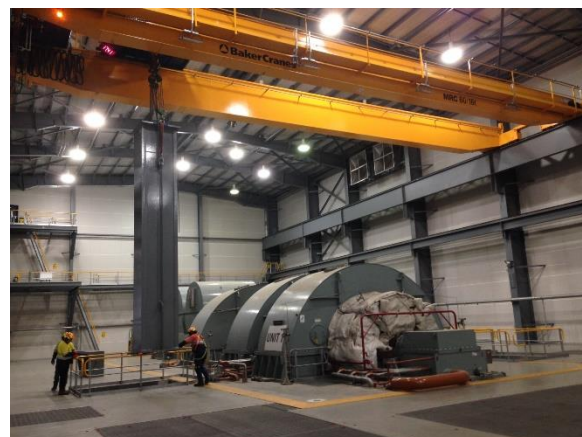
Figure 18: RHS column installation Unit 1.

In-service installation of the RHS (Figure 18) and wide trussed columns was completed prior to the 7-day statutory inspection outages. Once the structures were complete, the jacking process was able to be undertaken. This involved placement of large hydraulic rams between the top of the

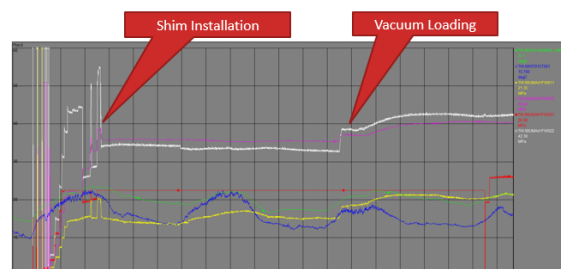
Figure 19: Strain Gauge Monitoring Of Pedestal Jacking.

Strain gauges (Figure 19) were also installed at critical locations on the structures to provide real time information about internal material stresses and movement during the jacking process. These strain gauges will be used for monitoring ongoing operation.

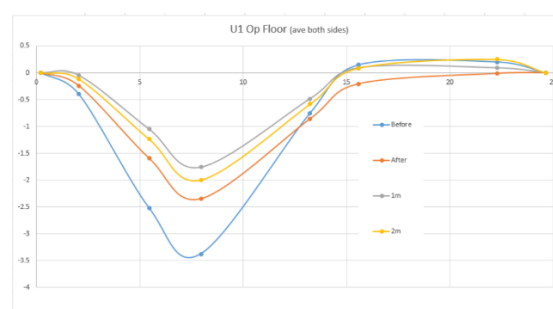
The magnitude of the lift achieved by the jacking process was within the expected range (1.2 – 1.5mm) for both units, and no further unexpected movement has been measured on either foundation since the completion of the works.

Figure 20: STG Pedestal Deflection Pre & Post Jacking

Post-works measurements to date (Figure 20) have confirmed that deflection of the foundation has been halted, with only minor movements due to changes in ambient temperature and operational loading now evident.
