MICROBially INDUCED DEGRADATION OF FIBRE REINFORCED PLASTIC (FRP) IN THE COOLING TOWER OF A GEOTHERMAL POWER STATION

T. Clark¹, K. Wade², N. Gibson³

This paper describes a technical investigation, undertaken following discovery of wide-spread degradation of the Fibre Reinforced Plastic (FRP) structure of a geothermal cooling tower, after only 7 years' of service. The degraded FRP was found only in the top section of the tower, above the Drift Eliminator level. The subsequent investigation identified the cause of degradation as microbially-induced corrosion of the FRP material, due to the presence of sulfuric acid at about 1% concentration (pH 1). Several studies were conducted to understand the nature of the FRP degradation, its effect on the strength of the structural elements, and the extent of degradation over the tower's structure. Subsequent work considered a few possible ways to control bacterial growth and prevent the acid from accumulating. However, no suitable method could be found, with the decision taken to replace the affected FRP with new, acid-resistant FRP material. Because this type of degradation had not been previously reported, selection of new material require

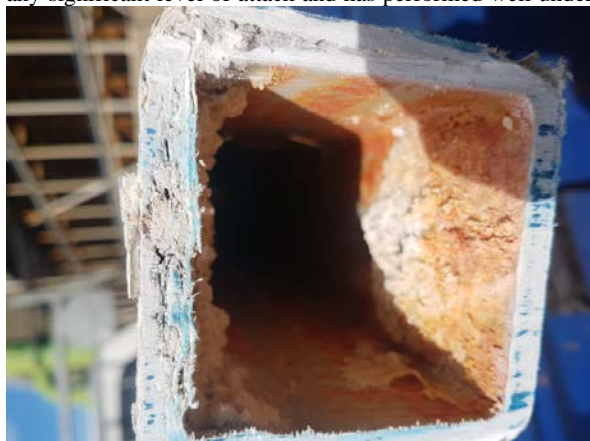
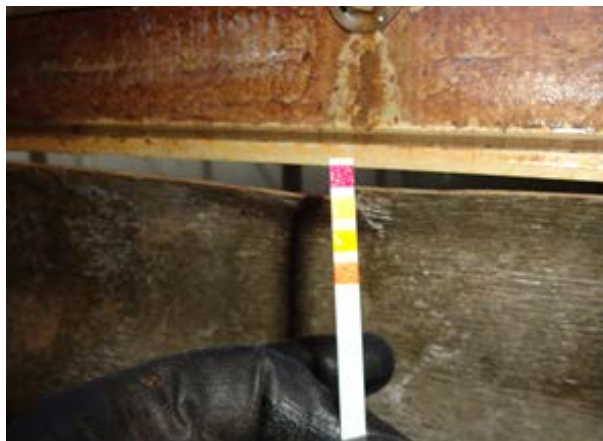
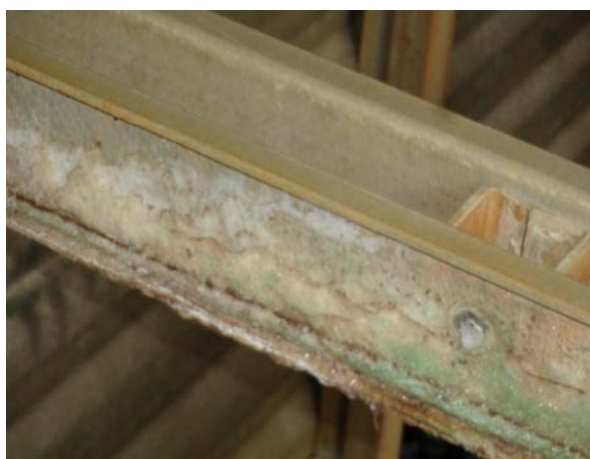
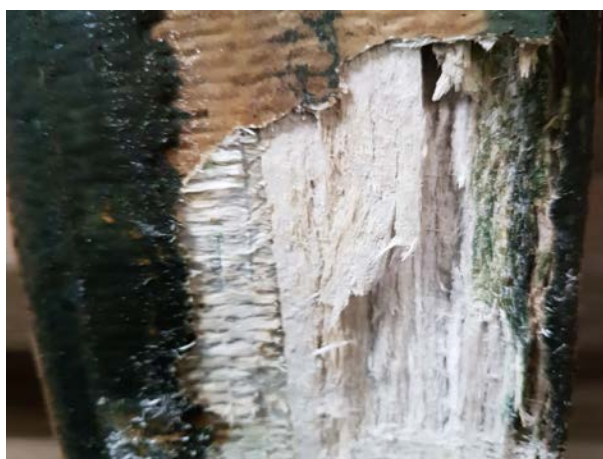
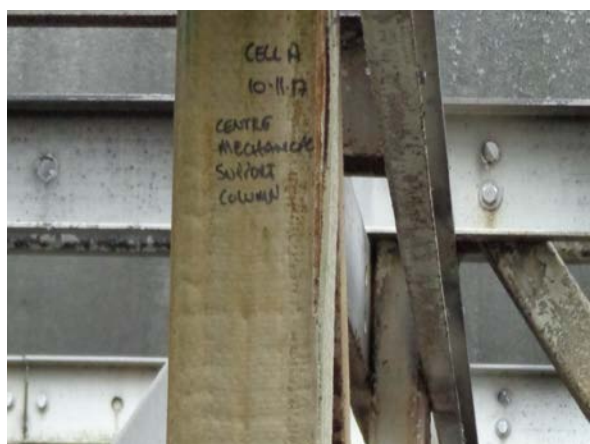
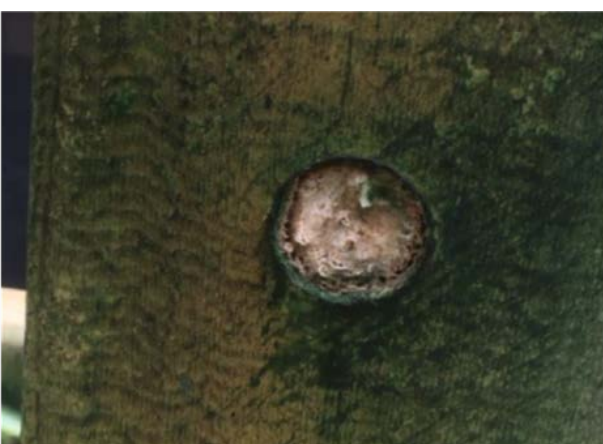
The presence of obvious decay of the FRP structure was first observed during the station outage in November 2017 (7 years after the station was commissioned in 2010). Typical examples of damaged sections of FRP are shown in Figure 4. Significantly, this damage was almost entirely observed above the DE layer. Although some deterioration was noted below the DE and above the Fill Pack, this was limited and appeared to be propagating down from above.

While the areas of decay appeared widespread within the DE-to-Fan Deck zone, much of the FRP in this area appeared to be unaffected. Hence, the decayed areas were dispersed throughout the zone, although an underlying pattern became apparent. The worst affected areas were close to the walls (external and internal) of each cell, where continually moist conditions prevailed. In these areas a slimy biofilm layer was present, especially apparent on the horizontal surfaces of the girts and roof beams. FRP decay became less apparent, moving inwards towards the central fan well, where the structure appeared much dryer.

Some columns were removed for destructive testing and significant deposits of an unknown white substance were noted inside these columns. The texture of the fiberglass in the walls of the damaged columns and girts was described as “powdery”. The damage appeared to start from the inside of the columns and from drill holes in the girts and roof beams. Deformation of columns and girts were obvious physical indicators of severe deterioration. However, there were several, more subtle, symptoms of the decay process:

Therefore, it became clear that the FRP had been under sustained attack by sulfuric acid, probably since the tower first started up 7 years earlier. This was a result of widespread colonization of the FRP by Sulfur Oxidising Bacteria. The presence of sulfuric acid at around 10 g/L (pH 1) is well beyond the range at which these SOB bacteria will normally grow. This conclusion further suggested that the acid was accumulating in and on the decaying FRP, because it was not being washed away. The lack of a “water wash effect” above the DE layer explains why acid attack was almost entirely restricted to this zone, since pH-controlled water can wash the structure below the DE level. The few areas of decay below the DE were attributed to sulfuric acid running down the inside of the columns all the way to the splice joint, which is just above the top of the Fill Pack. Clearly, water droplets falling from the DE could not wash the insides of the effected columns.

Figure 4: Examples of FRP degradation in the tower zone above the Drift Eliminator layer

decision was taken to repair the structure with an acid resistant FRP material.

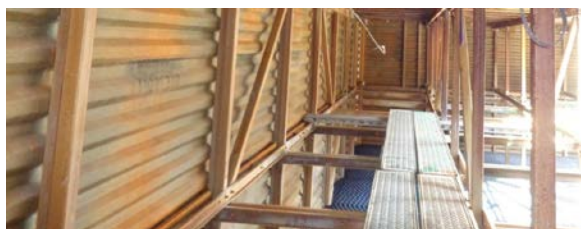
Figure 5: Columns in cell D selected for core sampling (the first 4 columns against the external (south) wall and the adjacent 4 in the second row)

The cores were examined to characterise the extent and nature of acid attack on these columns. Five of the 8 columns showed at least one core with significant degradation (thickness loss). The worst of the 8 columns (col. +3) had one core with 85% loss of wall thickness. Across all 8 columns, the average of the largest thickness losses measured was 34%. There was a trend in thickness loss from the top (least) to the bottom (most) of the effected columns, which is consistent with the idea that sulfuric acid can run down the inside of the columns. Visual examination of the degraded cores showed that some columns were being attacked from the inside, while others from the outside surface. The column which had the greatest level of degradation (col. +3) was being attacked entirely from the inside and looked apparently normal on the outer surface.

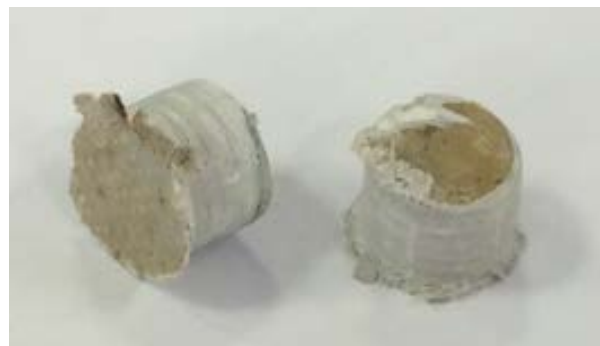
Two “reference cores” from Columns 1 and 4 were taken about 0.5m below the DE level and were found to be intact, with no evidence of decay and returned neutral pH values (see Fig. 6).

Figure 6: Photograph of intact, undamaged 16 mm cores, sampled below the Drift Eliminator level.

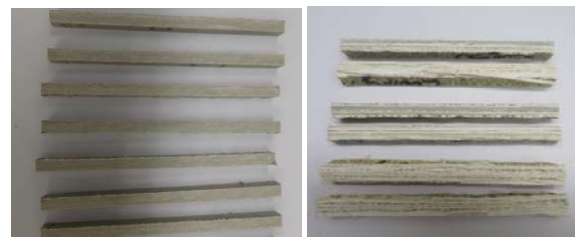
the original polyester material. This is further illustrated in Figure 10, which shows photographs of the original polyester material before and after 2 weeks incubation in acid, showing severe delamination of the test specimens.

Figure 10: Photographs of test specimens cut from samples of the original tower FRP, before (left) and after (right) two weeks incubation in acid. Note severe delamination.
