# Lessons Learned from the Rotokawa Condensation Induced Water Hammer Incident

Ivo M.R. Lemmens<sup>1</sup>,

**Keywords:** *Condensation Induced Water Hammer, Steam Hammer, Learning from Incidents, Rotokawa*

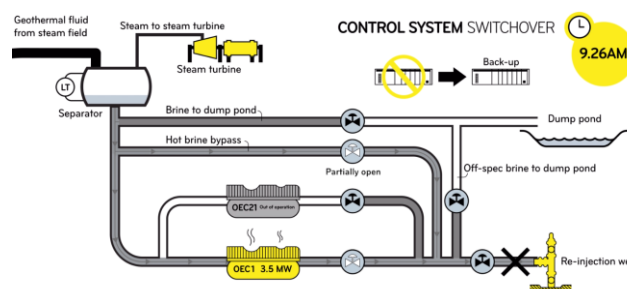
At 9:26 am, a control system malfunction triggered the automatic switch over from the primary to the backup control system. The temporary force that had been put in place in the primary control system, did not transfer to the backup control system. Without the force, the backup control system caused the brine reinjection well control valve to close, and reinjection flow to stop.

Figure 4: Control system switch over

- The fact that symbolic variables, in this case used for the temporary forcing of the off-spec brine control, are not part of the variables that are automatically transferred between primary and backup control systems, turned out to be specific to the brand of the control system and is not common across most brands of control systems. Control technicians should be made aware of this.

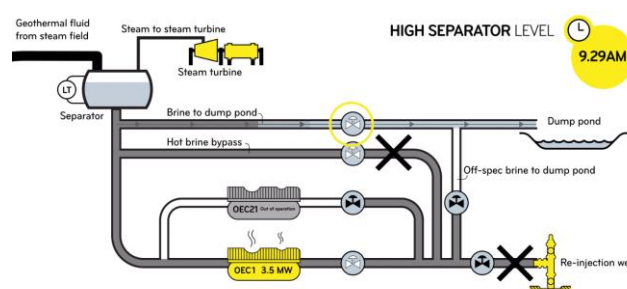
Due to there being no outlet for the brine, the separator level started to rise. At 9:29 am, the hot brine bypass automatically opened to full capacity in response to the high separator level but was not able to pass any flow due to the brine reinjection well control valve being closed.

Figure 5: High separator level

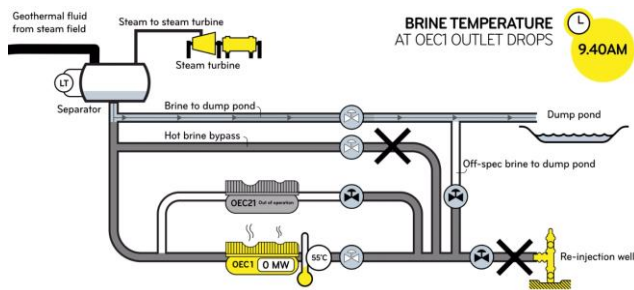
At 9:40 am, the brine temperature at the OEC1 outlet had dropped from approximately 130 °C to 55°C due to continued vaporisation of cold pentane whilst there was no brine flow.

**Figure 6: Brine temperature at OEC1 outlet drops**

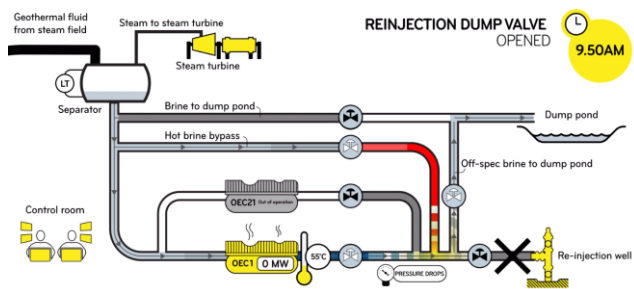
At 9:45 am, the operators in the control room attempted to reestablish brine flow by manually opening the reinjection well control valve, which opened briefly to 10% before the control system automatically overrode this due to the off-spec brine detection and immediately closed the reinjection control valve again.

**Figure 7: Attempt to reestablish brine flow resulting in CIWH**

The lower reinjection back pressure caused the incoming hot brine from the hot brine bypass to flash and generate > 90 vol.% of steam. With the OEC1 control valve initially briefly shut (not shown in figure 7), the piping section between the hot brine bypass mixing point and the off-spec brine dump valves filled with predominantly steam. Subsequently, the OEC1 control valve opened and introduced cold brine into the steam filled section of the pipe. The mixing of the subcooled brine flow from OEC1 with the steam led to CIWH near the location of the hot brine bypass tie-in point.

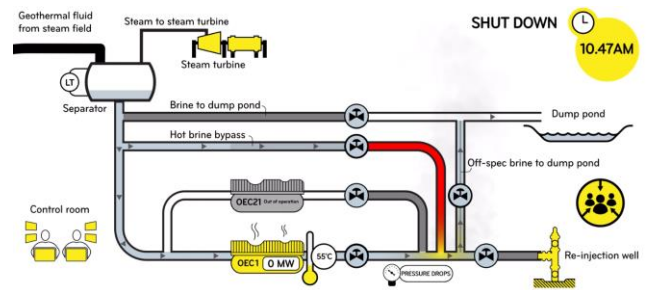
At 10:13 am, the ongoing CIWH eventually led to loss of containment of steam and a large steam leak was visible on the CCTV.

At 10:20 am, severe hammering and steam discharge was observed and reported by contractor personnel working on site. Mercury staff went across to Rotokawa to investigate and confirmed the ongoing steam leak and reported this back to the control room.

**Figure 8: Loss of containment of steam and emergency response**

- Site evacuation and station shut down should have been initiated without hesitation upon the detection of loss of containment of steam on the CCTV system. Initiating further investigation and confirmation in the field instead of immediate site evacuation and station shutdown, leads to unnecessary delay and potentially puts people at risk.

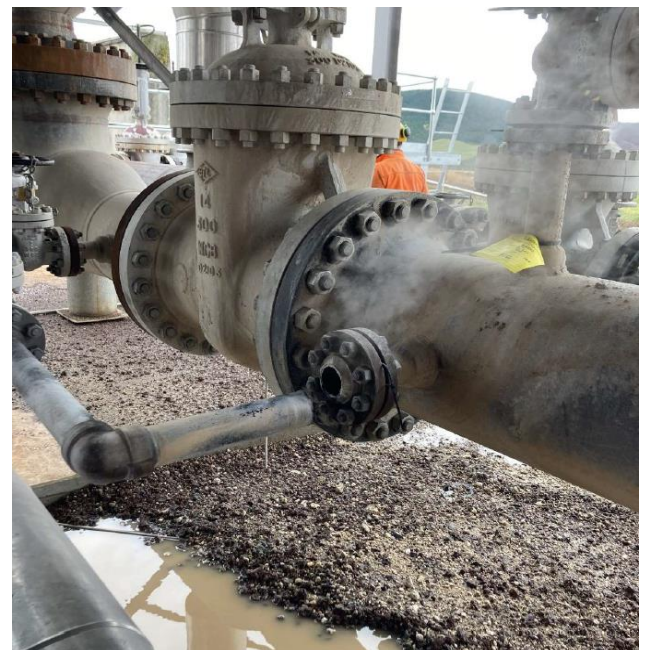
- A small-bore pipe connection had ruptured and opened.
- The OEC21 isolation valve gearbox had come apart allowing the valve stem and gate to be lifted. This valve acted as the single isolation between the operational steam field and the project work being carried out at OEC21. As a result, the isolation between the operational steam field and the OEC21 construction area was breached.
- A pressure instrument tubing connection had come loose.

**Figure 10: Ruptured small-bore connection**

- Instead of relying on one valve acting as a single isolation, a more robust isolation method such as air gapping, a spade isolation or a double block and bleed isolation should have been applied.

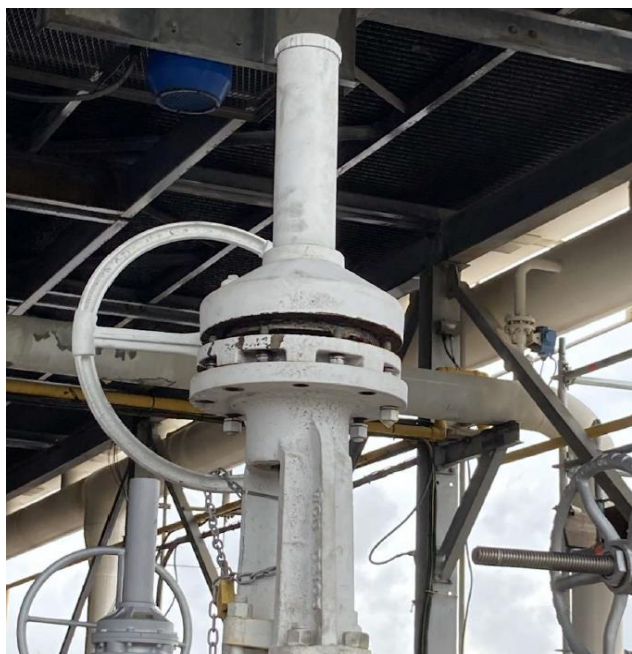
**Figure 11: Damaged isolation valve**

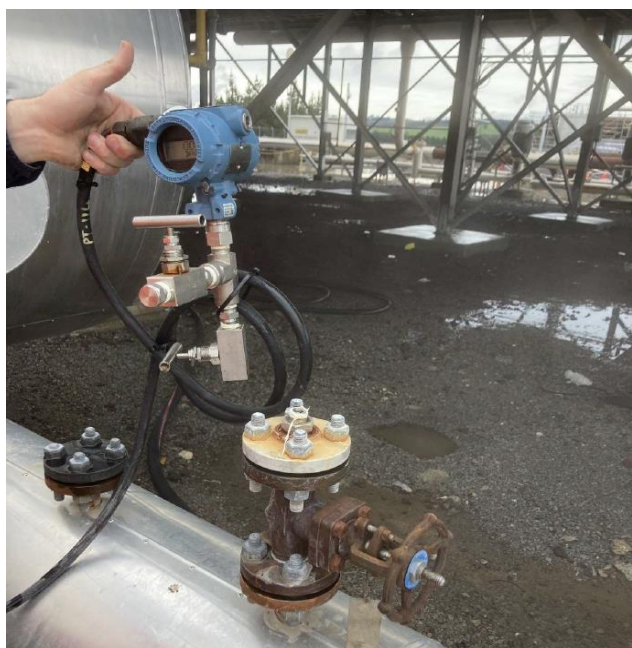
**Figure 12: Loose pressure instrument tubing connection**
