Stress Corrosion Cracking Failure of a Geothermal Steam Piping Rupture Disc

Keywords: *Stress corrosion cracking, rupture disc, geothermal, steam piping*

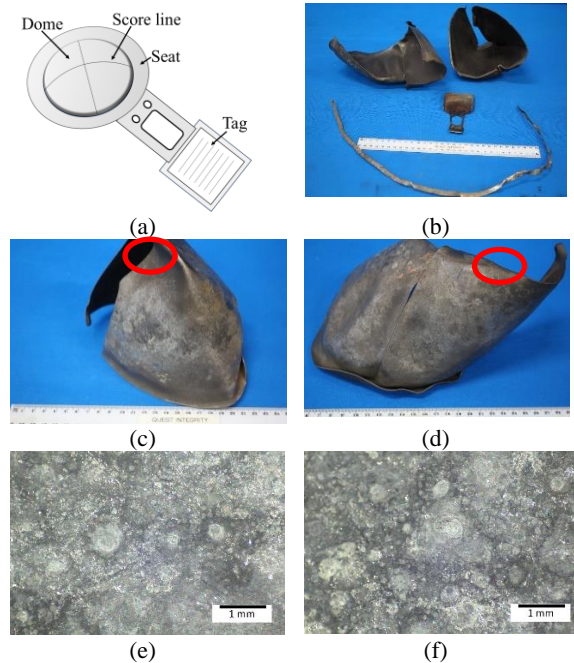
The failure mode of the current failed rupture disc was considered unusual. The disc opened on one of the score lines, but it was deformed upward along the score line instead of the petal burst, as shown in Figure 1. This failure mode was unlikely to have been caused by an over pressure event. This paper presents the investigation results of the unusual failure mode of the rupture disc.

Figure 1: Schematic figure of the rupture discs and photographs of the as-received failed rupture disc (b). (c) shows Disc piece 1 and (d) shows Disc piece 2. (e) and (f) show numerous pitting on the convex side of the rupture disc. The red circles indicate the location of the cracking.

The as-received failed rupture disc samples were examined visually, and Figure 1 shows the photographs of the disc sample. The seat and the tag were dislodged from the original assembly. The measured score depth was approximately 0.2 mm within the disc full thickness of approximately 1.2 mm. The disc split into two pieces along one of the original score lines. For convenience, the two-piece of the disc was arbitrarily named Disc Piece 1 (Figure 1 (c)) and Disc Piece 2 (Figure 1 (d)).

Numerous fine pits were observed on the convex side, see Figure 1 (e) and (f). A small section of the disc sample (60 × 50 mm) was cut and chemically cleaned for pitting survey. These fine pits had an average pit depth of less than 15 µm as measured by an optical microscope.

Cracking was observed only on the convex side exposed to the atmosphere. The cracking was approximately 60 mm from

the centre of the crossed score line, as highlighted by the red circle in Figure 1 (c). Cracking was also observed on the matching face on the other disc piece, as shown in Figure 1 (d).

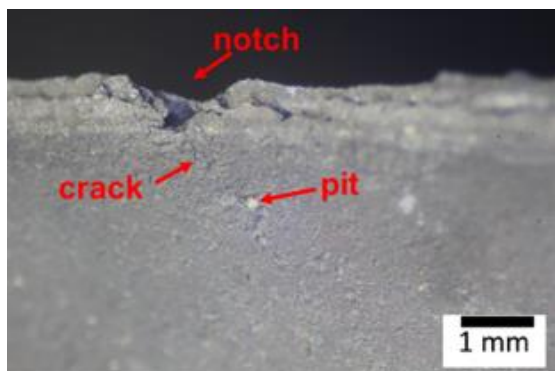
- A crack was observed to have propagated from a notch near the score line, as shown in Figure 2 (a). This crack was connected to another crack that propagated from a pit. In addition, two cracks were also observed at approximately 1 mm away from the notch area (Figure 2 (b)).
- The cracking was observed to be branching from the score line (Figure 2 [c] and Figure 3 [a]).
- Longitudinal cracking was also present along the cross-section of the score line, see Figure 2 (c) and Figure 3 (b).

(a) A crack propagated from a notch and a pit near the edge of the score line.

Figure 2: Photograph of cracks observed at the edge of the score line of the disc piece 1 at the area marked by a red circle in Figure 1 (c).

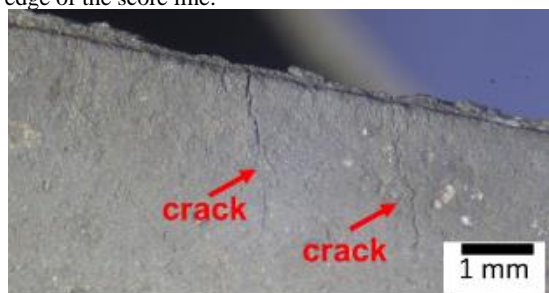
(b) Cracks propagated from the edge of the score line.

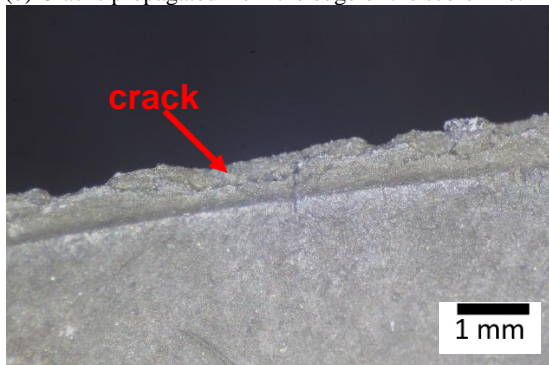
(d) A longitudinal crack along the score line.

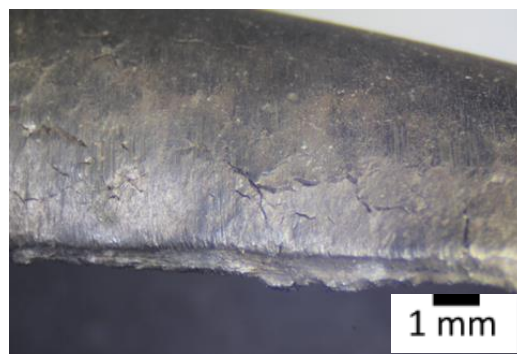
(a) Cracks branching from the score line.

Figure 3: Photograph of cracks observed at the edge of the score line of the disc piece 2 at the area marked by red circle in Figure 1 (d).

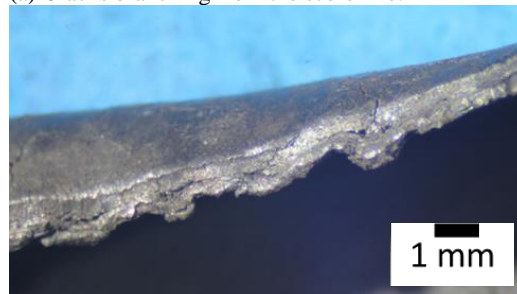
(b) A longitudinal crack along the cross-section of the score line.

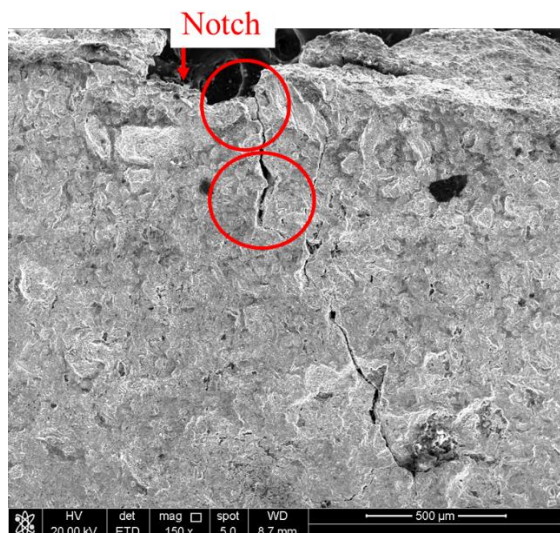
Figure 4 shows low magnification secondary electron (SE) SEM images of the crack at the notch shown in Figure 2 (a). High magnification SEM images are shown in Figure 5, together with the EDS analysis on the highlighted areas (Table 1). The EDS analysis indicated chloride contaminant near the notch and the cracking. In Figure 5 (a), possible NaCl was observed on points 1 and 2. Note, chloride is easily dissolved in water. The residual low concentration of chloride (0.5-2.3 wt.%) detected by EDS was enough to indicate the presence of significant chloride contamination. Apart from chloride, a high amount of corrosive species such as sulphur (7-15 wt.%) and contaminants such as magnesium, calcium, silicon, aluminum, and potassium were detected.

Figure 4: Low magnification SE-SEM images of the crack at the notch shown in Figure 2 (a).

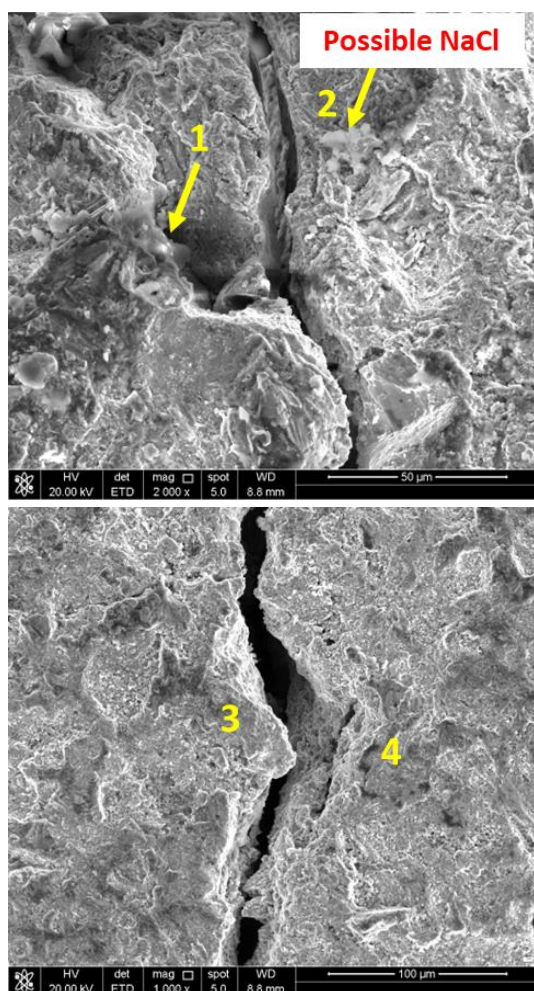
Figure 5: High magnification SE-SEM images of red circle marked areas in Figure 4.

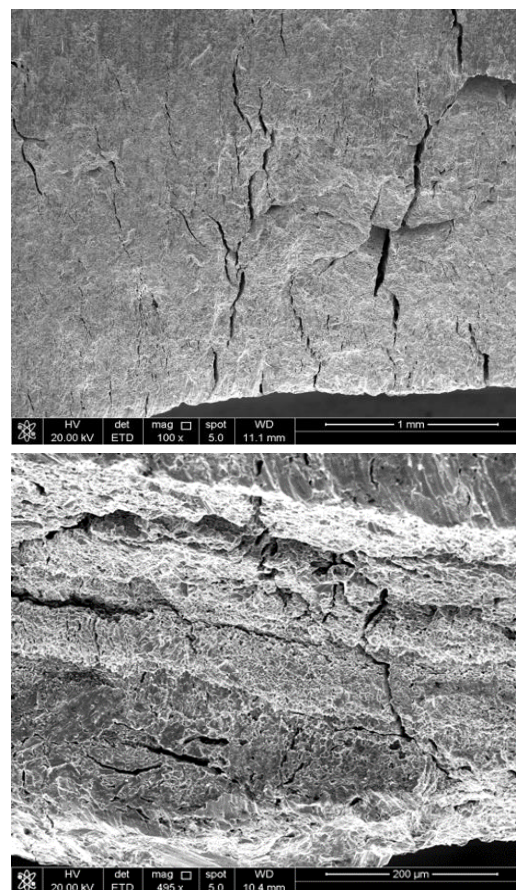
Figure 6 shows the SE-SEM image of cracks on the disc piece 2 sample. The figure shows multiple cracks with branching on both the convex side (a) and on the score line (b).

Figure 6: SE-SEM images showing crack branching near the edge at the location shown in Figure 3, Disc piece 2. (a) is top view of the convex side. (b) is the cross-section of the cracking along the score line.

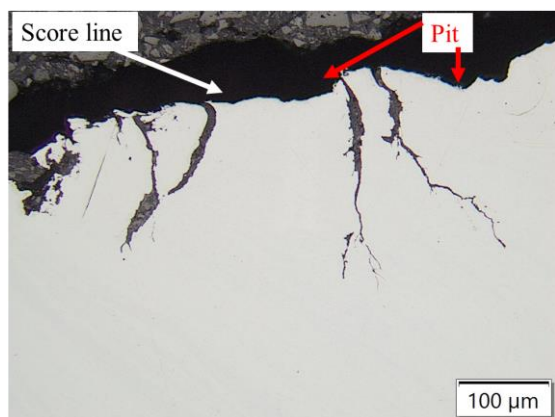
Figure 7 shows the polished cross-section of the sample. Cracks appeared to be branching from the corroded surface and from the likely high-stress area near the crossed-score line, see Figure 7 (a). Several pits were also observed near the cracks at the external surface, as indicated by red arrows in Figure 7 (a). In contrast, there was no cracking in the non-corroded area, as shown in Figure 7 (b).

(a) Cracks branching from the corroded surface of the score line.

Figure 7: Cross-sectional micrograph of the cracks near pits (a) and a non-corroded area with no cracks (b).

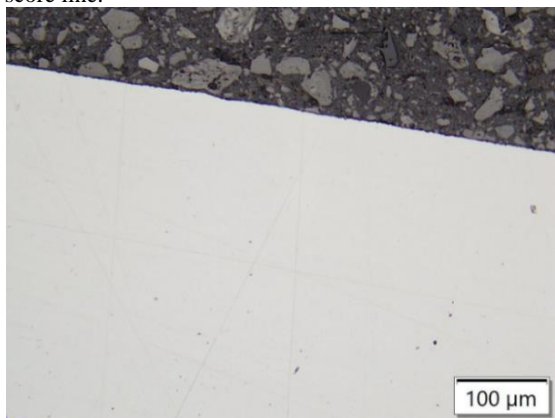
(b) No cracks at the non-corroded area.

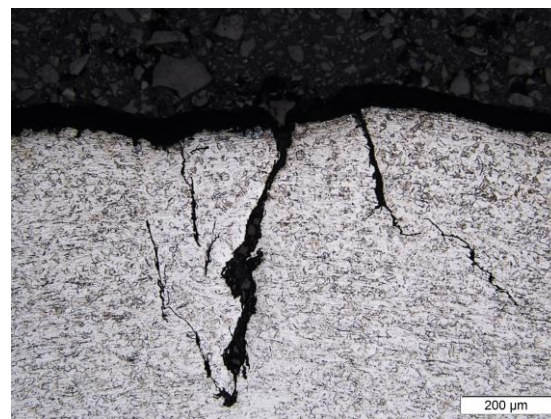
The micro-specimen was then electrolytic etched in 10 vol. % oxalic acid to reveal the microstructure. Figure 8 shows a mix mode of trans-granular and intergranular cracking. The general microstructure comprised of austenitic structure, which was typical of 316 stainless steel. Some delta-ferrite stringers were also present, which is commonly found in austenitic stainless-steel sheet material (ASM International, 2004). Note, Figure 8 (b) shows no strong interaction between the delta ferrite stringers and the cracking.

(a) Low magnification image of a crack.

Figure 8: A mix of trans-granular and intergranular mode of the cracking. Red arrows represent examples of delta ferrite stringers.

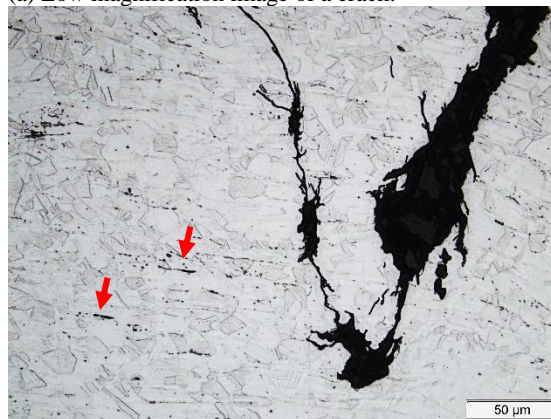
(b) High magnification of image (a), showing austenitic microstructure and several delta ferrite stringers.
