## WORKOVER ON MILOS 2 GEOTHERMAL WELL

## ABSTRACT

The Milos 2 geothermal well (Milos Island, Greece) blew out on September 1993 due to a serious damage occurred below the wellhead base flange.

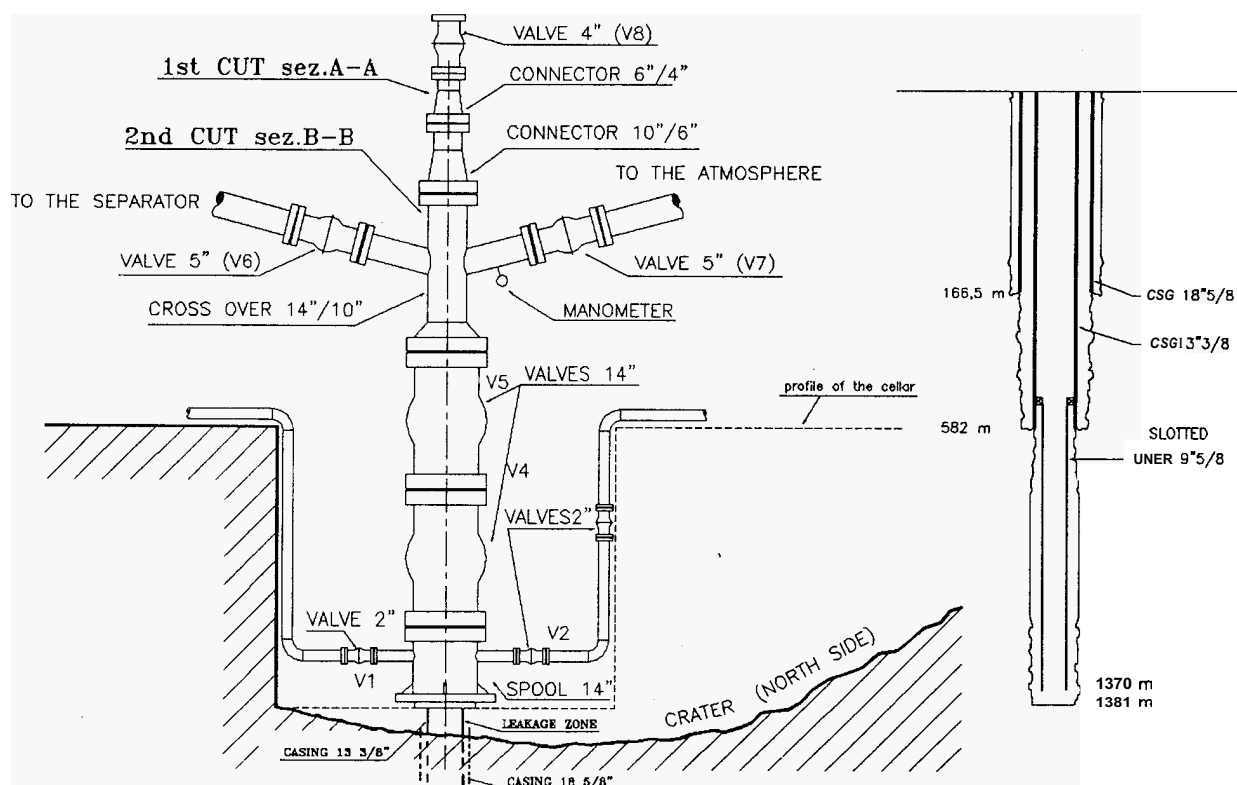
Figure 1. - Wellhead and casing profile

Figure 1 presents a schematic illustration of the well's technical profile and wellhead, which during the blow out was still anchored to the 13 3/8" casing.

valves V1, V2, V8 (fig.1) were inoperative and stuck in the closed position probably by the salt product during the blow-out.

- 1) removal of valve V8 by means of a cut in section AA (fig. 1)
- 2) partial demolition of the metallic structure encircling the wellhead;
- 3) removal of the 10"-6" cross-over by a cut in section BB (fig. 1);
- 4) removal of valve V5 (fig. 1);
- 5) digging around the well and demolition of the cellar;
- 6) removal of valve V4 (fig. 1) and checking the casing **failure**;
- 7) assembling a 21 1/4" flange on the 18 5/8" casing;
- 8) installing a new pre-assembled and tested wellhead;
- 9) valve closure, **killing** and cementing of the well.

Cutting was performed at a safe distance and involved sections AA and BB (fig. 1).

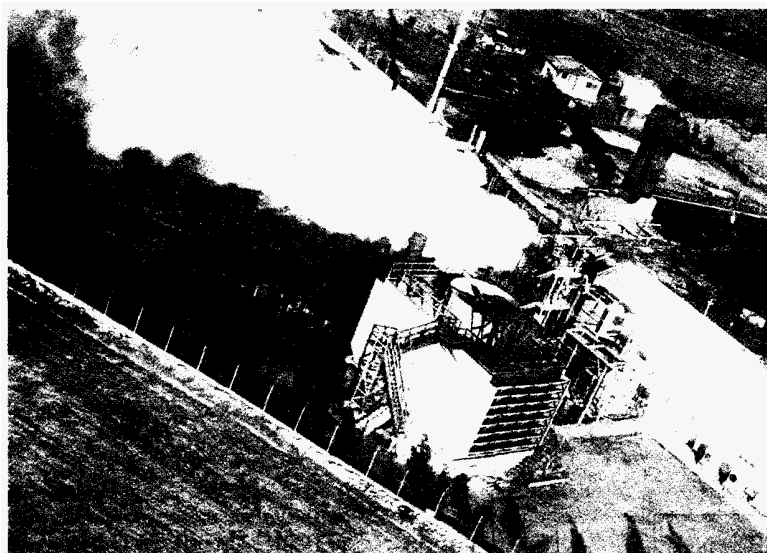
Figure 2. - General view of the plant

The blow out occurred suddenly and violently after a first phase of a week of slight leakage of hot water into the well cellar. The situation was as shown in fig. 2 and fig. 3.

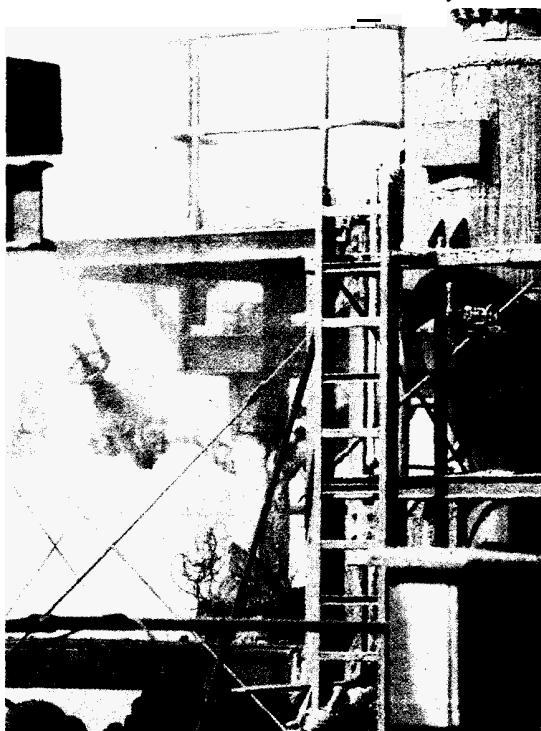
Figure 3. - wellhead

- the fluid loss was located in the cellar bottom below the base flange;
- localization of the precise site of failure was rendered impossible by the emanation of steam which hindered cellar access and visibility;
- one half of the cellar was practically destroyed by the fluid jet that had also formed a completely fluid-filled crater on the northern side (fig. 1, fig. 4)
- much of the metallic structures for pipelines and separators had become unsafe as the ground on which their concrete basements were anchored had been washed away

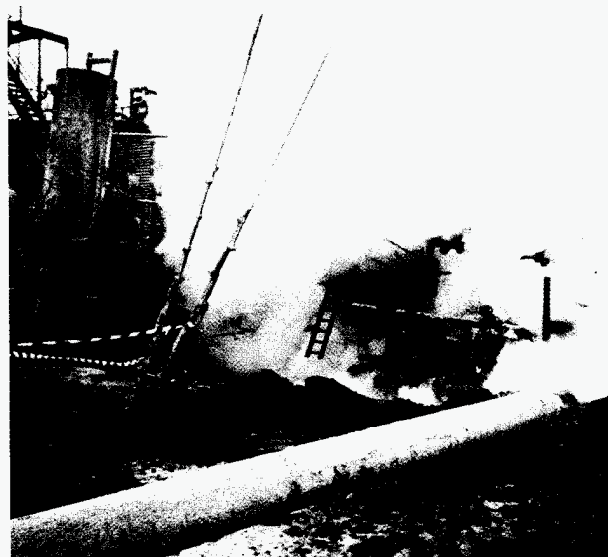
Figure 4. - North side crater

The flow of brine and steam coming from the well quickly destroyed the concrete of the cellar and produced a big crater around the well.
