# DEVELOPMENT OF A PROTECTIVE SHROUD FOR DOWNHOLE INJECTION TUBING

Michael Rock<sup>1</sup>

<sup>1</sup>Century Drilling and Energy Services, 166 Karetoto Road, Wairakei, Box 341, Taupo New Zealand

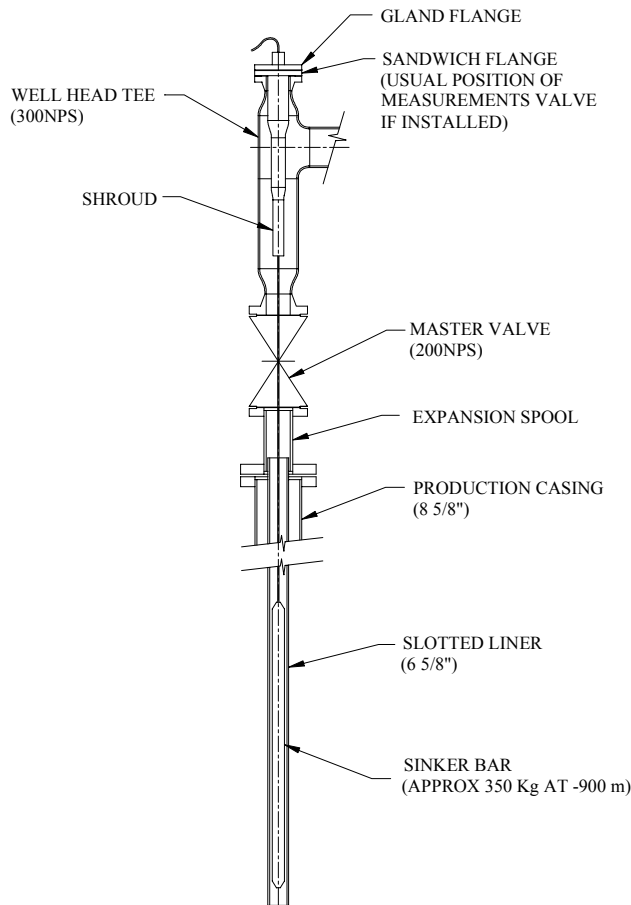
Figure 1  
Antiscalant downhole equipment

Downhole injection of chemicals in two phase wells to control calcite deposition within the well liner or casing has been used successfully in the Kawerau field (New Zealand) since April 1989. The components within the well consisted of tubing which is suspended from a glanded flange bolted on the measurements valve flange. The tubing is kept taut by a sinker bar attached to the lower end. A schematic of downhole antiscalant equipment is shown in figure 1. Although the original system worked reasonably well the tubing would break off immediately below the gland flange on a regular basis. Failure of the tubing was put down to fatigue caused by slugs of water deflecting the tubing towards the branch of the wellhead tee. The solution to this was to shield the tubing from the flow near the wellhead tee. A shroud was constructed from a single piece of pipe and welded to the underside of a sandwich flange. This shroud failed within two weeks of installation. The shroud broke off near the gland flange. Examination of the surface suggested fatigue had caused the shroud to fail. The fracture surface was in poor condition as the shroud had been hammering against the gland flange. Alternative shroud designs were then investigated.

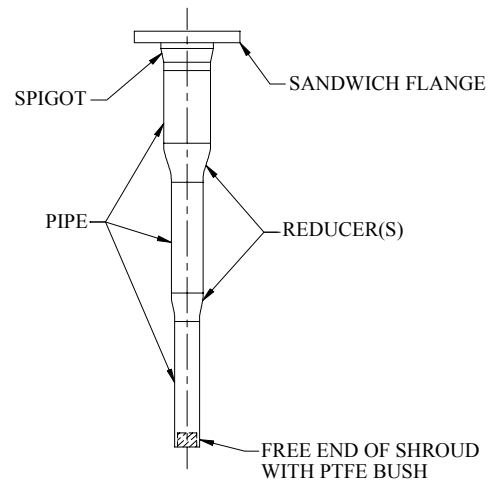
Figure 2  
Antiscalant tubing shroud

A shroud was then designed which would not be stressed beyond its fatigue limit when subjected to the same moment. A schematic of the shroud is shown in figure 2. Where

possible standard pipe and fittings were used as they are readily available and cost efficient. The attachment of the shroud to the sandwich flange had to be such that the effect of the weld on the shroud due to the bending moment was minimized. It also had to fit inside the wellhead pipework. The detail chosen resembled a welding neck flange. The shroud length was minimized by removing the measurements valve and fitting the sandwich flange directly to the wellhead flange.

Because of its resistance to fatigue compared with higher strength steels, low carbon steel was chosen for all components. SA106 grade B was used for the pipe & fittings while the spigot was to be machined from engineering round.

As an additional safeguard against failure the shroud was designed so that its natural frequency did not coincide with the vibration frequencies of the well. This was done by dividing the shroud into several sections of different stiffness. This raised the natural frequency above the well vibration frequencies. The reducing pipe sections has the benefit of reducing the sectional area of the shroud exposed to the flow. This should have the benefit of reducing the moment at the base of the shroud.

A PTFE bush was installed in the free end of the shroud to stop the antiscalant tubing from deflecting sideways and rubbing on the shroud.
