# EXPOSURE TESTS OF TURBINE MATERIALS IN GEOTHERMAL STEAM FROM A DEEP PRODUCTION WELL

Hideo Kato, Koji Furuya and Mitsuo Yamashita  
Fuji Electric Co., Ltd. 1-1 Tanabeshinden, Kawasaki-ku, Kawasaki-city 210-0856 Japan

**Key Words:** exposure test, turbine materials, geothermal, deep production well, coating, scale

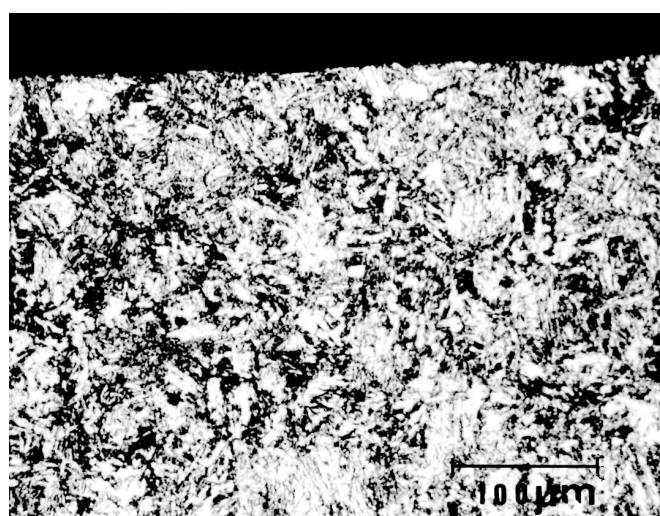
Figure 3 Microstructure of 13% Cr steel corrosion test specimen (after twelve months exposure)

13% Cr steel specimens showed no corrosion pits (Figure 3). Corrosion rate of the specimen exposed for twelve months was ca. 0.008 mm/year (Figure 4). As for 13% Cr steel with stellite brazed using silver solder, a slight corrosion was observed in part of the silver solder. Separation of stellite due to corrosion of base metal on the boundary was observed, which had probably developed from blowholes caused during brazing. Corrosion rate of this specimen after twelve month exposure was ca. 0.007 mm/year, almost same as that of solid 13% Cr steel specimen. Ti-6Al-4V specimens had no pits and the corrosion rate after twelve months exposure was very small being less than 0.001 mm/year.

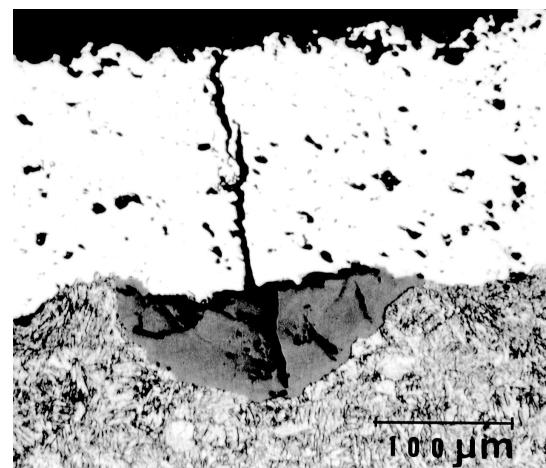
Figure 5 Microstructure of 13 % Cr steel corrosion test specimen coated with Cr<sub>3</sub>C<sub>2</sub>-NiCr (after twelve months exposure)

$\text{Cr}_3\text{C}_2\text{-NiCr}$ , a candidate material as anti-abrasion coating, already showed cracks on the edge after three months exposure. The cracks were found to reach the base metal side of the boundary and considerable corrosion of the base metal was observed (Figure 5). Corrosion rate was ca. 0.007 mm/year. As for  $\text{Cr}_3\text{C}_2\text{-FeCrAlY}$ , separation of the surface layer of the coating was observed and its apparent corrosion rate was 0.019 mm/year, including weight loss due to separation. However, as corrosion of the base metal was scarcely observed, the substantial corrosion rate is supposed to be less than 0.01 mm/year.

Specimens coated with  $\text{Cr}_3\text{C}_2\text{-NiCr}$ , a candidate material as anti-abrasion coating, had cracks on the edge. And it is supposed that through these cracks geothermal steam invaded into the boundary and caused separation of the coating layer from base metal and the corrosion of base metal. Cracks in the coating layer could be a cause of progress of corrosion and lowering of strength. These phenomena showed a great influence on fatigue strength. This can be understood taking into consideration that fatigue strength lowered sharply by ca. 37% compared to that of unexposed base metal though the lowering of fatigue strength of base metal itself due to exposure was only ca. 8%. Meanwhile,  $\text{Cr}_3\text{C}_2\text{-FeCrAlY}$  specimens had no cracks though they showed some separation. Consequently, invasion of geothermal steam into the base metal was only a little and fatigue strength of the specimens increased about 19% compared to that of uncoated specimens. Probably, this was mainly due to a mechanical strengthening effect of the coating layer. Thus, it was confirmed that freeness from cracks in coating layer contributed to improving the fatigue strength.

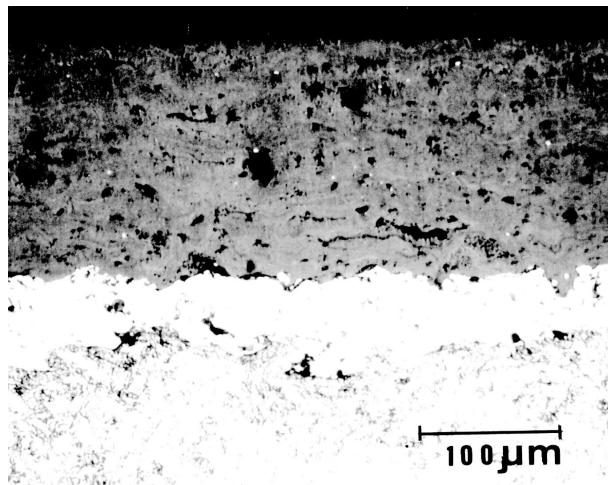
Figure 6 Microstructure of 13 % Cr steel corrosion test specimen coated with CoNiCrAlY+Al<sub>2</sub>O<sub>3</sub> · TiO<sub>2</sub> (after twelve months exposure)

As for anti-scale deposition coating, only  $\text{CoNiCrAlY+Al}_2\text{O}_3\text{-TiO}_2$  showed excellent results, having only a small amount of scale deposition and moreover it showed no cracks or separation (Figure 6). The corrosion rate was also very small (less than 0.001 mm/year). Candidate coating materials other than this showed blowholes and cracks or separation, however their corrosion rates (after twelve months exposure) were less

$\text{CoNiCrAlY+Al}_2\text{O}_3\cdot\text{TiO}_2$  coating, one of the anti-scale deposition coatings, gave the best results in corrosion test among six kinds of coating which were tested this time. Only this kind of coating showed no blowholes, cracks or separation and had only a little scale deposition. Corrosion rate was also the minimum. This time, only corrosion test was applied to  $\text{CoNiCrAlY+Al}_2\text{O}_3\cdot\text{TiO}_2$  coating, however this material is supposed to be one of the very promising coating materials taking everything obtained in the above-mentioned tests into consideration.

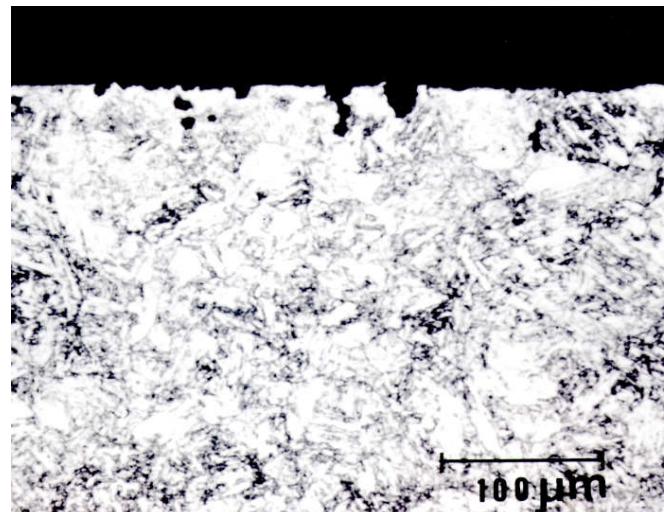
Figure 7 Microstructure of 13 % Cr steel stress corrosion cracking test (applied stress: 685 MPa)

Though some slight pits were observed all over the surface, 13% Cr steel showed no cracks (Figure 7). The maximum depth of the pits was ca.  $30 \mu\text{m}$ . As for 13% Cr steel with stellite brazed using silver solder, slight corrosion was observed on the base metal near the edge of stellite chip. Slight pits were also observed on the base metal but cracks were not found out.

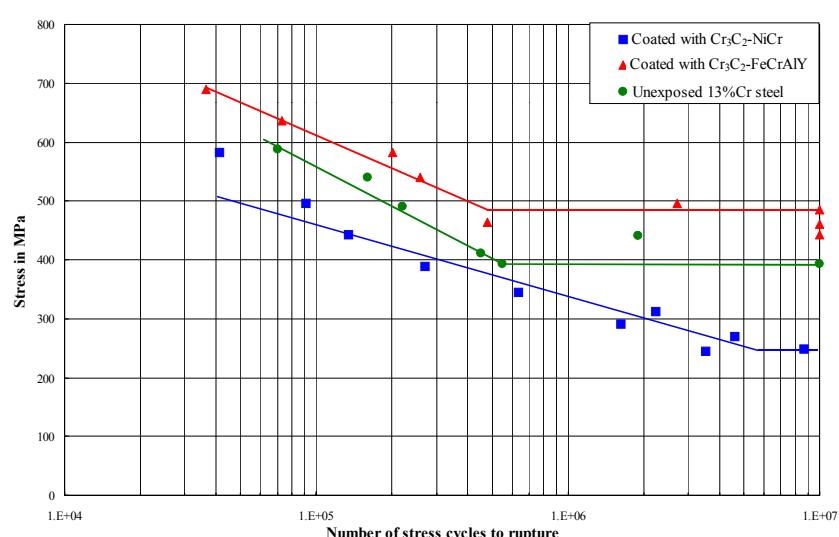
Figure 8 S-N diagram

Specimens coated with  $\text{Cr}_3\text{C}_2\text{-FeCrAlY}$  specimens showed good adhesion, though a little separation of the coating layer from the base metal was found near the final fracture surface. Subcracks were observed only in the highly stressed specimens. Fatigue strength has been increased by about 19% compared to that of the base metal (Figure 8).
