The Philippines' First Geothermal Relief Well

PNOc Energy Development Corporation, Ft. Bonifacio, Makati City, Philippines

Philippine National Oil Company Energy Development Corporation (PNOc-EDC) drilled Well 5R-13D, the first geothermal relief well in the Philippines. Well 5R-13D is probably the only relief well in the geothermal industry drilled using a single shot directional survey system. This well was designed to relieve the pressure of the uncompleted Well 5R-12D that blew out and toppled down the drilling rig on top of it after encountering a shallow pressurized two-phase zone at 450m estimated at about 4 MPa. Early completion of Well 5R-13D was very important to control the environmental, social and economic impact brought about by the continuous discharge. For a time, Well 5R-12D discharge contains part of the re-injected brine from the adjacent re-injection well.

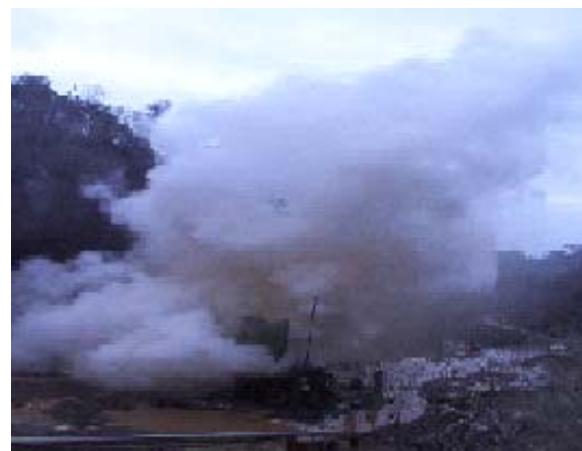
The well was drilled as programmed last July 19,2003 to August 2,2003 with the 20" casing shoe set at 106m with good cement returns. The 17-1/2" hole was drilled without problems down to 427m where the first partial loss circulation (PLC) was encountered. Two cement plugs were set to contain the total loss circulation (TLC) at 436m - 441m. On and off TLC was encountered at 441m - 447m and the well was eventually drilled blind with mud down to 450m. At this depth, the string was pulled back to the 20" casing shoe in order to build up mud volume and drill the remaining part of the hole to 455m for the total depth (TD) of casing. However, upon reaching the shoe, the well kicked. The blowout preventer was closed and fresh water was pumped through the string at 14 – 18 bpm. After 30 minutes, steam discharges came out to the surface most notably in between the substructure and shale shaker tank area. It further intensified spewing mud, soil and rock particles. In less than eight hours, the drilling mast slowly leaned and dropped towards the shale shaker tank and into the Malitbog River (Figure 1). The substructure was engulfed inside the crater-like scour measuring 12.5m x 10m at about 7.5m deep.

Figure 1: View of the blowing Well 5R-12D taken from the relief well pad

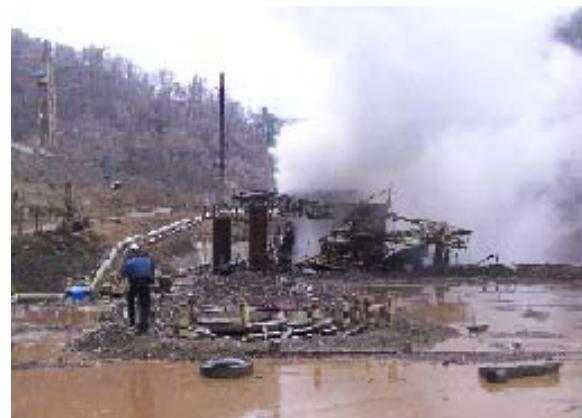
Well 5R-12D is located along the Malitbog river on one side and the foot of the mountain on the other. To save time and cost in pad preparation, the only logical location for the relief well is the area above 5R-12D. This is about 170m North and 31m higher in elevation (Figure 2). This pad however is a landslide fill and is about 35m west from the Bayabas Fault, believed to be the main conduit of the shallow pressure zone. A total of eight grout holes were drilled to 30m and about 11,000 sacks cement were used to consolidate the area.

Figure 2: Relief Well 5R-13D, located left and above Well 5R-12D

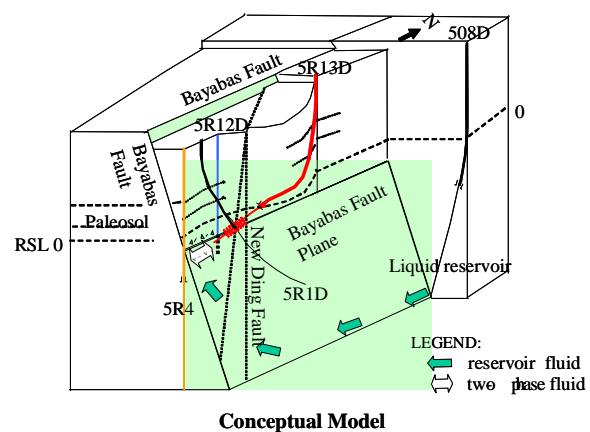
The original well design program was to kick-off at 120m at a build-up rate of 4.8°/30m for a drift angle of 39° and an azimuth of 202°. Concerns however were raised since the Bayabas Fault, believed to be the major conduit of the shallow pressurized zone, is only 35m west of the relief well 5R-13D at surface. It is dipping towards the welltrack and runs parallel with the welltrack azimuth (Figure 3). At the programmed anchor casing shoe (ACS) depth of 330m TVD, the Bayabas fault is close at 7m from the welltrack. For safety consideration and provision for any welltrack deviation during actual drilling, the welltrack direction was revised towards the left at an azimuth of 193° up to the ACS depth to have a safe distance of about 17m from the Bayabas Fault. After setting the anchor casing, the well was turned back to the right at an azimuth of 210° to hit the target at bottom.

Figure 3: A conceptual model showing the Bayabas Fault dipping towards the 5R-13D welltrack (Palma, 2003)

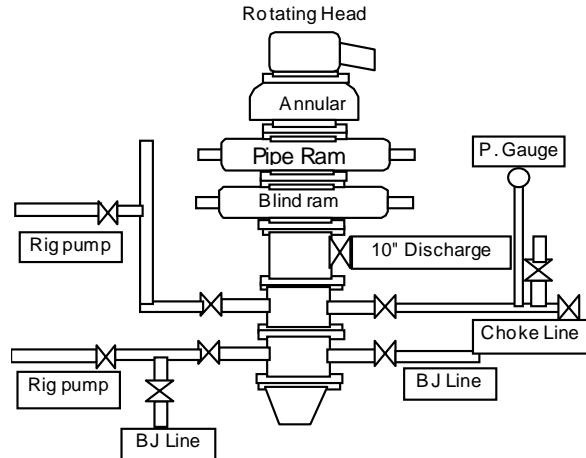
Figure 4: Diagram of the revised wellhead set-up

There were four major rig components that were modified. First was the pumping unit. Instead of the standard two slush pump compliment, a total of four slush pumps were installed. Moreover, two BJ cementing units were on line against the standard one unit compliment. The second modification was the mud and water tanks. Three additional mud tanks with agitators, one of which is complete with mud mixing hopper, were installed. These tanks served as the holding tanks for the weighted mud. A total of four water tanks were installed, instead of the standard two tanks. Two PH tanks were also available for the BJ pumping unit. The third modification was the installation of additional rig engines to accommodate the extra pumping units, agitators and mud mixing hoppers. The fourth modification was the wellhead set-up (Figure 4). A 10"

diameter banjo box, complete with 10" discharge lines and silencer, was installed on both the 21-1/4" and 13-5/8" BOPE setup. An additional drilling spool with two side ports was also incorporated to equally divide the entry ports of pumped fluid. A wellhead pressure gauge was also installed both at the wellhead directly and near the driller's console for easy monitoring by the driller.

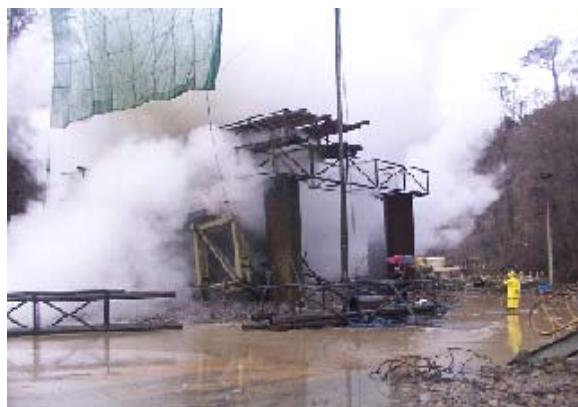
One of the effects of Well 5R-12D discharge was its interference with the transmission line located about 300m away. At one point, this caused the power plants to trip. To resolve this, poorboy discharge diffusers were installed to restrain the intensity of discharge (Figure 5). These are basically set of long span pipes placed on top of the discharging well. Moreover, a wide net was also installed to minimize the spread of the discharge water component to the location of the relief well.

Figure 5: View of the fabricated discharge diffuser and the net (taken when Well 5R-12D was already partially quenched)

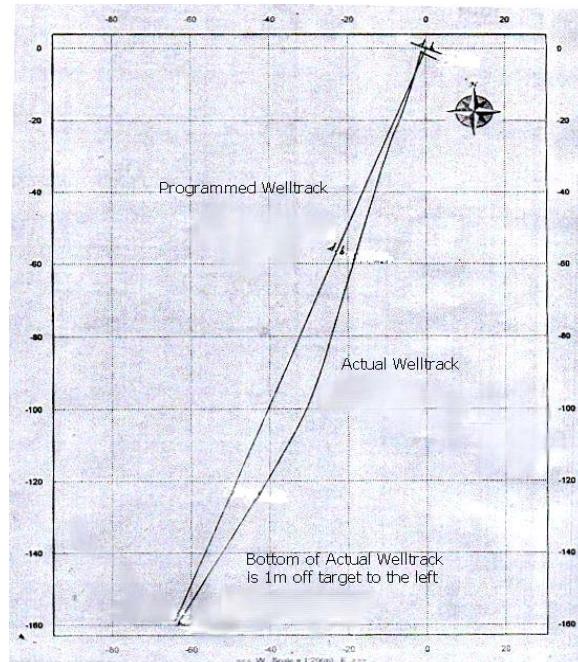
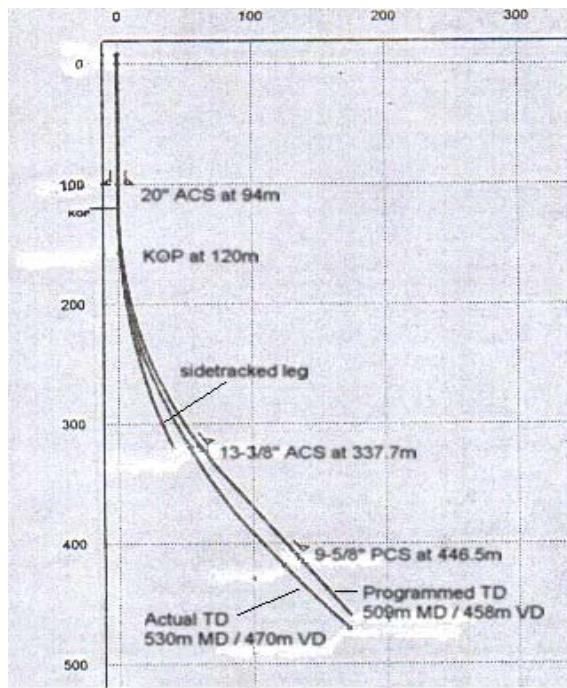
Figure 6: The top view and the vertical profile of the original program against the actual welltrack (anadrill Schlumberger Report)

As can be seen, the well was successfully directed to the left of the original program up to the anchor casing shoe depth then turned back to the right to bottom as in the revised program. It was projected to be just about 1m left of target at bottom. The difficulty was in achieving the desired inclination.

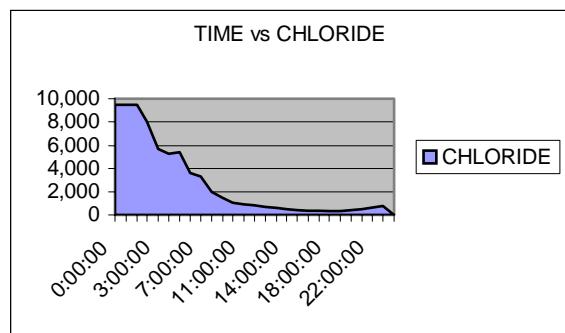
At 0600H of October 26,2003, killing operation commenced by pumping 240 bbls weighted mud at 11 ppg followed by water at 43 bpm with zero wellhead pressure. The pumped weighted mud came out of the discharging well minutes later. The intensity of the discharge drastically dropped after one hour of pumping but a low-level geysering type of discharge persisted even after hours of pumping water at 46 bpm. The continued reduction in chloride level however suggested an ongoing but slow quenching process (Figure 7).

Figure 7: Graph of the reducing chloride content of 5R-12D discharge during quenching after drilling blind dated October 26,2003 (Palma,2003)

A second batch of 730 bbls weighted mud at 11 ppg was pumped followed with water at 46 bpm and eventually killed the well. Well 5R-12D was basically quenched 24 hours from the start of the total kill operation. There was no immediate significant change in wellhead pressure (WHP) of the adjacent Well 5R-4 after the quenching activity.

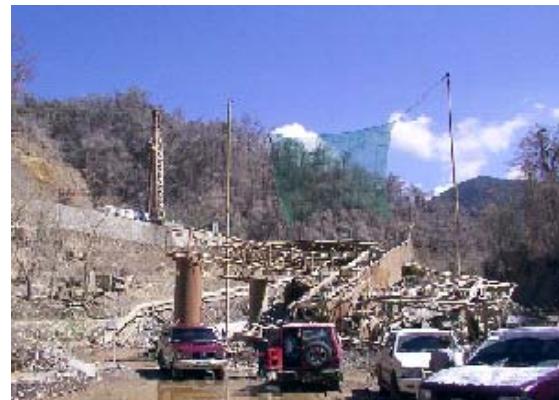
A total of 5-1/2 hours were spent waiting on cement (WOC) with the pumps off for the cement to harden. No more discharge manifestations were observed on Well 5R-12D area during this period (Figure 8).

Figure 8: View of Well 5R-12D after it was totally contained

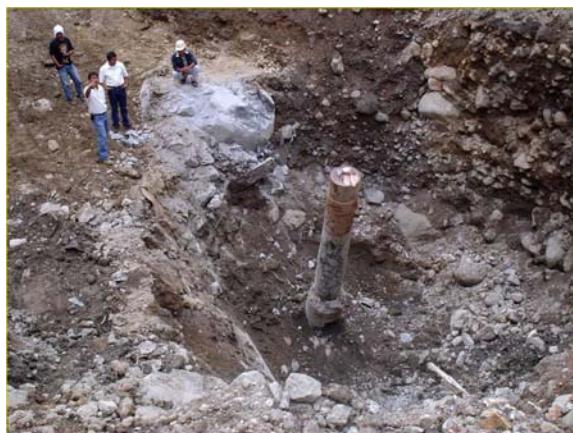
The second set of clearing activity was the excavation of the cellar to determine the extent of damage on the 20" casing. This would determine the type of cement plugging strategy to be implemented to fully isolate Well 5R-12D at surface. After excavating about 8m from surface, it was noticed that the 20" casing was still bent at an angle of 20° from vertical. Referred to the original depth of the cellar floor, it was determined that the 30" conductor pipe and the 20" surface casing dropped by about 3.5m. Further excavation was not pursued since the excavated depth was already below the adjacent river bed level and water started to fill up the excavated hole. Moreover, a retaining wall will be required since walls of the excavated section exhibited symptoms of collapse. Figure 9 shows the excavated cut-off casing.

Figure 9: The topmost cut-off casing of Well 5R-12D

A BJ cementing unit was mobilized and an adaptor was welded on the 20" casing to connect with the BJ lines. Water was pumped into annulus between the casing and string. Fortunately, communication to bottom through this annulus was observed thus option 1 was executed. A total of 5 cement plugs were conducted for a total cement slurry volume of 769 bbls. This is equivalent to 787m cement column to surface assuming a 17-1/2" hole. Table 1 is the tabulated cement plugging details.

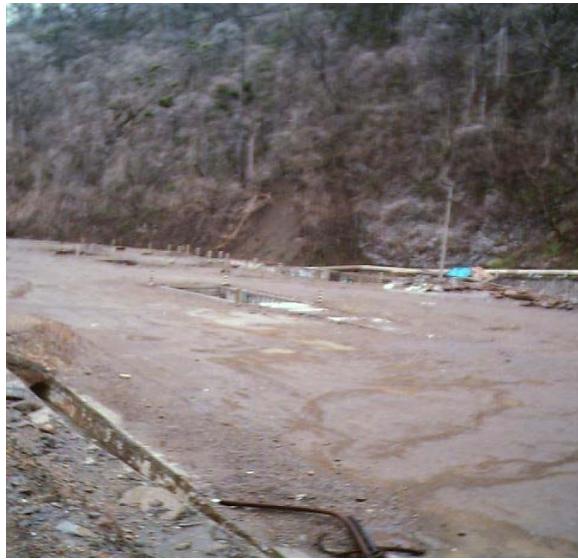
Figure 10: View of the cellar built to replace Well 5R-12D

Given the stable condition of the Well 5R-12D pad, it was decided to rehabilitate it and construct another cellar adjacent to Well 5R-12D (Figure 10). This will serve as a spare cellar in case another re-injection well will be needed in the area.
