Damaged Wellhead Rehabilitation Well OK-5, Southern Negros Geothermal Production Field, Negros Oriental, Philippines

Carlo M.R. Borromeo and GP dela Cruz

PNOC-Energy Development Corporation, Merritt Road, Fort Bonifacio, Taguig, MetroManila, Philippines

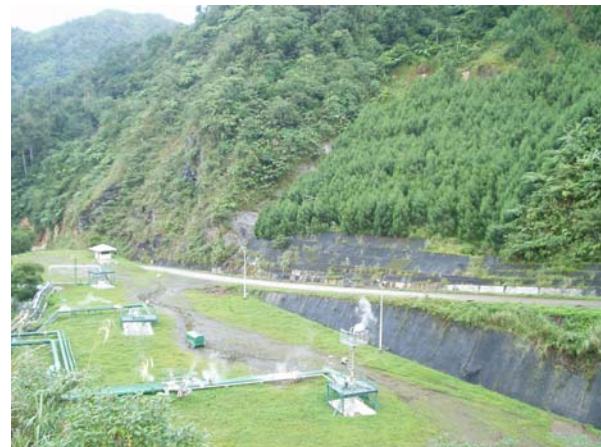
Figure 1: The Well OK5 Wellhead Pad

The Okoy 5 FCRS and the 20 MWe OK5 Modular Plant was commissioned in 1994 with three production wells OK-5, BL-1D, and BL-2D located in a production well pad cut along a rugged terrain. Such pad location poses a high risk in terms of land/rock slides. Right above the said pad is a high and almost vertical slope of cracked rock and soil formation. See Figure 1 below. Well Okoy 5 was the first well drilled in this pad as part of the exploratory phase. However, considering the limited space available for drilling sites, two additional directional production wells

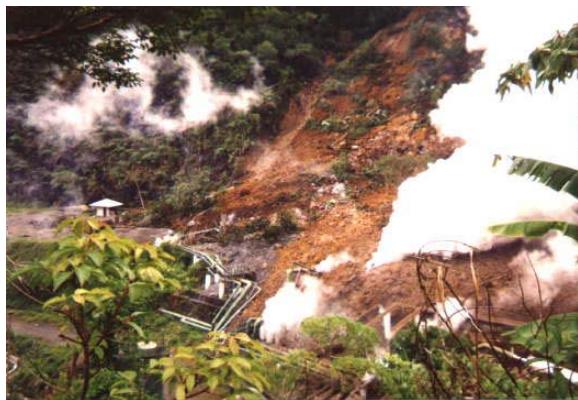
Figure 2: The Landslide

On October 23, 1998 during the height of a typhoon, a massive landslide with an estimated volume of debris of about 50,000 cubic meters (Bien, 1999) engulfed the production well pad and damaged the wellhead. The landslide occurred right after a period of intense rainfall. Post landslide analyses revealed that heavy rainfall, steep slope, loose soil and the presence of a plane of weakness provided by an unmapped fault contributed triggered the landslide (Bien, 1999). The modular plant was immediately put on house load that day and was shutdown after 4 hours when PNOC-EDC invoked Force Majeure (Quenvenco, 1998). Debris totally covered the production pipelines and wells OK-5 and BL-2D. Well OK-5 discharged uncontrollably through the debris at fullbore discharge to the atmosphere. See Figure 2. Access and mobility in and around the site was limited due to the muddy debris. Clearing of the debris was necessary before damage assessment can be conducted. It took 28 days to partially clear the production well pad to allow closer inspection of the damage. Slope stabilization was also necessary to ensure the safety of personnel working in the area (Diamante, 1998). The power plant, operated by the state-owned National Power Corporation (NPC), was immediately put on shutdown when PNOC-EDC invoked Force Majeure as provided for in the Steam Sales Contract. With this provision, it overrides the 75% Guaranteed Generation provision in the Contract and PNOC-EDC, the steam supplier, was not liable to pay any charges to NPC on generation losses throughout the 6½-month rehabilitation period.

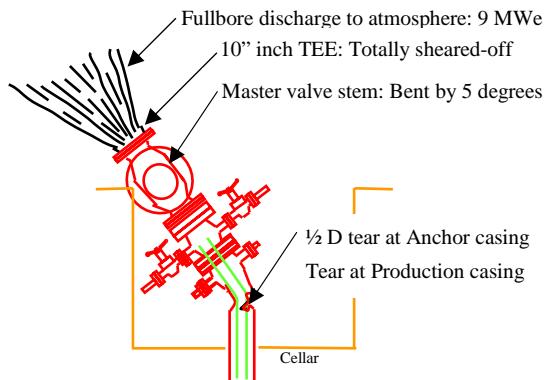
Figure 3: Extent of damage on the wellhead

The wellhead 10" tee above the master valve was completely sheared-off at the flange neck weldment and the well was discharging fullbore to atmosphere.

The weldment between the CHF and the 13 3/8" anchor casing was partially sheared with an opening of about 1" resulting in a minimal leak of steam at the area.

The wellhead components from the CHF up to the master valve were held in place only by the 9 5/8" production casing. The whole wellhead was tilted at about 37 degrees and resting on the cellar wall. The master valve stem was bent approximately 5 degrees. It was not possible to operate the valve. See Figure 3 below.

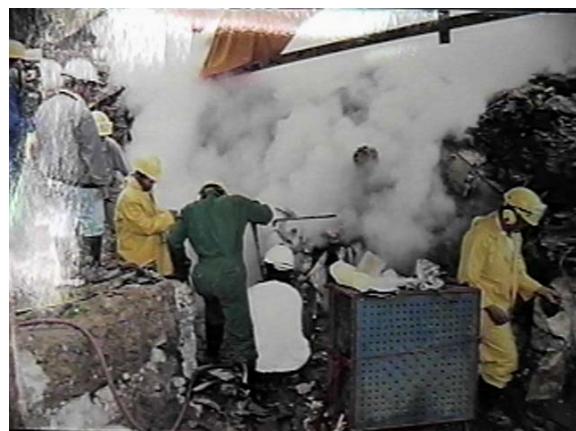
Figure 4: Steam, heat, and noise around the work area

- (1) The noise level was intense and communication was possible only through hand signal or written notes.
- (2) Rainy weather made the surrounding soil muddy slowing down mobility around the wellhead.
- (3) There was poor visibility due to the presence of escaping steam in the wellhead cellar making welding difficult.
- (4) Movement of the 9 5/8" casing when the well was quenched.
