Hydrogen Induced Cracking of Low Strength Steels in Geothermal Fluids

Keith A. Lichti, David M Firth and Annette D Karstensen

MPT Solutions, PO Box 31-310, Lower Hutt, New Zealand

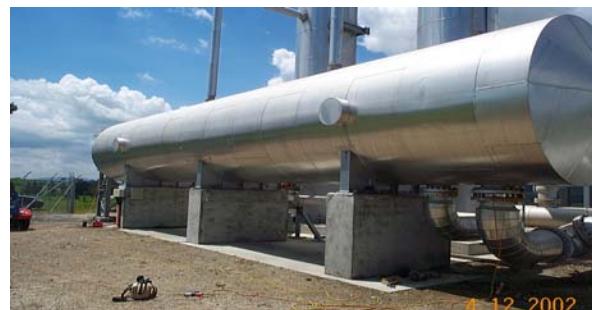
In December 2002 severe cracking was detected in a brine accumulator in a geothermal power station after 2 years of service, see Figure 1. In the following year, severe cracking was detected in a steam purifier of the same power station, see Figure 2. The station was commissioned in 2000. Both vessels were critical to the operation of the station.

Figure 1: View of Brine Accumulator Vessel.

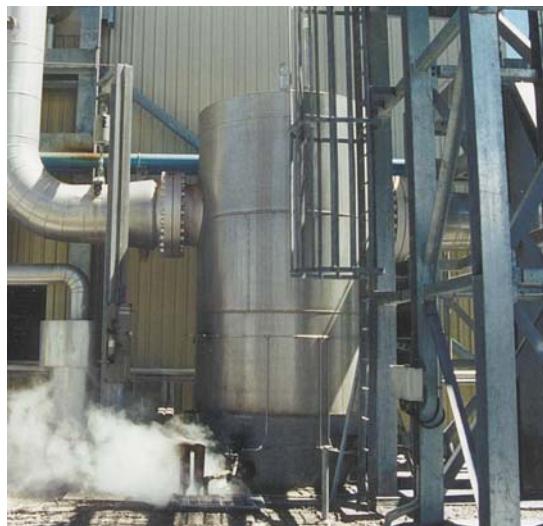
Figure 2: View of Steam Purifier Vessel

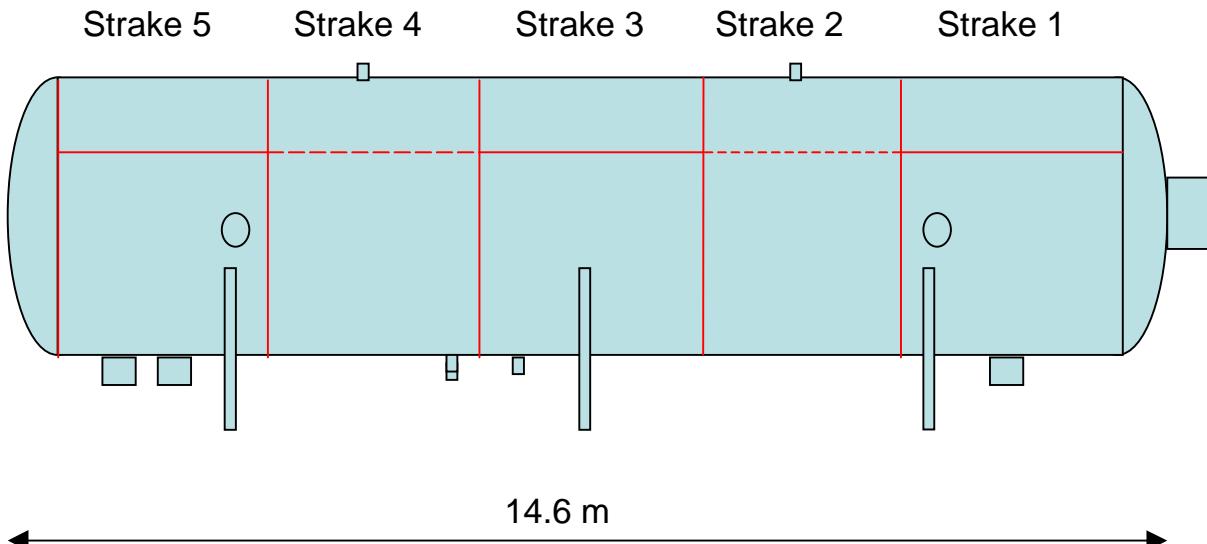
Figure 3: Illustration of brine accumulator weld layout.

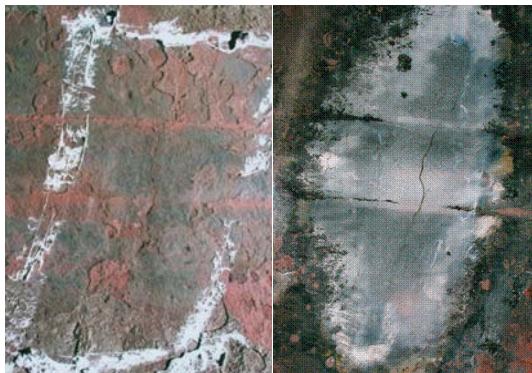
Figure 4: The typical surface of the vessel with a fine crack seen in the formed corrosion products and appearance after removal of corrosion products.

During operation the water level was about $\frac{1}{2}$ way up the vessel and a distinct water line could be seen with the lower portion having evidence of a different scale compared to the top. The top portion of the vessel was covered with a layer of oxide/corrosion product, Figure 4, presumed to be a

mixture of mill scale, welding slag from the submerged arc welding process and corrosion product formed in service. Cracks were evident in these deposits over a number of welds.

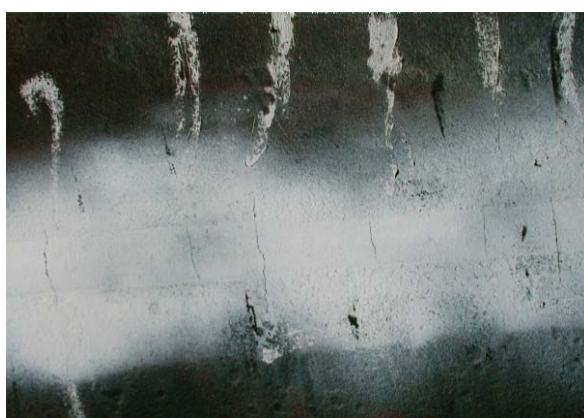
Figure 5: Vertical cracking in a longitudinal seam weld as seen after removal of corrosion products.

Removal of the corrosion products and scales by grinding revealed a greater distribution of cracks, Figures 5 and 6. The majority of the cracks ran transverse to the welds and appeared to be either centered about the centerline of the weld or one of the heat affected zones.

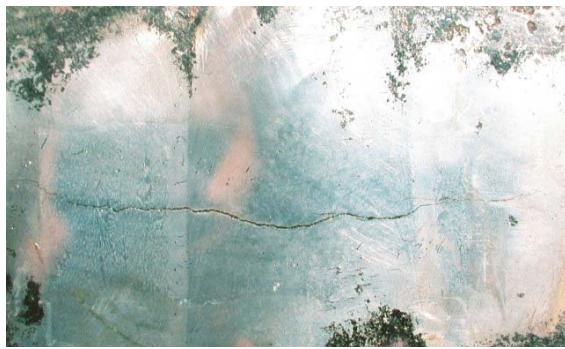
Figure 6: Horizontal crack transverse to circumferential weld C5 seen after removal of the corrosion products.

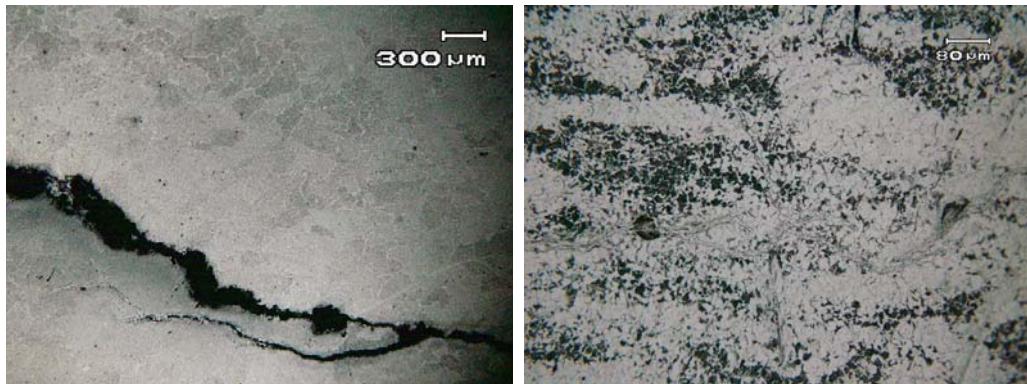
Figure 7 illustrates the in-situ metallography of the brine accumulator vessel walls in the area of cracking. Figure 8 shows a cross section of a weld area that was provided later. The parent plate shell material had a fine grained ferritic/pearlitic structure with a typical grain size of 0.01 mm. The welds had a coarse grained structure typical of a low carbon steel weld and the HAZ had a very coarse grain size up to 0.1 mm, with a coarse Widmanstatten structure.

The grains present in the capping welds were aligned perpendicular to the surface with a band of ferrite along the interdendritic grain boundaries. The weld had a typical distribution of inclusions seen as round black particles, these being variously rich in Mn/S, Fe/O and Al/O. The weld structure was typical of being produced by submerged arc welding with a high energy input. The cracking seen at the surface was relatively straight, at time branched and the cracks were open, Figures 4, 5, 6 and 7. The wide cracks were filled with corrosion product indicating the cracking had been present for some time.

**Figure 7: In situ metallography around accumulator cracking in the weld (on left) and the parent material (on right).**

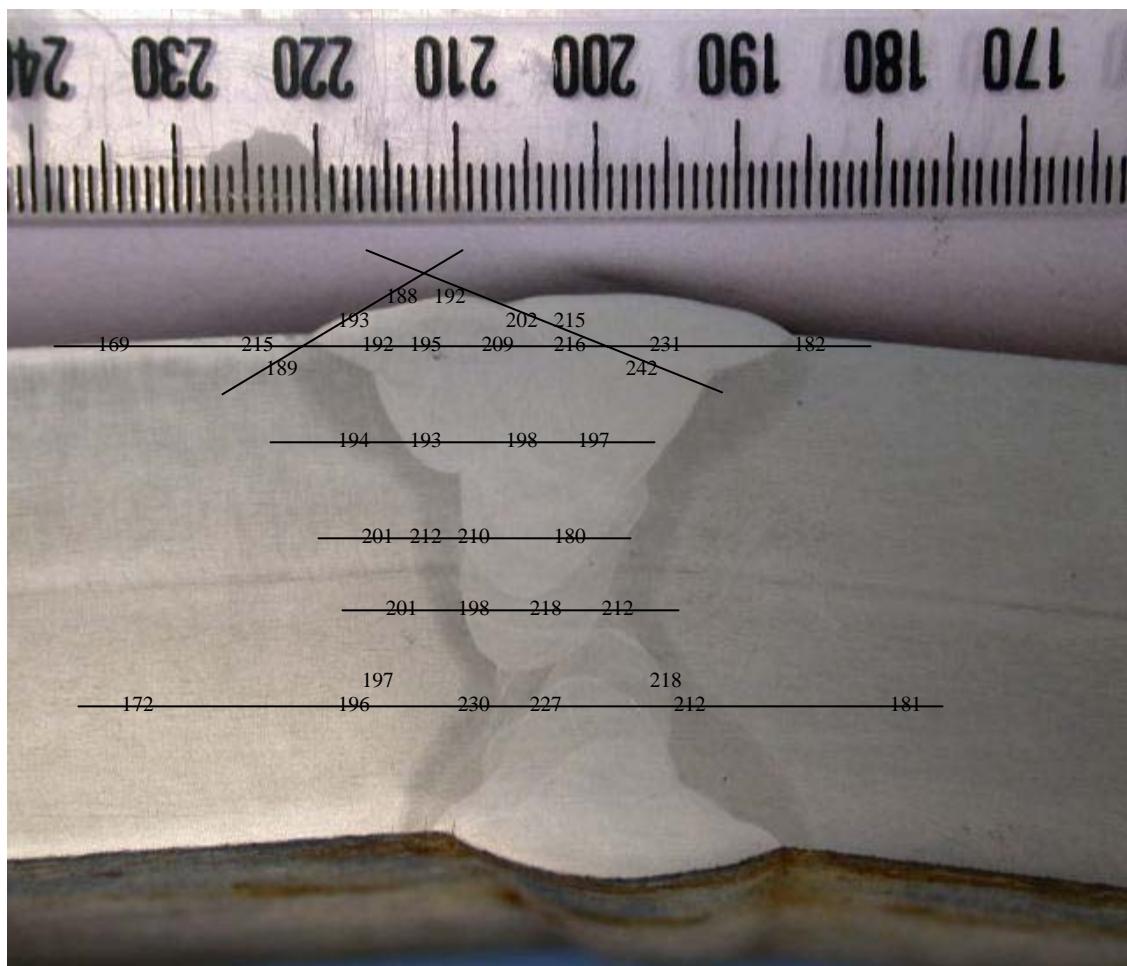
The section of brine accumulator shell material provided later had a horizontal seam weld with a typical crack extending into the parent material. A cross section of this horizontal weld, Figure 8, also shows the results of a Vickers Hardness survey and macro etching. The hardness values were all less than 248 HV (< HRC 22). A total of 10 passes were used for the weld, 6 on the outside and 4 on the inside.

**Figure 8: Cross section of typical horizontal seam weld in brine accumulator. Vickers Hardness (BS427: Part 1:1961) results, HV10.**

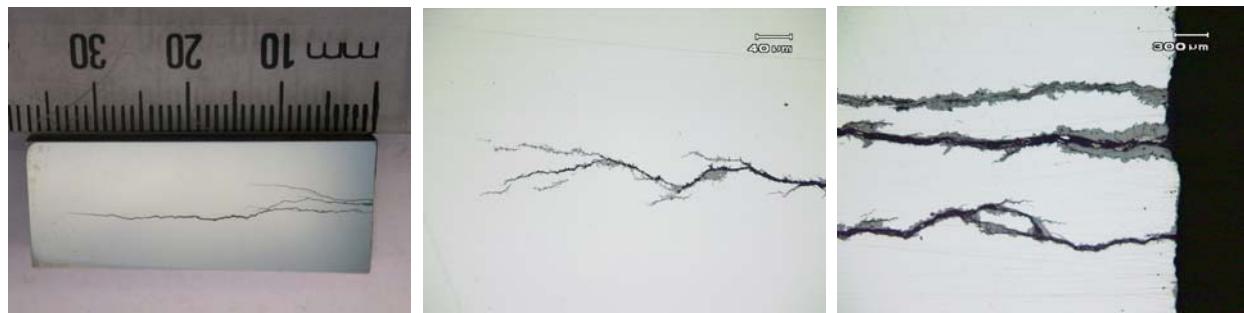
Two parts of a large weld crack were cut from the provided sample. One was sectioned through a crack, the second was broken open to reveal the fracture surface. The crack was open and filled with corrosion products, Figure 9. Three major cracks initiated and one propagated to within 5 mm of the outside wall. The crack directions, on the macro scale were all perpendicularly to the surface and were all relatively straight. The majority of the cracking was transgranular. However, on a microscopic scale side branches going backwards and at 90 degrees to the main cracks were in evidence.

Figure 9: Open crack in longitudinal seam weld filled with corrosion products.

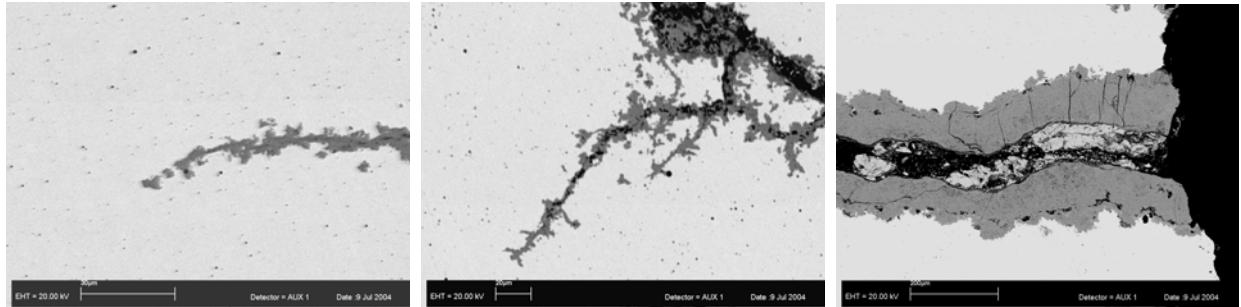
Figure 10: SEM views of the crack tip, side branches and crack initiation sites.

The crack opening and crack tip areas were examined in detail using a Scanning Electron Microscope (SEM) with Energy Dispersive X-ray (EDX) analysis facility. The results are summarized in Figure 10. There were no remnants of the crack that had not been subsequently corroded. Corrosion products and scales seen in the cracks were as follows:

- Crack tip areas: Fe/O with occasional islands of Fe/O/S

- Crack mouth area: S/Fe in central area, Fe/S crystals within the S/Fe areas, a layer rich in Si/O, Fe/O next to the metal surface.

These analysis are consistent with products seen in similar environments, namely magnetite (Fe_3O_4) in the crack tip and next to the metal surface at the crack mouth, a layer of silica (in this instance separating the magnetite from the iron sulfides and iron sulfides that were mainly pyrite (FeS_2) with some pyrrhotite ($Fe_{(1-x)}S$).

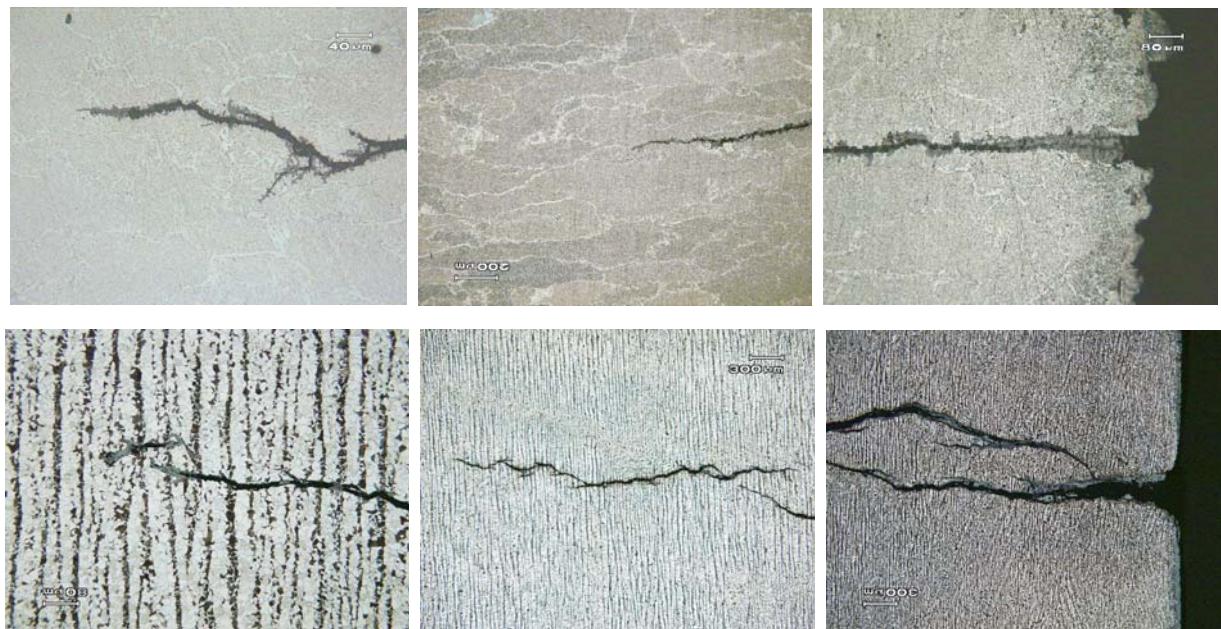
The weld was etched using Nital to reveal the microstructure in the cracked areas, Figure 11. The cracks in the capping pass on the inside of the vessel followed distinct ferrite areas in the capping weld that were present along the interdendritic grain boundaries and these were subsequently corroded. This suggests that the cracks initiated intergranularly. The cracks that appear to be going in the reverse direction were also corroded out areas of ferrite. The crack tip area of the shorter cracks were in a weld tempered zone containing finely dispersed iron carbide in ferrite. The long crack ended in the capping weld of the outside of the vessel.

Figure 11: Microstructure in areas of cracking; Top in weld metal, Bottom in parent metal.

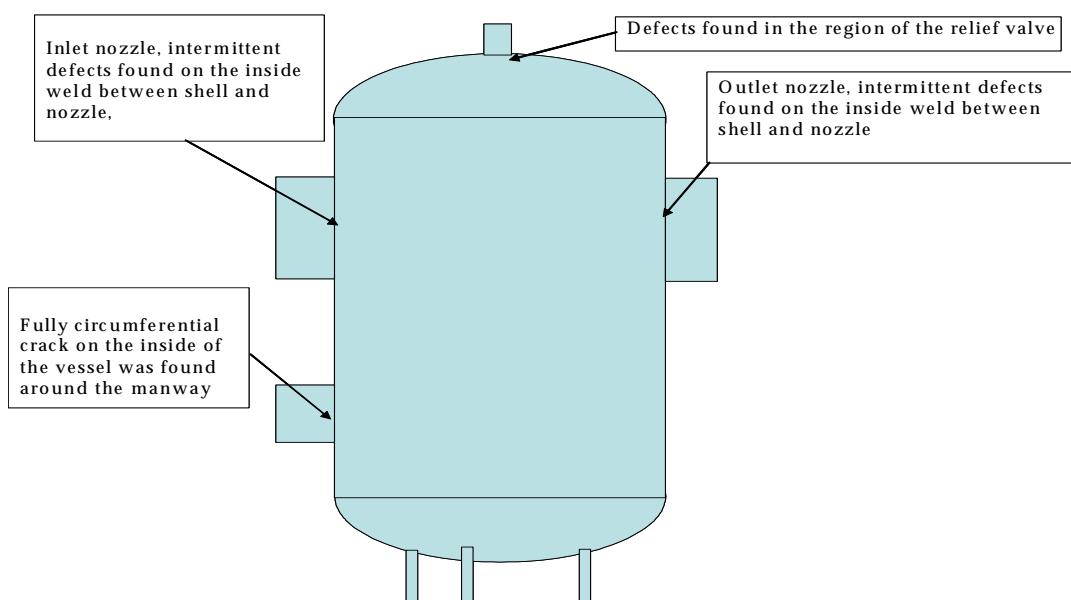
The steam purifier is shown schematically in Figure 12. The base of the vessel was made of stainless steel while the upper shell was made from 32 mm carbon steel as noted in Table 1. The inlet and exit nozzles were reinforced while the manway and relief nozzles were not. All of the welds had more than one finishing pass on the inner surface.

Figure 12: Illustration of cracking distribution of steam purifier welds.

Cracking was observed on the inside surfaces in the nozzle to shell welds. The small diameter relief nozzle had shallow radial cracks. The inlet and outlet nozzles had short cracks along the circumference of the welds, as illustrated in Figure 13, while the manway had a longer circumferential crack that went right around the nozzle. A contracted NDT

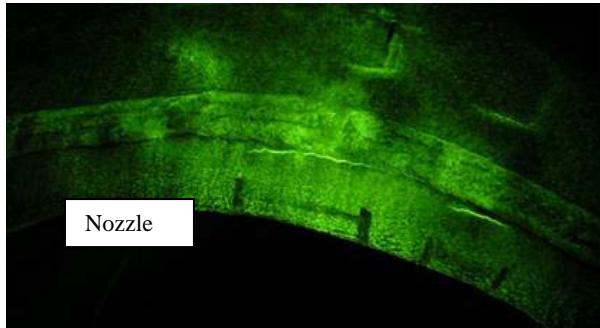
The cracking on the relief nozzle was similar to that seen in the brine accumulator being perpendicular to the weld. The cracking in the manway and the inlet nozzle was in the toe of the weld on the plate side, while the cracking in the outlet nozzle was in the toe of the weld on the nozzle side, see Figure 13. The longest flaw found on the inlet nozzle was 420 mm long and 22 mm deep.

Figure 13: Illustration of cracking at the top of the outlet nozzle at the toe of the weld on the nozzle side at the 12 O'clock position.

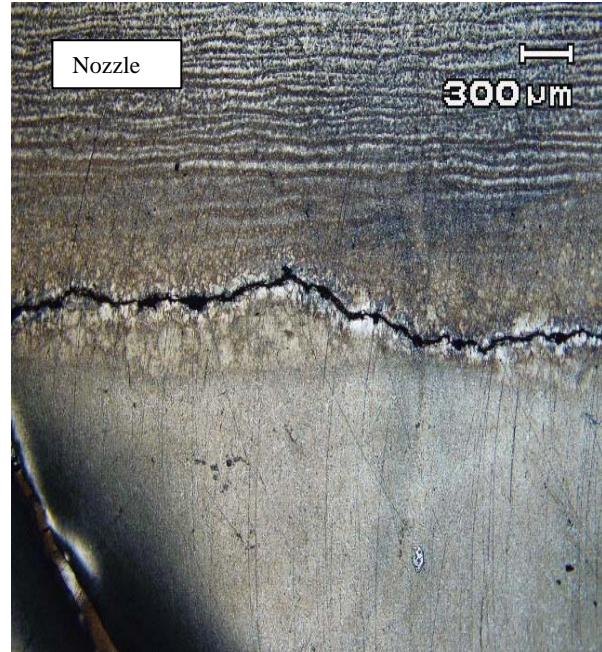
In-situ metallography and replication techniques were used to determine the structure of the welds and HAZ areas in the cracked regions. Figure 14 shows cracking in the outlet nozzle that has similar characteristics to the cracking seen in the brine accumulator with the major difference being that the cracking appeared to have initiated in the coarse grained HAZ where the structure is more prone to hydrogen embrittlement, however this could not be confirmed as no laboratory samples were available.

Figure 14: Microstructure in the area of typical cracking next to the outlet nozzle at the 3 O'clock position.

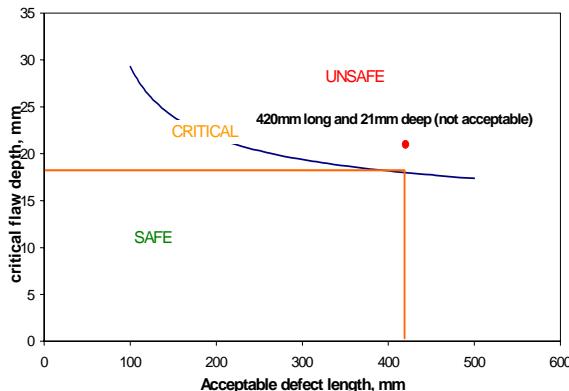
Prior to repair additional NDT was completed in the region of the reinforcement pads on the inlet and outlet nozzles. The NDT identified significant regions of lack of fusion, clusters of small inclusions and small areas of porosity in the roots of welds of the external reinforcement pads. Where practical these were designated for removal but some were embedded at depths where removal by grinding was not possible. These impossible to remove defects were assessed and were considered acceptable under operating conditions as they fell below the assessment line of Figure 15.

Figure 15: Maximum acceptable flaw length as a function of flaw depth for inlet/outlet nozzles.

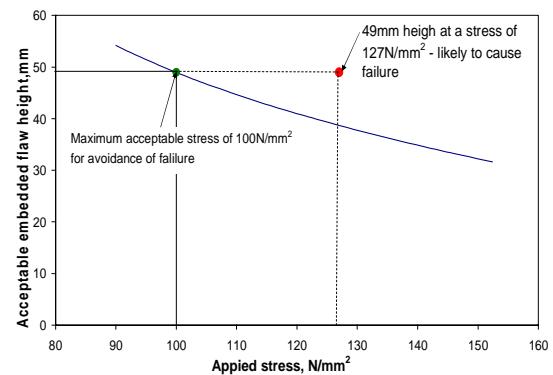
An additional fitness-for-purpose assessment was completed on the embedded flaws in the reinforcement pads. The nominal hoop stress, as a result of a 40.2 barg pressure hydro test ($1.75 \times$ operating pressure as recommended by ASME VIII Div 1), was calculated to be 127.5 N/mm^2 . In accordance to the defect assessment this pressure would cause the 49 mm high flaw that was present to fail, Figure 16. The assessment shows that a maximum nominal stress of 100 N/mm^2 could be tolerated under hydro test conditions, this correspond to a pressure of 35 barg. This pressure was used for the hydro test, being $1.5 \times$ the operating pressure to ensure vessel integrity without risk of ligament failure in the reinforcement pads.

Figure 16: Applied stress as a function of acceptable flaw height for embedded flaws.
