Lifetime Prediction of a Recirculating Geothermal Cooling Water Pipeline

Keith A. Lichti¹, Rolan P. Vera Cruz² and Melchor A. Ballesteros³

A carbon steel recirculating cooling water pipeline in a geothermal power station experienced an increasing number of leaks after 17 years of operation. A risk based inspection internal and external survey of surface corrosion and remaining wall thickness measurements by Non-Destructive Ultrasonic Testing (UT) identified specific areas of continuing high risk of perforation while other areas exhibited low and acceptable rates of damage accumulation. A Life Cycle Analysis (LCA) approach was used to identify options for repair / replacement, comparing new coated steel vs. new stainless steel or relining of existing pipeline. Replacement with Type 316L stainless steel was the most economic option with a pay back period of 7 to 10 years for the additional capital investment.

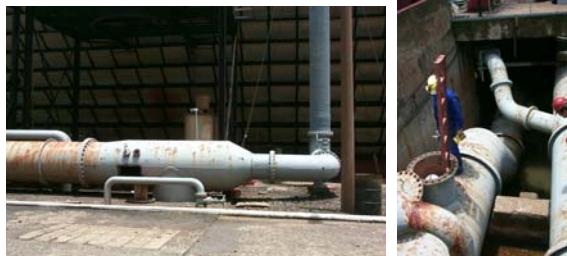
Hot-Side CW – manhole access was provided on drained sections of the pipeline (refer to Figure 3). The CT Distribution Pipeline was accessible through a cutout section on the pipe wall (Figure 3, left photo). Preparations were also made for external UT measurements on the pipe.

Cold-Side CW - This pipeline was not accessible for internal inspection (see right photo in Figure 3) but wall thickness measurements were made from the outside by UT.

Figure 3: Locations for access to Hot-Side CW pipelines, at vertical T (at left photo), manhole to subsurface straight pipe section (at right photo). Cold-Side CW pipeline is seen at right of right photo.

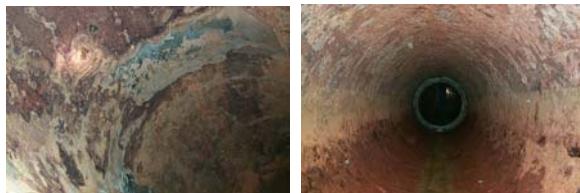
Visual inspection of the pipe internals of the Hot-Side CW pipeline showed that the original PE lining was no longer present in some portions of the pipe, most noticeably at the T-section of the pipe (junction between HWP Outlet Pipeline and CT Distribution Pipeline), shown in Figures 3 and 4. In these areas, only small patches of loosely adherent linings that could easily be removed by hand or by using a metal spatula remained. The steel substrate under these loose adherent linings showed less thickness loss than where it was exposed. Differences of up to 4 mm in thickness between the exposed and unexposed portions were observed. Erosion-corrosion was the main corrosion damage mechanism suggesting the inhibitor was unable to protect the exposed steel under turbulent conditions.

In those areas where the PE lining was still evident although no longer adherent to the substrate metal (e.g. Figure 4), significant protection from the corrosive cooling water was still provided to the underlying metal.

Figure 4: Hot-Side CW loss of PE and erosion at T and retained PE in straight pipe.

The remnant PE linings could be easily dislodged by hand and underneath the lining, the substrate steel showed a smooth surface with uniform grey/black corrosion products over the metal surface. X-Ray diffraction of removed and dried corrosion product revealed these products included magnetite, hematite, and goethite as well as hydrated ferrous sulfate as expected for aerated geothermal condensates (see Table 1). These films appeared to have some protective ability, presumably with the benefit of the added inhibitor and shielding provided by the PE.

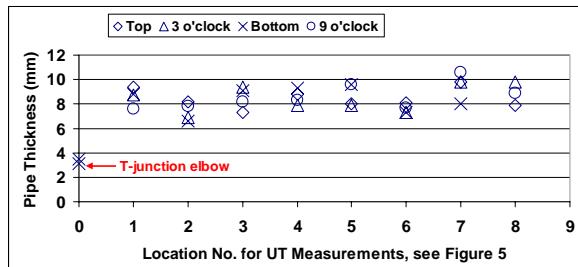
- Hot-Side pipes are subjected to a more aggressive environment than the Cold-Side pipes.
- Accelerated thinning occurs preferentially at localized areas of the CW pipelines where the turbulence is high, such as pipe Ts, Ys and elbows.
- On the Hot-Side CW pipeline, the greatest loss of material due to erosion-corrosion was at the Hot-Side T-pipe section at the transition between the HWP Outlet Common Pipeline and the CT Distribution Pipeline - perforations have already occurred in the past and thickness values as low as 3mm were measured.
- The siphon breaker section of Unit 6 had been repaired by welding an outer shell over an area where perforation had occurred. Other regions of Cold-Side CW pipeline of Unit 6 that were measured show low risk of perforation from corrosion.

Figure 6: UT measurement results from HWP (Location 9) to T (Location 0) as given in Figure 5, July/01.

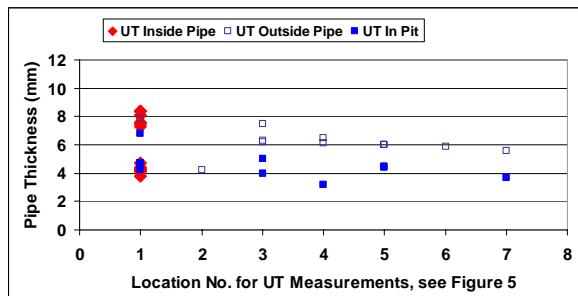
Figure 7: UT measurement results for Distribution Pipeline, taken from outside of smaller diameter pipe (Locations 2 to 7) and from outside and inside of section next to T (Location 1) as given in Figure 5, July/01. The inside measurements are at and beside areas of erosion-corrosion.

The calculations suggest that the PE lining provides up to 8 years of corrosion protection in some straight pipe sections and that section #2 is experiencing significant erosion corrosion, being beyond end of life (for the target remaining wall thickness). The number of perforations expected per year is also predicted to increase over previous years, making this pipeline a critical component in determining operating costs (through unplanned outages).

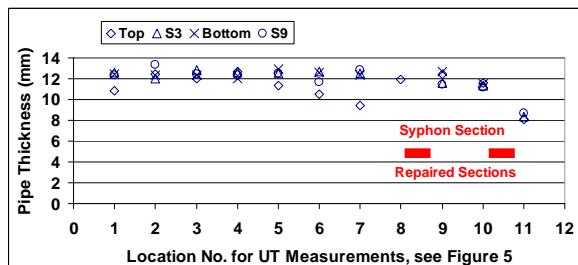
Figure 8: UT measurement results for Unit 6 Cold-Side CW, taken from outside for areas not repaired as given in Figure 5.

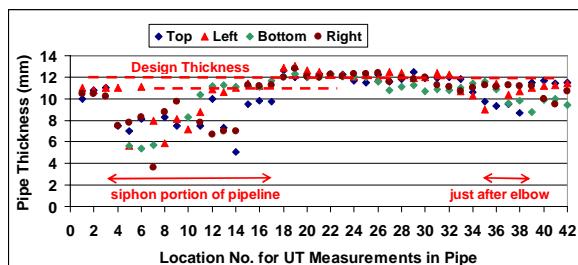
The data for the repaired siphon breaker area was complemented by the results obtained previously for Unit 5, Figure 9. That survey showed a high level of risk in the siphon breaker section of the CT Cold Well Outlet Pipeline around the standby water level where perforation and repairs had occurred in Unit 6.

Figure 9: Results of a previous UT survey of Unit 5 Cold-Side CW pipeline completed in 1999. Note the order of locations is reversed from Figure 8.
