Corrosion and Scaling Deposits in the Berlín Geothermal Field

Elizabeth C. Henríquez

LaGeo S.A. de C.V., 15 Av. Sur, Colonia Utila, Nueva San Salvador, La Libertad, El Salvador, C. A.
eheenriquez@lageo.com.sv

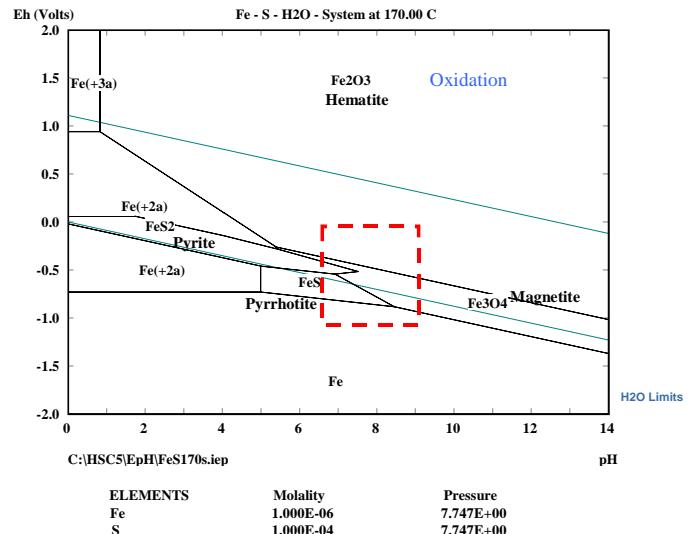
Figure 3: Pourbaix Diagram at 170°C in Berlin Geothermal Field.

An attempt to construct Pourbaix diagram was undertaken using a theoretical value of Fe at a temperature of 170°C.

In general, in Berlin geothermal field, the deposits in the surface equipment are found in the area of magnetite, few hematite, pyrite and pyrrhotite with neutral pH (Figure 3).

The presence of these deposits is due to the heat loss along the pipeline and starts to form condensates which attack the metal (Giggenbach, 1979). This produces the dissolution of Fe and the deposition of magnetite and consequently of other oxide minerals. With the presence of H_2S , pyrite and pyrrhotite are formed until magnetite is formed again and other oxide minerals.

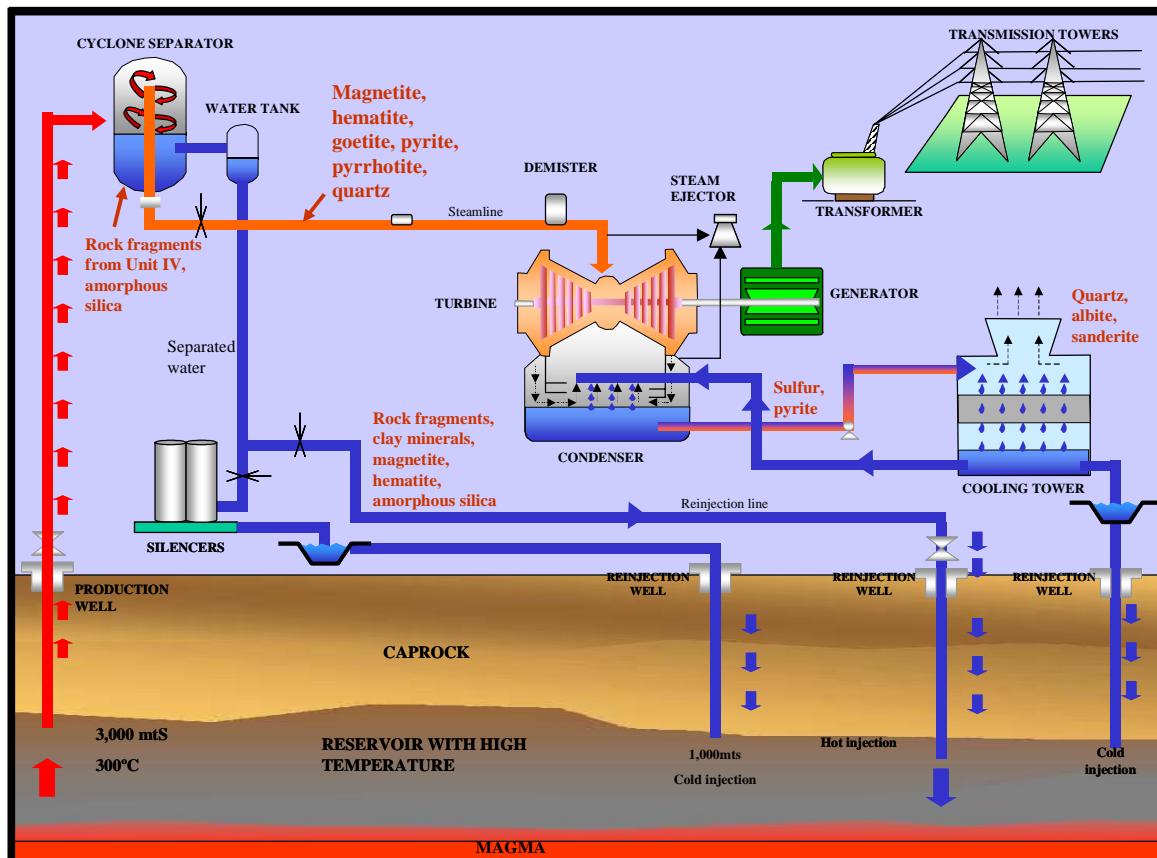
Figure 2: Process flow diagram and its deposits

In summary, the deposits found were a) Steam line : corrosion products, b) Two-phase pipeline: corrosion products and scaling products, c) Reinjection line: corrosion and scaling products, d) Cyclone separator: rock fragments (Unit IV), e) Water tank: rock fragments and few scaling deposits, f) Valves: scaling deposits and few corrosion products and f) Weirbox: scaling deposits.

These deposits can be seen in Figure 2 (See page 4).
