Mitigating a Deep-Seated Landslide Hazard- the Case of 105 Mahiao Slide Area, Leyte Geothermal Production Field, Philippines

Winston Philip C. Pioquinto¹, Joeffrey A. Caranto¹, Lauro F. Bayrante¹, Mark H. Zarco² and Sandra G. Catane³

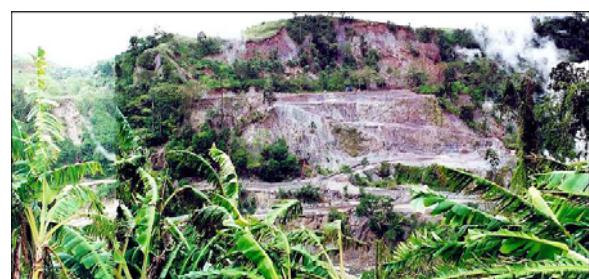
operations were ordered stopped. New cracks however appeared three years after and landslides occurred along the slopes above the upper road after a typhoon in 2000 and 2001 (Figs. 4 and 5). Selective benching was then undertaken to arrest the slides with installation of concrete-lined canals and masonry walls at the toe. However, coincident with the Guinsaugon landslide last February 2006, bulges at the toe, massive re-activated cracks near the crown (~300m length; ~500m above the toe), small slides along the slopes as well as cracks on the bedrock and masonry walls at the toe prompted a re-evaluation of the area, and subsequently construction of corresponding mitigating measures to avert the landslide risks involved (Herras and Caranto, 1996; Leynes, 1999; Leynes, 2000; Pioquinto and Leynes, 2001; Pioquinto, 2006).

Figure 5. Photo taken last 2001 showing minor benching undertaken to address the landslides after Typhoon Auring.

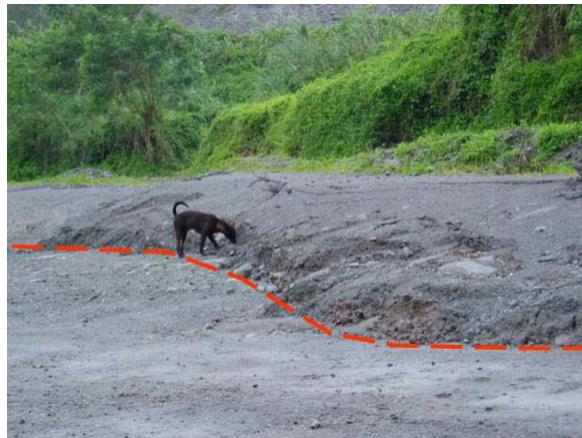
lower road along the inner portion of the road (Fig. 7). A huge boulder with obvious cracks and detached slabs was also seen just beside the road posing risks to traffic (Fig. 8). Meanwhile, in the upper road, cracks were noticed perpendicular as well as oblique to the road with some recent slide scars (Figs. 9 and 10). Tension cracks mapped as early as year 2000 were already present upslope of the upper road so that the rains could have aggravated the situation as these present cracks emanated. Moreover, some recent microfault displacements were also observed on rock outcrops just above the lower road (Fig. 11) and rock samples reveal a fault-britticated nature of the tuff breccias present at the base of the slide (Fig. 12; Rossel, 2006).

Figure 7. Pressure heaves or bulges found at the lower road which appeared at the same time when cracks were observed at the upper road after a period of continuous rains in the project site.

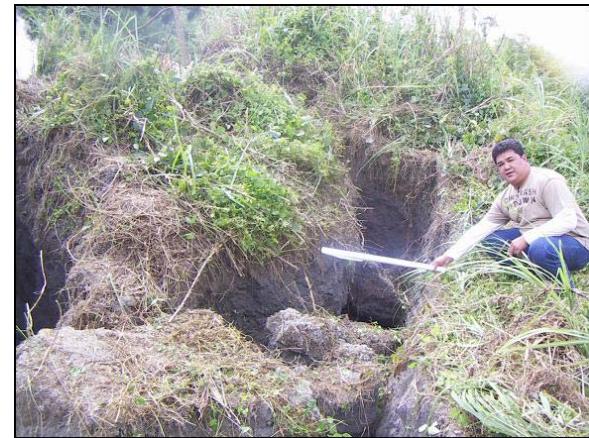
Figure 8. Cracks noted within the bedrock at the base of the slide.

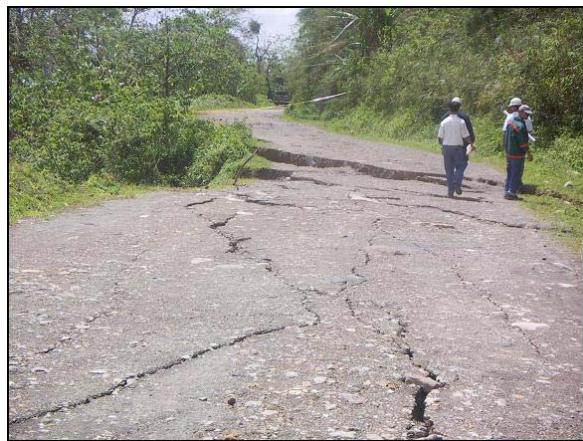
Figure 9. Photo shows cracks along the upper road within the slide area.

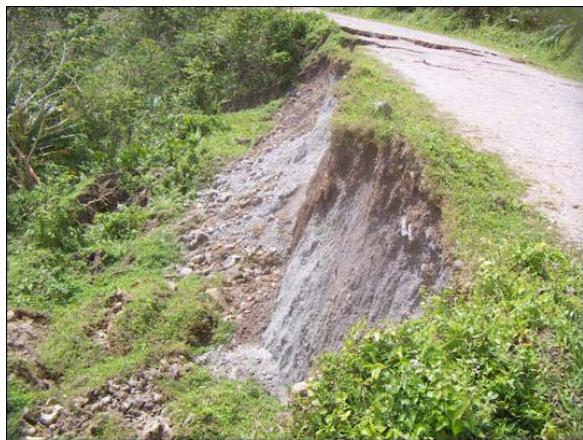
Figure 10. Smaller slide scars noted beside those cracks along the upper road.

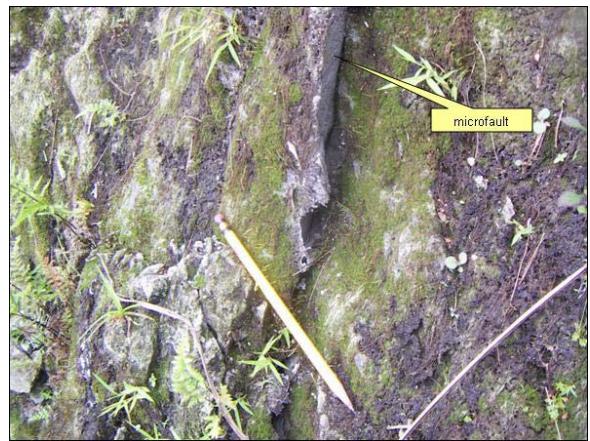
Figure 11. Photo shows recent microfault displacement on a bedrock near the base of the slide.

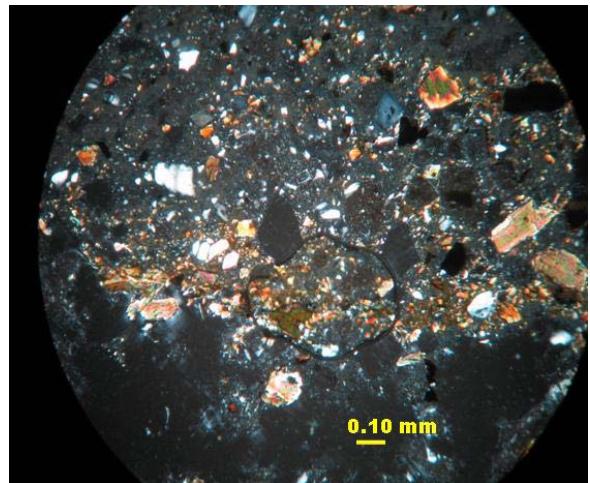
Figure 12. Thin section photo of a rock sample showing a fault-brecciated nature of bedrock at the base of the slide.

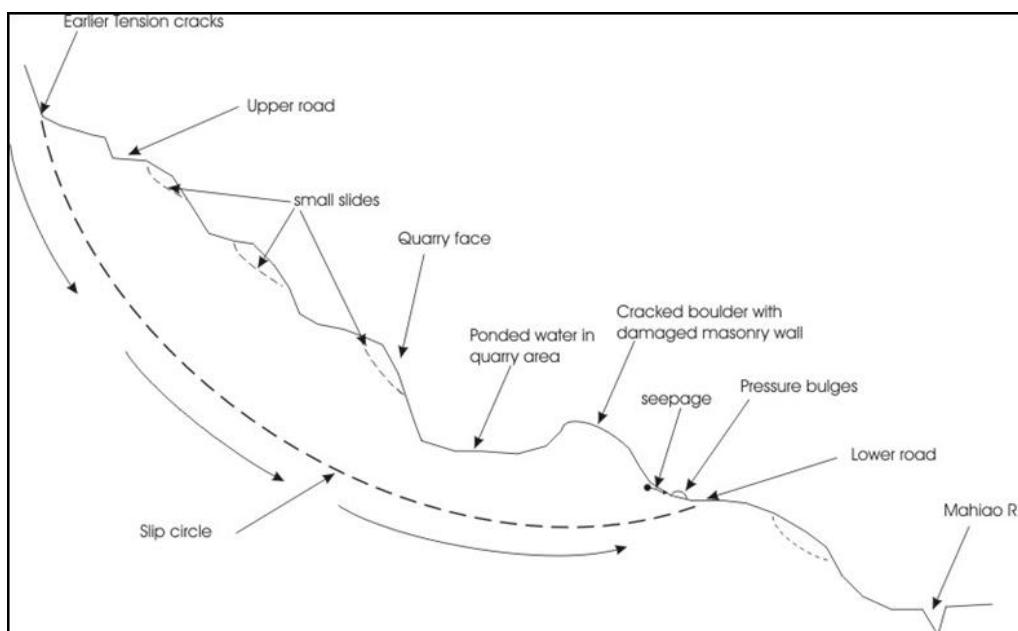
Figure 13. Schematic profile of the 105 Mahiao slide area. (Note: not drawn to scale)

Based on the above observations and recent data, the 105 Mahiao slide is possibly an ancient reactivated slide with a huge block movement of rotational type. It has a big slip circle with smaller slips within where the tension cracks upslope of the upper road may represent the crown or top portion of a huge mass movement downslope. The toe of this slide could be the portion along the lower road indicated by the pressure heaves or bulges. The schematic profile of the 105 Mahiao slide is illustrated in Figure 13.

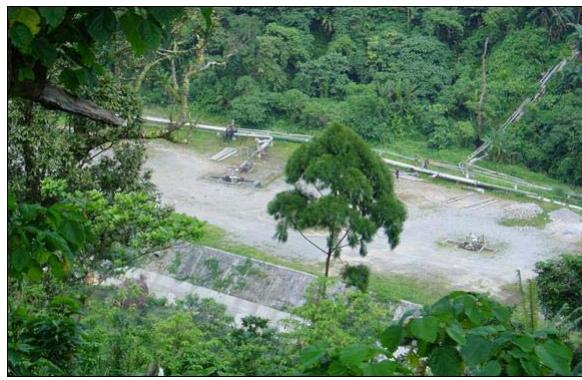
The sliding mass in the 105 Mahiao vicinity is approximately 800,000 cubic meters. At a very rapid movement, such volume is large enough to obliterate the injection pad with 3 injection wells downstream (Fig. 14). In addition, spillage of slide materials can create damming of the Mahiao River just below the slide area. Such damming may probably flood the separator station located about 300m upstream from the injection pad (Fig. 15). Not including the physical damage costs of separator station and reinjection wells, power plant generation outage alone may translate to a revenue loss of around 87,000 USD per day.

Figure 14. Photo of RI pad which is directly along the path of the 105 Mahiao landslide (viewed from the upper road).

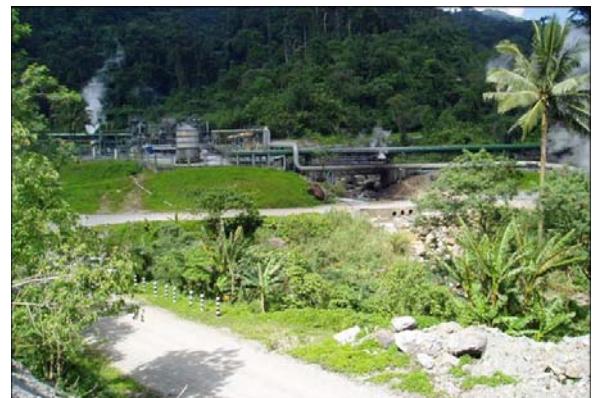
Figure 15. Photo showing the separator station located 300m upstream of Mahiao River from the RI pad that will be directly affected by the 105 Mahiao landslide (viewed from the lower road).

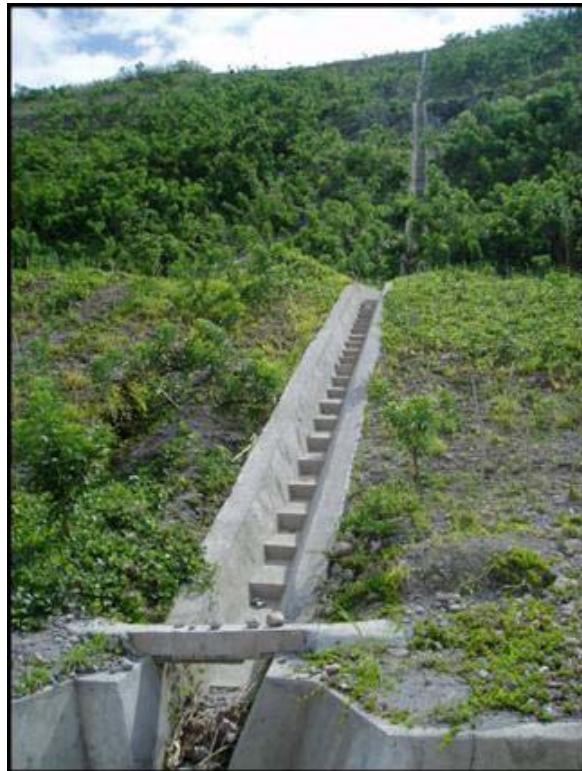
Figure 16. Photo showing concrete-lined ditches designed to address surface run-off in the slide area.

In view of the huge risks involved, engineering mitigating measures were implemented in the 105 Mahiao slide area. These are the following: (1) construction of concrete-lined interceptor canals both parallel and longitudinal to the slope contours (Fig. 16); (2) construction of masonry walls with weep holes and horizontal cross drains at the base or toe of the slide; (3) regrading or benching of slopes at appropriate intervals and gradient (~1.4H:1V) (Fig. 17); and (4) revegetation.

groundwater seepage and increase shear strength property of the slope materials. Seepage should be effectively addressed because it creates additional load within the slide mass and creates pore water pressure which is detrimental to soil cohesiveness. If soil cohesion is reduced due to seepage, slide will eventually happen. Plant roots help hold the soil materials together thus minimizing the effect of pore water pressure.

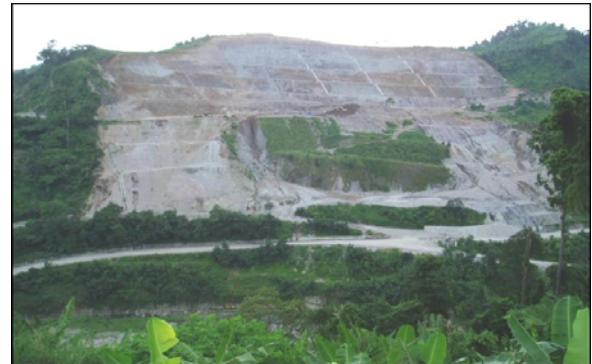
Figure 17. Photo showing slope modification implemented at the 105 Mahiao slide area.

The rationale of the benching operation was to unload some mass at the upslope portion to the downslope portion at applicable factor of safety. If mass is transferred from higher to lower parts, you could effectively decrease the acceleration of the slide thus decreasing its momentum to move at farther distance. Movement could even be hampered because of a lesser force generated by a reduced load. The less distance traveled by a mass movement contributes to lesser momentum thus lowering the associated risks. During the benching operation approximately 123,000 cubic meters of overburden materials were removed in the upper slopes or near the crown of the slide area.

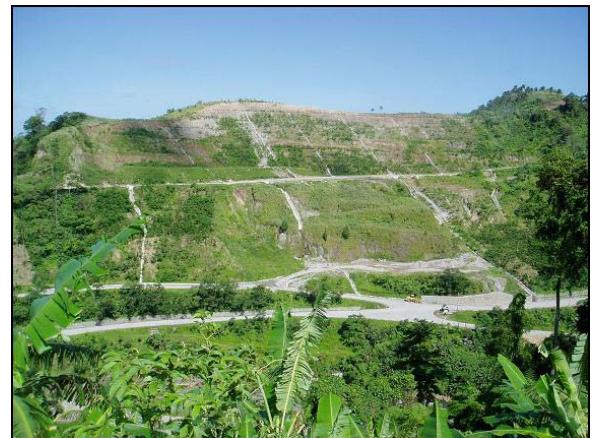
To date, there are no recorded or observed evidences of movement or ground deformation in the vicinity, even after earthquakes and typhoons that had transpired attesting to the effective stabilization of the 105 Mahiao landslide (Fig. 18).

Figure 18. This is the photo of the 105 Mahiao landslide area taken after almost a year after all mitigating measures were implemented.
