Wairakei Power Station – New Zealand

Plant Modifications Arising from Operational Deficiencies, Technology Advances and Life Extension Studies

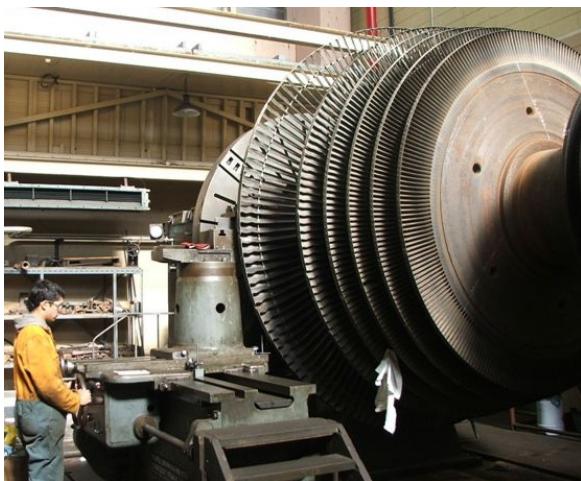
Figure 4 - Turbine rectification lathe. 2009 Machining off blade row LP7, of an MP machine rotor at about 3rpm, in preparation for reblading. Lathe operator is behind the rotor. Rag on rotor signals to assistant when to increment the tool post.

The IP blading issue was not solved until new rotors were fitted in 1990 (G1) and 1991 (G4). Among the attempted solutions were changing the number of diaphragm vanes, changing blading to higher strength material, peening and radiusing the root faces, and fitting lacing tubes. None of these significantly altered blade life. High cycle fatigue was addressed by long packet banding welding into 180° arcs. Use of fixed interval pre-punched banding was phased out in favour of punching the holes exactly where the blade tenons were, seeking to minimise bending stresses on the blades. Tenon peening methods were changed to minimise potential work hardening. Understrap welding was adopted for the higher stressed banding, especially when repairs were performed. Of special note was the last stage blade tenon failures that occurred very early in the life of the MP machines. To solve this problem, the banding was removed, new tenons formed by shortening the blades, lighter cross section banding fitted and both sides of every blade welded

to the banding. Heat treatment was then performed using the turbine rectification lathe to slowly rotate the blades through a bath of molten lead.

In earlier times blade repairs were performed with parent metal but Inconel is now exclusively used. PWHT is adopted in all cases where this can be practically undertaken. Nothing was able to be done with the leading edge erosion except ensuring that the diaphragm interstage drainage functioned correctly. Some blades were refurbished by welding in new leading edges but modern manufacturing processes make new blades more cost effective than repair. Stellite leading edges have been tried but the life extension could not justify the additional cost. Station staff developed quite some expertise at reblading and modifying work practices to address the blade problems as they arose. The record time for blading work from trip until return to service is 44 hours. The shortest blade life is now a minimum of 120,000 operational hours but many blade rows, especially on the MP rotors, are still original after 280,000 running hours.

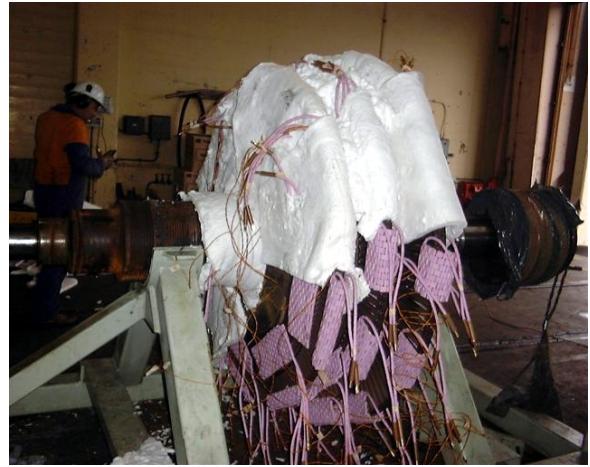
There have been 5 major types of blading problems over the life of the machines. The IP machine blades failed by cracking out of the pullface corners of the fir tree roots or out of the closing blade rivets. High cycle fatigue caused failures of some of the shorter blades at the base of the aerofoil. There have been banding failures as the tenons have cracked or the peened over edge has been stressed past yield. There has been cracking emanating out of the lacing tube holes. The leading edges of the last stages' blades have been eroded by water droplets. On the last stage of the MP blades, as much as 40mm of metal was removed from the outer extremity of the blade.

Figure 5 - Rotor heat treatment post weld repairs to remedy tenon erosion.

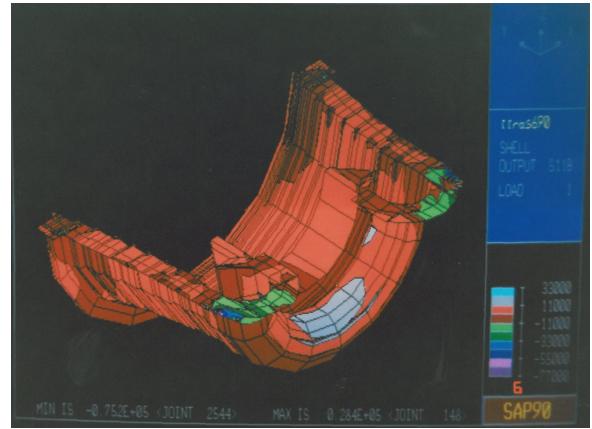
The original MP inner casings were made of cast iron. They were subject to significant steam cutting, wash and handling defects. These defects also contributed to diaphragm damage. As repair options were limited, replacement was the only viable option. Finite element analysis was undertaken in 1992 to check the adequacy of a change in material to more erosion resistant stainless iron (Figure 6). The replacement units were cast and machined by NZ Railway workshops at Hillsdale, Dunedin, after reverse engineering the originals. The replacement stainless iron casings are still in near new condition with no significant maintenance having been required after 15 years service.

Figure 6 - Finite Element Analysis of the MP Inner casings 1992

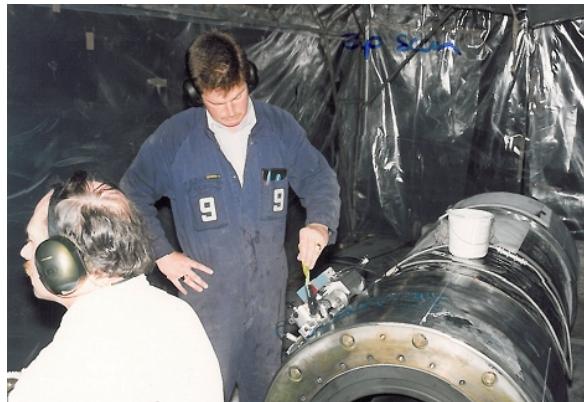
All of the generator endrings are ferritic. They have been removed at least once for inspection as well as NDT performed on the assembled rotors over the last twenty years (Figure 9). Arc damage was found in one rotor that necessitated replacement. For the remainder, machining defects and other damage were able to be dressed out after assessing the stresses using Finite Element Analysis. In situ

Figure 9 - Zip Scan of a generator rotor in 1988

balancing was performed after overspeed tests on return to service.

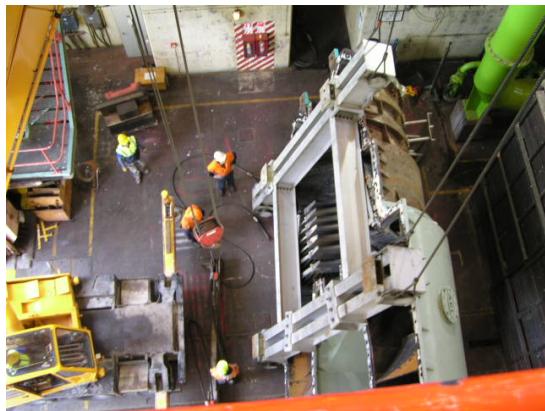
Figure 10 - Photograph of Top MP casing rolling frame in use in 2008

An example of this is the constructing of a frame to facilitate the rolling of the top MP casings by two cranes (Figure 10) rather than having to axially split the casing by unbolting and then rolling the two unbolted sections.
