Repowering Steamboat 2 and 3 Plants with New Axial Flow Turbines

Tom Buchanan, Wade Posten, Sean Berryman

Ormat Nevada, Inc., 6225 Neil Road, Reno, Nevada, USA 89509

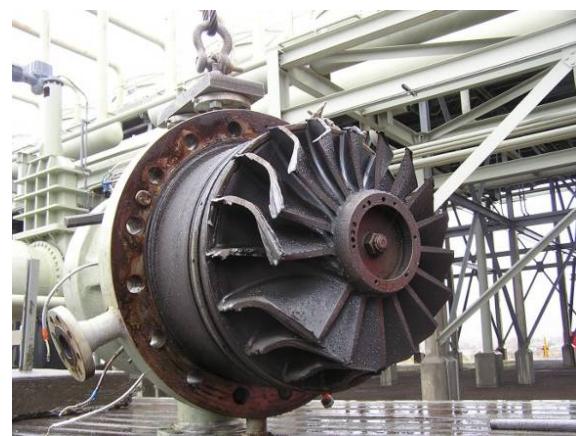
Photo 2: Failed Wheel

In early 2006 expander 201 experienced a wheel failure, plant stock had been exhausted and delivery times for new wheels were at least 12 months out. Over most of 2006 efforts were made to salvage the best of the failed wheels by trim balancing them in an effort to keep the plant at reasonable generation capacity. Expander 201 experienced repeated outages during 2006 attributed to the use of the trimmed wheel. It was clear that a long term solution was needed to either find alternative wheel replacements for the turbo-expanders or replace the expanders in their entirety.

In early 2007 expander 201 was down again with wheel failure and expander 202 experienced a catastrophic wheel failure that also caused catastrophic failure of the shaft seal and lube oil system, rupturing the lube oil reservoir tank. Throughout 2007 and early 2008 various replacement wheels are installed with varying success and still significant down time.

With the failure of expander 201 early in 2006, it was clear that replacement wheels would be almost impossible to obtain from the original manufacturer or other after market suppliers. The biggest challenge was that the most successful wheels had been machined from forged titanium alloy and the supply market for forged titanium alloy had become extremely tight. The immediate and only solution was to try to take failed wheels with the least defects and trim and balance them and return them to service. Photo 2 shows a typical failed wheel and Photo 3 shows a wheel trimmed to run as a temporary solution.

A technical solution for the replacement expander wheels needed to be obtained. Fortunately, Ormat is fundamentally a technology company and has a broad range of technical expertise in the organization. The task was assigned to Ormat Systems Limited (OSL) based in Yavne, Israel to identify alternative raw materials, reverse engineer the wheels, procurement and manufacturing. OSL developed a plan to engineer several replacement wheels from aluminum alloy which was more readily available than the titanium. The procurement and engineering effort for the titanium alloy wheels would continue in parallel. In the end, OSL supplied three aluminum wheels and two titanium wheels for installation over the period of late 2006 to early 2008. During this period the Ormat Nevada Operations group and the OSL team maintained a constant dialog on wheel performance and improvements. Although a solution for replacement expander wheels had been obtained, overall plant availability continued to be unacceptable.

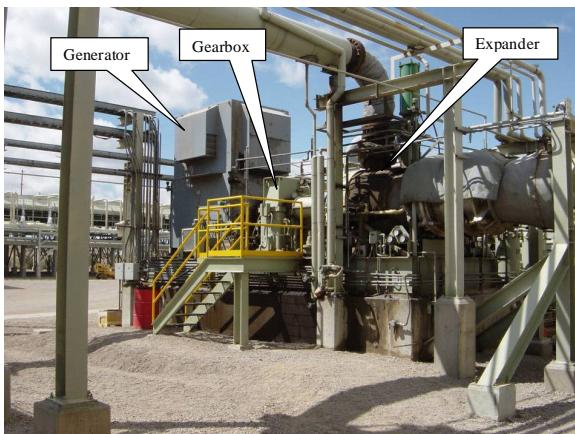
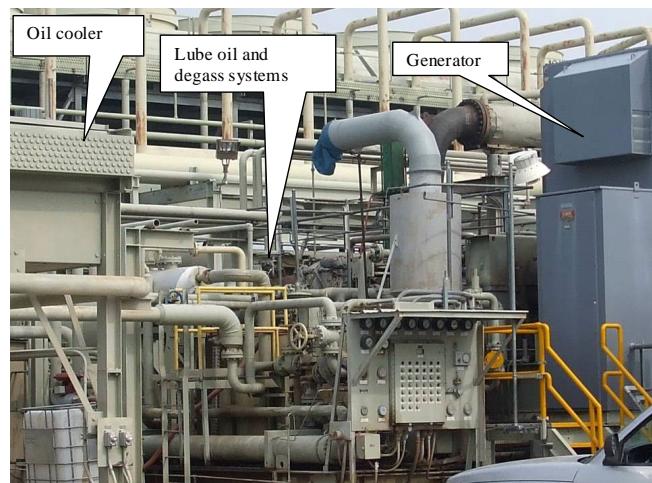
Photos 4 and 5 show the turbo-expander arrangement with gearbox and oil and degass systems

Due to the high speed of the turbo-expander unit, the external gear box and specialized seal and lubrication systems add significant complexity to the expander with many parts and instruments requiring on-going preventive maintenance. This was a significant factor in the comparison of the two options.

1. The turbo-expander unit is a relatively high speed machine. The shaft seal system incorporates a labyrinth seal designed to allow some of the working fluid gases to pass to the bearing side to prevent oil from passing into the process. This gas leakage combines with the lubrication oil as it exits the rotor housing. In order to separate this gas and return it to the process the mixture is heated and sent to a degassing tank where the isobutene can evaporate. Recovered oil is returned to the oil reservoir tank and the separated isobutene vapors are sent to a gas recovery compressor and eventually to the plant air cooled condensers.

Based on the rugged simplicity of the Ormat turbine design, cost, availability, demonstrated reliability and experience Ormat chose to replace the turbo-expander units with Ormat turbines.

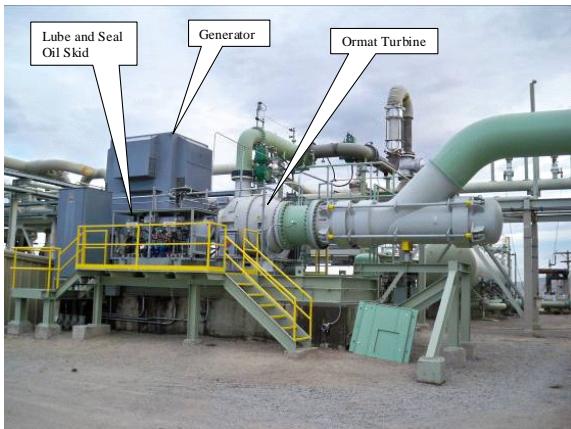
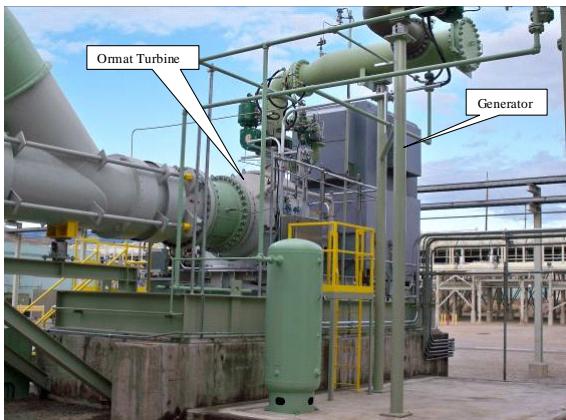
Photos 6 and 7 show the Ormat Turbine retrofit without gearbox and with new lube and seal oil skid.

Since the Steamboat 2 and 3 plants were originally designed to utilize isobutane as the working fluid and the existing heat exchangers and balance of plant systems would stay in place, the new turbines would be designed and optimized to work with isobutane. Ormat has a track record of designing and installing expansion turbines utilizing a variety of working fluids, process conditions and sizes from a few kilowatts to tens of megawatts. This experience allowed turbines to be designed and optimized for this specific application and working fluid. The design includes a low speed 1,800 rpm turbine, eliminating the speed reduction gearbox, standard materials of construction, standard bearing and seal components and much simplified lube oil and seal oil auxiliary systems. The design also eliminated the need for the complicated lube oil degasification and recovery systems.
