Corrosion in Concrete Structures of the Leyte Geothermal Production Field, Philippines: Characterization and Implications

Sylvia G. Ramos, Edwin H. Alcober, Ruperto V. Villa, Jr., Josephine B. Rosell

Energy Development Corporation, Fort Bonifacio, Taguig City

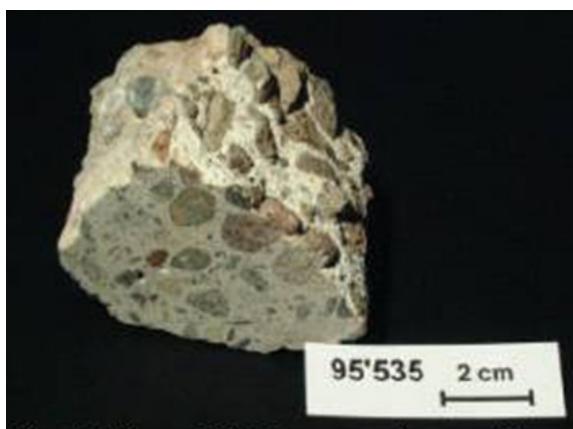
The exposed surface of the sample showed removal of the cementitious matrix, leaving the aggregates exposed (Fig.1). Another rough surface was presumably the result of an existing crack. Remnants of a corroded steel bar was observed at the other side of the sample opposite to the exposed surface (Fig. 2).

Figure 1: Rock Muffler sample shows removal of cementitious matrix, leaving aggregates exposed.

The deterioration in the South Sambaloran rock muffler is basically attributed to chemical attack promoted by the low pH and the presence of hydrogen sulfide (H_2S). The latter, although a weak acid, may oxidize into the stronger sulfuric acid (H_2SO_4) given the prevailing conditions of high temperature, moisture and oxygen availability. Sulfuric acid is capable of attacking the cement matrix, reacting with the alkaline components, predominantly the $Ca(OH)_2$ resulting from cement hydration to form $CaSO_4$. This explains the concentration of $CaSO_4$ in the vicinity of the exposed surface, as well as the layer of low-alkalinity revealed by phenolphthalein test. The process will be continuous, as the attacked cement matrix is softened and removed by acid, and fresh cement surface is exposed to the aggressive ions. A linear progression with time will give a conservative estimate of the expected progression of concrete deterioration.

To control chemical attack using the South Sambaloran rock muffler as a case study, the best remedy is to make a dense concrete of low permeability, and to minimize content of chemicals vulnerable to aggressive ions (Torrent, *et al.*, 2004). Portlandite content must be kept low and blended cements with high amounts of fly-ash, pozzolan, or blast-furnace slag must be used.

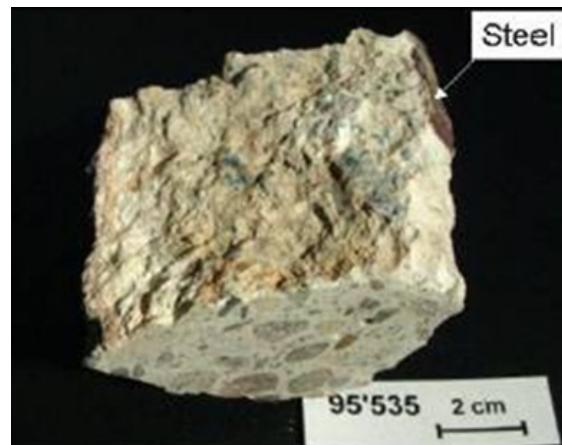
Figure 2: Remnants of corroded steel bar at the other side of sample

The corrosion products of the steel bar were analyzed for infiltration products of salts. Small amounts of chlorides were identified besides iron oxides. The presence of other oxidation states of iron or of iron hydroxides cannot be excluded. Zones adjacent to the corrosion products are rich in Ca and Si as expected from hardened cement paste.

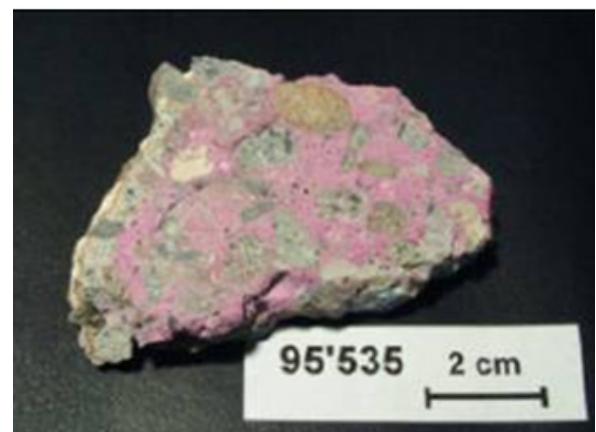
Figure 3: Phenolphthalein test

The phenolphthalein test revealed a layer (ca. 5 mm deep) of non-alkaline concrete at the exposed surface (Fig. 3). A brownish rim about 1 mm deep was also noted inside the non-alkaline zone. The structure of the concrete appeared

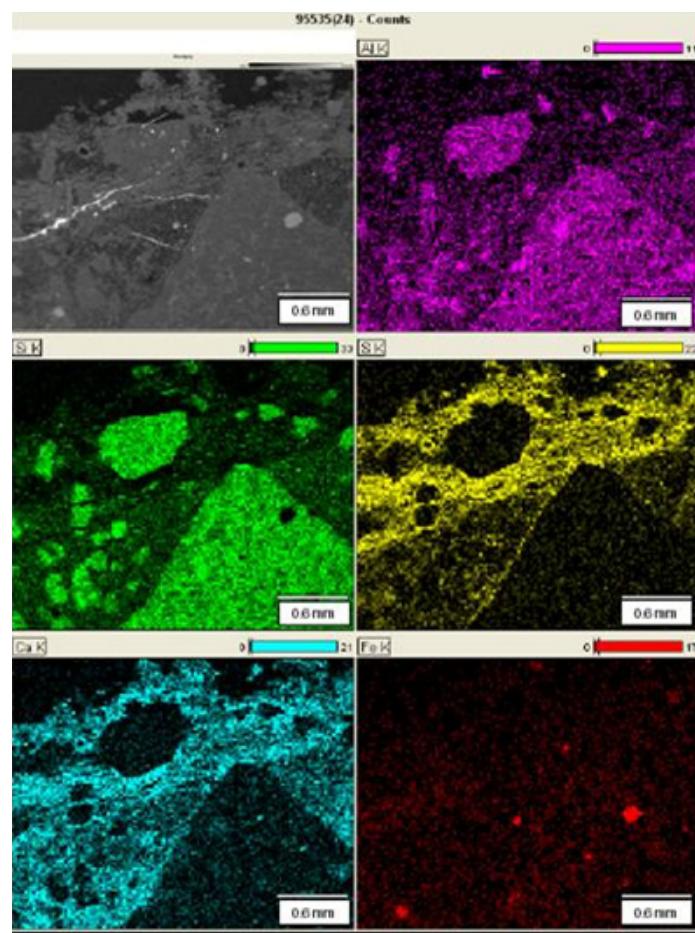
SEM-EDAX analysis of polished sections of the crumbly top layer exposed to aggressive atmospheric conditions showed the predominance of gypsum and anhydrite (Fig. 4). Crack formations within the investigated zones were rarely observed. The large aggregate grain in the lower right corner of Figure 4 displays an enrichment of sulfur along its boundaries. This zone was further investigated by elemental mapping. The sulfur in these zones is again present as secondary formations of gypsum or anhydrite. A spot analysis of a single, sulfur-containing crystal in this zone displays no other relevant elements besides Ca and S (Fig. 5). Some of the gypsum crystals display minute layers of an Al-containing phase accompanied by Ca and S. These layers are most probably transformation products of gypsum into ettringite or monosulphate. Gypsum and anhydrite are however strongly dominant as S-bearing phases in this zone. Pores in the top 10-mm layer exposed to acid attack simply contain Ca and S, which are again indicative of gypsum or anhydrite.

Figure 4: SEM-EDAX mapping of top layer shows enrichment in S and Ca.

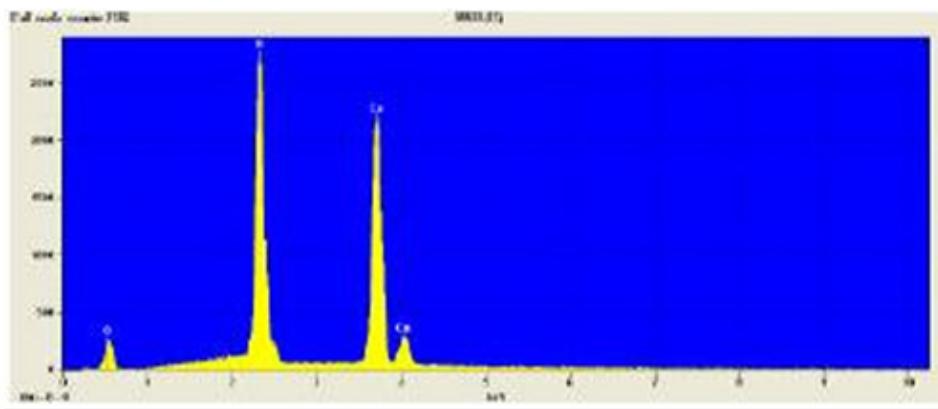
Figure 5: Spot analysis of secondary formed gypsum or anhydrite in top layer.

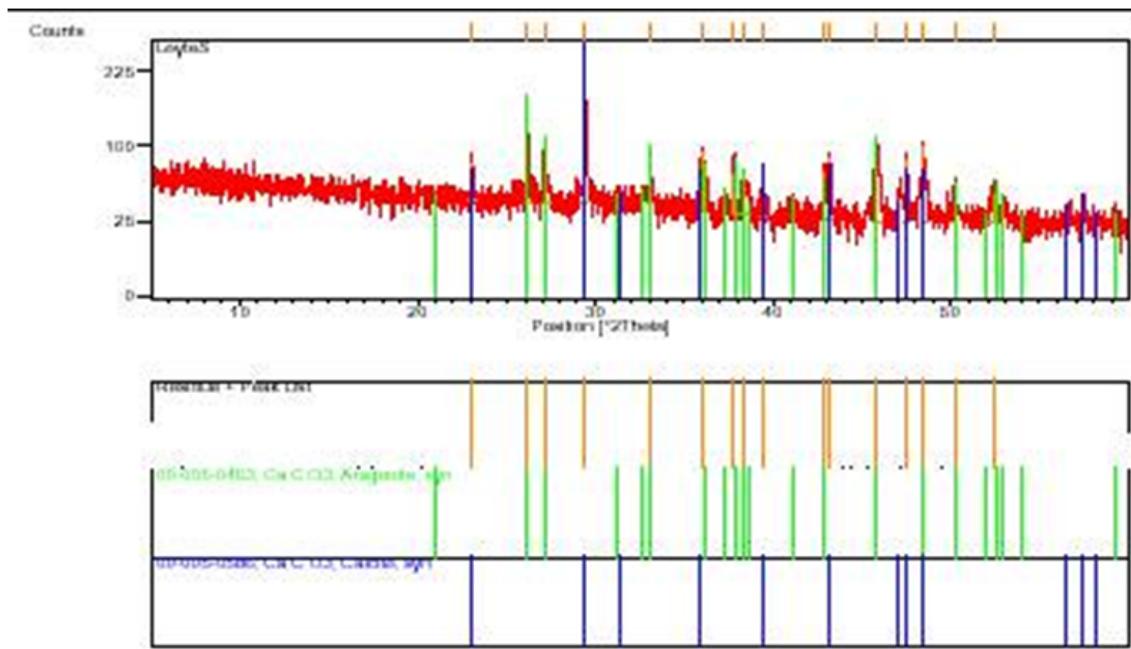
Deeper inside the concrete, approximately 10 mm from the corroded steel bar, a white powdery seam was observed around a larger aggregate which protruded from the crack surface. Based on XRD analysis, this seam consists of secondary formations of calcite and aragonite (Fig. 6).

Figure 6: XRD analysis shows secondary calcite and aragonite around aggregate 10 mm from steel bar

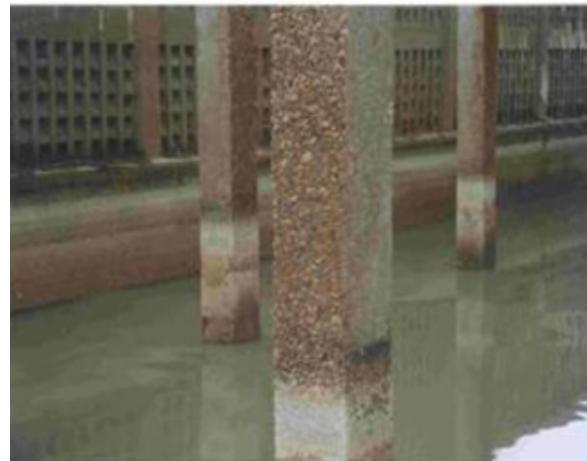
A rectangular slab was saw-cut from one of the corroded posts of the Upper Mahiao spray tower during the October 2005 annual preventive maintenance service in LGPF (Fig. 7). The sampling was timed during this period when the posts were accessible and the infrastructure was undergoing rehabilitation work.

Figure 7: Corroded concrete posts of the Upper Mahiao spray tower.

The highly porous cement matrix of the concrete posts became soft and friable; thus, reducing its ability to bind the rock aggregates and making it easily washed away by spraying waters leaving aggregates sticking out of the concrete surface. Based on observations during the PMS, portions of concrete posts being sprayed upon by power plant effluents were most affected by corrosion.

The damaged concrete posts of the Upper Mahiao spray tower were repaired in October-November 2005 during the annual PMS. The spray tower was totally shut down on October 5, 2005, and was drained and cleaned before the start of repair on October 7. The corroded sections of the spray tower concrete posts were removed and resurfaced with a special cement mix of high density blended with fly-ash because it is more resistant to chemical reaction. The posts were jacketed up to fluid level, and the tower basin was lined with molded high-density polyethylene plastic that is durable as well as resistant to chemical attack. The rehabilitation of the whole infrastructure was finished on November 15, 2005, and the spray tower was immediately put back in service after completion of the repair.

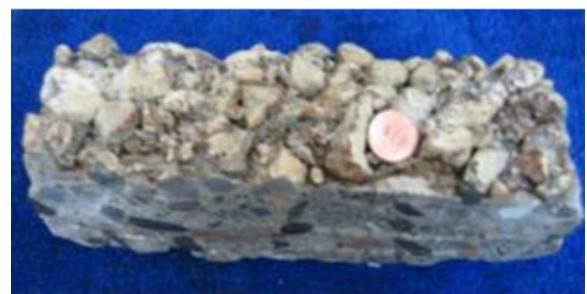
The concrete slab showed an orange-colored oxidized surface. Its cementitious matrix has been removed leaving the aggregates exposed and protruding out of the concrete surface (Fig. 8).

Figure 8: Rock aggregates protruding out of the corroded concrete surface.

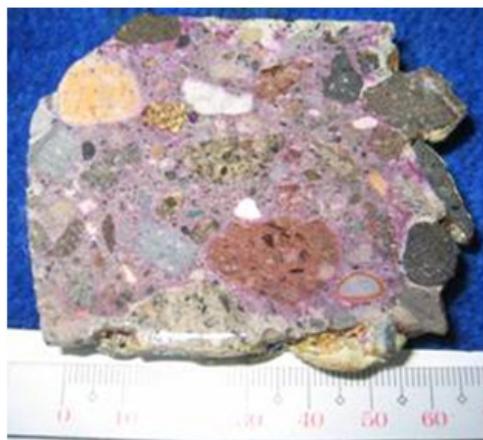
Figure 9: Phenolphthalein Test.

The concrete slab was cut along its cross section to obtain a freshly exposed surface where phenolphthalein solution was applied. Fresh, unaltered areas of the concrete sample became red or purple, while altered portions remained colorless (Fig. 9). The depth of alteration, defined by the colorless sector of the concrete sample was subsequently measured under the binocular microscope. It ranges from 4 mm to 5 mm within the cement paste which had direct surface contact. For the portion of concrete where aggregates were exposed, deeper alteration levels were measured in the cement matrix ranging from 9 mm to 17 mm.

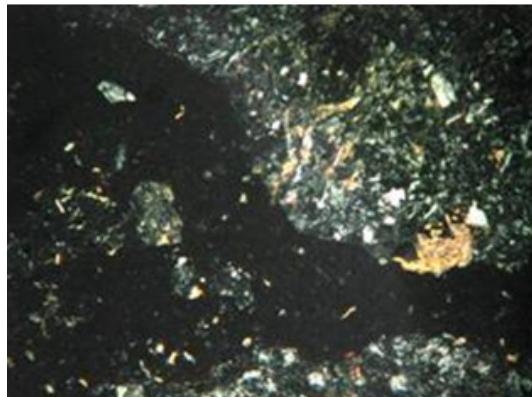
These rock aggregates lie in a primary matrix of cement paste together with smaller, commonly angular fragments (<1 mm) of green-red hornblende, zoned and twinned plagioclase, biotite, andesite, and scoria (Fig. 10). In the outer portion of the concrete sample, the primary cement matrix has been replaced by finely crystalline calcite (Fig. 11). Round vugs are common in the matrix.

Figure 10: Rock aggregates lie in the original dark cement matrix.

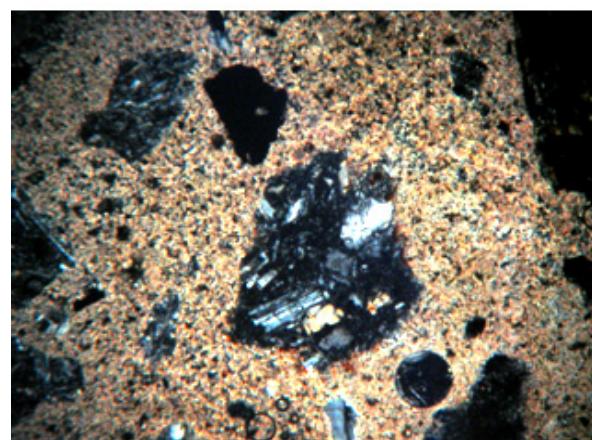
Figure 11: Cement matrix replaced by fine crystalline calcite; round vugs present in the matrix.

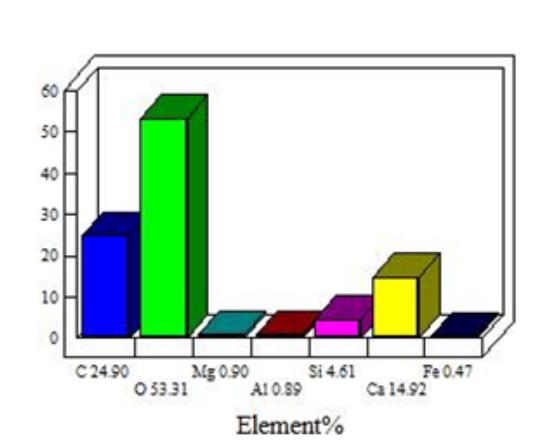
Figure 14: EDX analysis of ZEDS concrete sample.

EDAX analysis of cement matrix of the concrete sample (Fig. 14, Table 3) shows the dominance of calcium, carbon, and oxygen confirming that calcite (CaCO_3) is the main alteration mineral replacing the concrete matrix as observed in the petrographic examination. Other minor components in the cement matrix are silicon, magnesium, and iron which more likely represent the remaining original cement paste of the concrete.
