## Mechanisms of Erosion-Corrosion in Well 311D, South Sambaloran, Leyte Geothermal Production Field

Erlindo C. Angcoy, Jr., Archibald L. Abarquez, Romeo P. Andrino, Garry F. Cañete,  
Melvin D. Lledo, Christine H. Siega and Ruperto R. Villa, Jr.

Energy Development Corporation, Energy Center, Merritt Road, Fort Bonifacio, Taguig City, Philippines

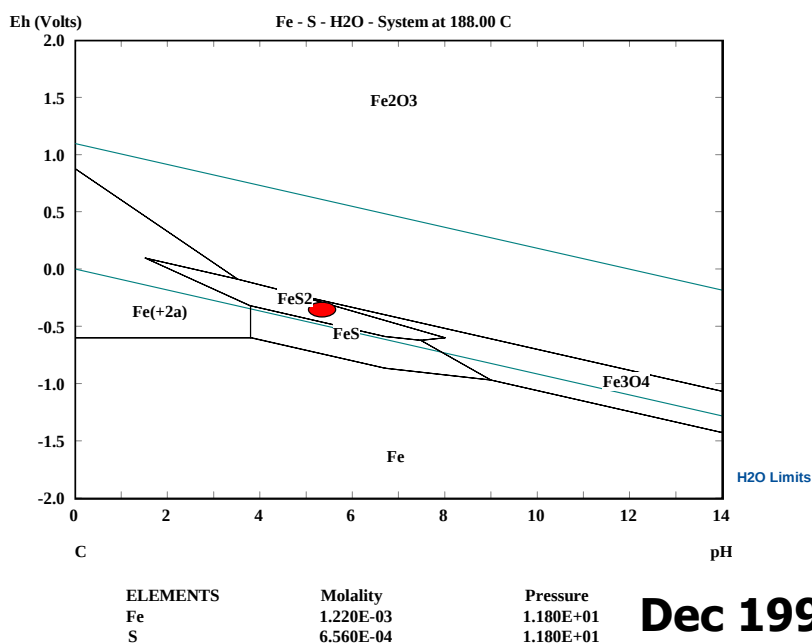
Flow calculations summarized in Table 1 (based on equation 1) show that a 311D total mass flow of 10 kg/s will have a velocity inside the 13-3/8" production casing (7 m/s) exceeding the erosional velocity (6 kg/s) if the TSS level is  $\geq 45$  ppm. If 311D total mass flow reaches 18 kg/s, then erosional velocity (10 kg/s) is exceeded at a lower TSS level  $\geq 8$  ppm. Both cases are valid based on historical discharge characteristics of 311D. Thus, thinning of the production casing results from alternate corrosion (between metal and geothermal fluid) and erosion of bare metal and passive films by suspended solids. The suspended solids are initially formation materials that pass through the slotted liner and trigger the removal of protective passive films formed inside the well when 311D water phase was still present. The discharge chemistry of 311D in 1998 when plotted in a Pourbaix diagram shows formation of corrosion products that form the passive films (Fig. 2).

**Figure 2: Pourbaix diagram of historical highly two-phase well 311D discharge chemistry.**

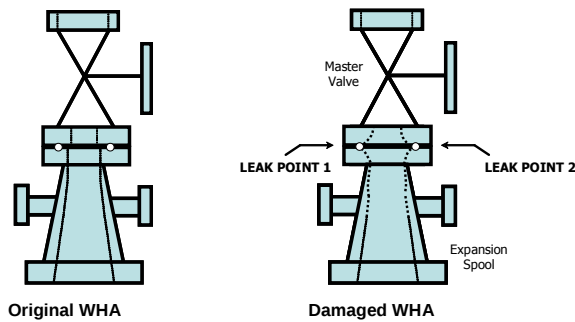
In the wellhead assembly of well 311D, recurring damage was documented in the mating flange connections of the expansion spool and master valve confined along the two opposing wingports (Fig. 3) and could be attributed to the combined effects of flow patterns within the wingports and the suspended solids in the flowing stream. This can be aggravated by stresses due to wellhead vertical movements beyond the design limit that may be experienced during changes in well operating conditions either due to throttling or variations in mass flow. Thus the wellhead assembly leaks were usually observed during preventive maintenance periods.

**Figure 3: Damages in wellhead assembly (WHA) of well 311D (not drawn to scale).**

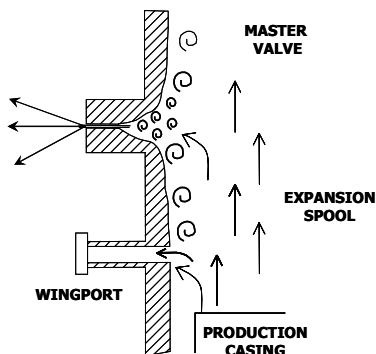
Flow is altered as the fluid passes through the 3-1/8" diameter wingports that induce eddy currents downstream (Fig. 4). Thus, suspended solids and mists in the fluid are drawn towards the wall and attack the metals downstream and along the wingports. The flange face has a conservative thickness allowance of 3 inches, before metal loss propagates outwards into the groove and the seal ring. At a thinning rate of 0.25 inch/10 yr, no leak is expected to develop in the mating flange connections for a long time provided that the mating flange connections are in static equilibrium. This equilibrium may be upset if the wellhead of well 311D vertically moves above the design limit ( $\pm 6$  inches) that can induce branchline stresses which can no longer be compensated by pipe support systems. As such, the resulting stressed points along the wingport become vulnerable to erosion-corrosion leading to leaks since a pressure gradient draws the high velocity steam, corrosive mists and suspended solids towards the stressed and worn points aggravating the localized metal losses.

**Figure 4: Mechanisms leading to well 311D wellhead assembly damage (not drawn to scale).**

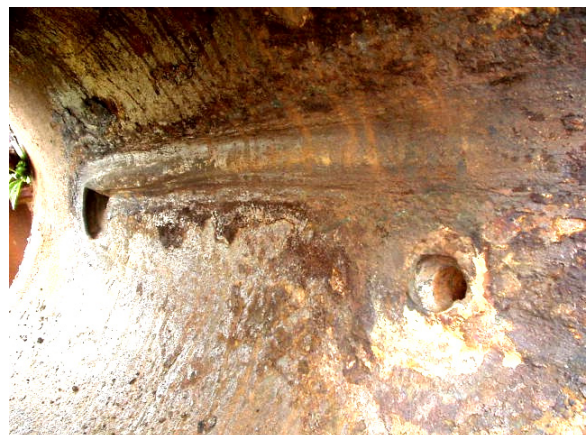
The dominant mechanism of mechanical erosion by suspended solids cause accelerated thinning rates in the sweepbend and the branchline based on UT monitoring data. High thinning rate in the sweepbend is influenced by the angles (10-20°) at which the suspended solids impact the walls. In the branchline, the increased rates are highly correlated with location of high turbulence (i.e., reducer and near the branchline stub-in point to two-phase header). Leaks in the tapping points of bypass lines and vents are due to the combined effects of (1) solids erosion due to turbulence downstream of tapping points (Fig. 5, striking resemblance with the erosion marks downstream of the wellhead assembly wingports) and (2) localized corrosion attack in heat-affected zones (HAZ). HAZ like welded connections underwent changes in properties making them less resistant to corrosion. Rough edges and protrusions inside the tapping points may also be initial points of erosion-corrosion attack.

**Figure 5: Damages in the tapping points of the 2-inch diameter bypass line and 1-in diameter vent viewed from inside the branchline.**

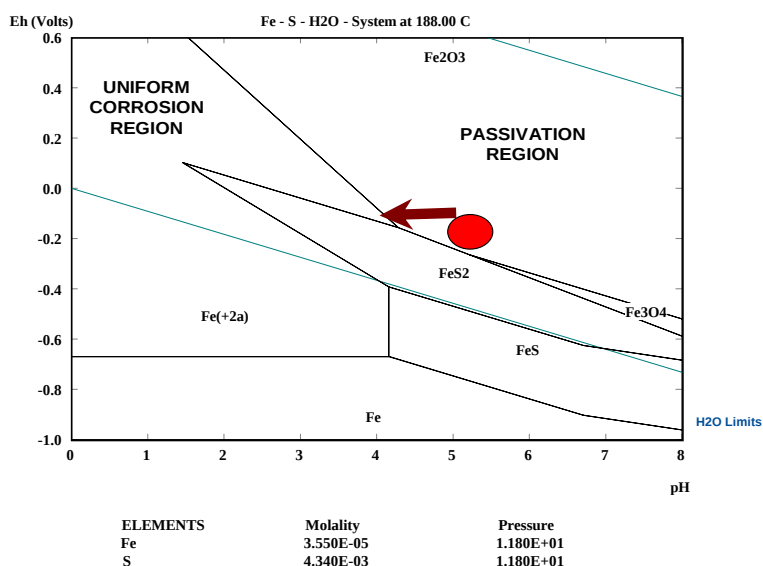
The entrained water phase of 311D consists of brine mists and steam condensates. Two-phase fluids stagnate in dead legs (between flange connections and in external attachments like sampling points and vents) and condense in these "heat sinks" through convective heat transfer with the surroundings. Condensates conductively cooled below line temperatures (188°C) dissolve more corrosive gaseous species (e.g., CO<sub>2</sub>, H<sub>2</sub>S, volatile Cl if present) to form acidic solutions. The pH of the nearly-pure condensates declines readily in the absence of the buffering effect of minerals normally present in brine. Water chemistry at line condition was recalculated using the conductive heating feature of WATCH 2.1 from sampling condition (25°C). At 188°C, the Pourbaix diagram indicates a stability area shifted towards the region of uniform corrosion when the solution pH declines to ~4.3 (Fig. 6).

Figure 6: Pourbaix diagram of well 311D condensate chemistry at line temperature (188°C).

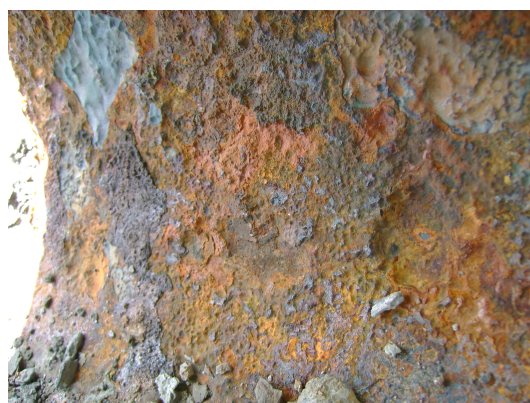
The 30-inch diameter two-phase header experienced rapid thinning in a limited section within and downstream of the 311D stub-in point. The severity of the thinning led to the replacement of a 6 m section after ~10 years of utilization. Few scratches/grooving marks in the replaced pipe suggest that the damages are not caused by solids erosion. The internal surface of the replaced pipe showed irregularly-shaped craters either on the metal surface or on the adhering corrosion products (Fig. 7).

Figure 7: Internal surface of the replaced 30-inch two-phase header.

Well 311D was mechanically cleared and relined to reinforce vulnerable sections of the casing and address the worsening thinning in the deeper part of the production casing based on the caliper survey log. The manageable calculated thinning rate of 0.64 mm/yr in the production casing did not justify installation of a downhole mitigating measure to capture suspended solids from the wellbore. Immediate solutions were focused in addressing the wellhead assembly damages which included lining the vulnerable portions of the expansion spool with abrasive-resistant layer, reinforcement of the flange connections and revisions of pipe support systems to relieve stresses. Future directions are inclined to duplicate the successful hot brine wellhead washing implemented in wells 301D and 306D (Angcoy et al., 2005) since washing through the wingports will mitigate erosion-corrosion from the wellhead to downstream sections by (a) scrubbing suspended solids in steam and (b) buffering the acidity of the water phase due to absorption of more corrosive gas species. All appurtenances attached to the sweepbend and branchline were reviewed for relocation in areas of least turbulence and for insulation to minimize condensation. A limited section of the two-phase header was also reinforced with a higher pipe thickness to anticipate rapid thinning within the mixing points.

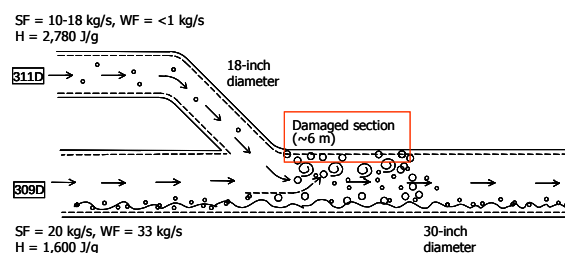
This phenomenon is primarily attributed to the effects when the steam-dominated discharge of well 311D mixes with the watery discharge of well 309D. Because of the difference in pipe diameter, a “Bernoulli effect” could occur when a higher velocity well 311D discharge enters the two-phase header. Bubbles or cavities from the water flow of well 309D can be intermittently drawn towards the lower pressure area and rapidly collapse in the upper walls producing a shock wave that dents the metal surface (Fig. 8). After mixing, some steam of well 311D condense and absorb more gas species increasing the corrosion potential of the mixed water phase. Some of the pits in the pipewall initiated by the cavitation effect develop into a local galvanic cell that promotes pitting corrosion and develops into pinhole leaks.

Figure 8: Mixing of wells 311D and 309D discharges.
