Gunung Salak Geothermal Power Plant Experience of Scaling/Deposit: Analysis, Root Cause and Prevention

Gunung Salak Geothermal Power Plant, PT. Indonesia Power

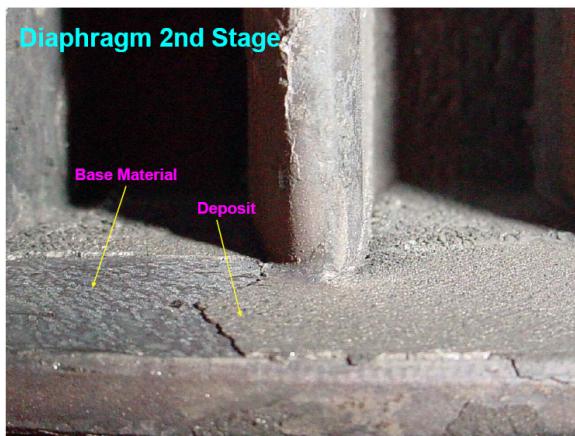
The result of inspection was quite shocking: the some thick deposit was found on the 1st and 2nd stages of the turbine leading and trailing edges. On the 2nd and 3rd stages of the turbine diaphragm (Figure 2 and 3), the thickness of the deposit reached 0.2 to 0.6 mm. The deposit also accumulated on the leading and trailing edges, but this accumulation was more uniform than in the 1st stage. Different from those three stages, the 4th stage of the turbine diaphragm had only a thin layer of material with 0.05 mm thickness. A clean turbine diaphragm surface was seen in the 5th and 6th stages. This was not unpredicted because the steam had a quite high water content in these stages and could trigger blade corrosion.

Figure 2: Deposit on 2nd stage diaphragm.

The cleaning methods of chisel chipping and fine grinding were used to remove the deposit from turbine blades. This technique caused a rough surface on the diaphragm blade, a condition that could disturb the steam flow dynamic. Careful visual inspection showed that there were no signs of corrosion on blade surfaces. This observation meant that there were no corrosion effects on the turbine material because of the turbine's interaction with steam.

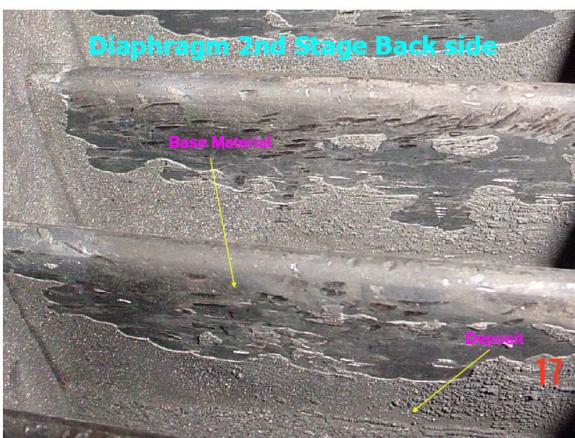
Figure 3: Deposit on the back side of 2nd stage diaphragm.

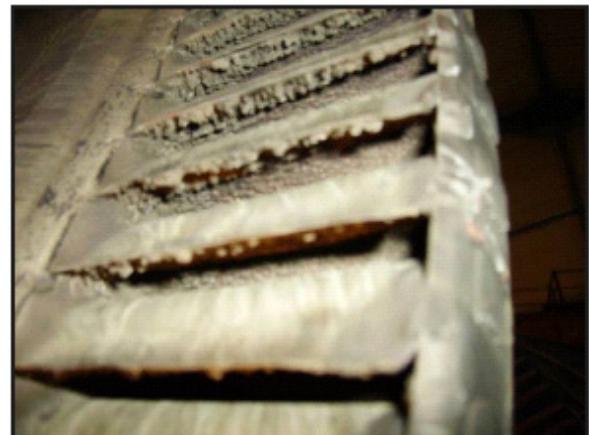
Similar to the turbine diaphragm, the rotor blade experienced deposition problems in its first two stages. The deposit developed until it reached 1.1 – 1.8 mm thick. Figure 4 shows the condition of the 1st stage rotor blade before cleaning. The deposit thickness was reduced to 0.5 – 0.7 mm on the 2nd stage of rotor blade. The 1st stage rotor

diaphragm. The thickest deposit was on the 1st stage with a thickness around 1.2 mm. The deposit was accumulated on blade had a thicker deposit than the 2nd stage. This is normal because the 1st stage interacts with steam flow with larger kinetic energy. On the 3rd and 4th stage rotor blades, a thin layer of deposit about 0.5 mm covered the blade uniformly. The clean shape of the 5th and 6th stage blades made the cleaning job easier. The cleaning job was done with chisel chipping and fine grinding as with the turbine diaphragm. Figure 5 shows the overall condition of 1st, 2nd, and 3rd stage blades before cleaning. It is important to note that there were no signs of steam corrosion on turbine surfaces.

Figure 4: 1st stage rotor blade before cleaning.

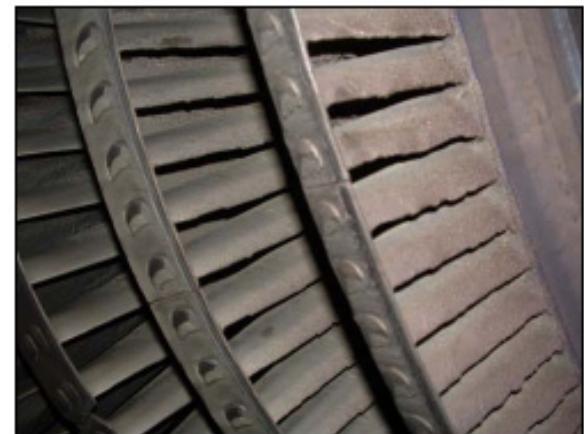
Figure 5: 1st, 2nd and 3rd stage rotor blades before cleaning.

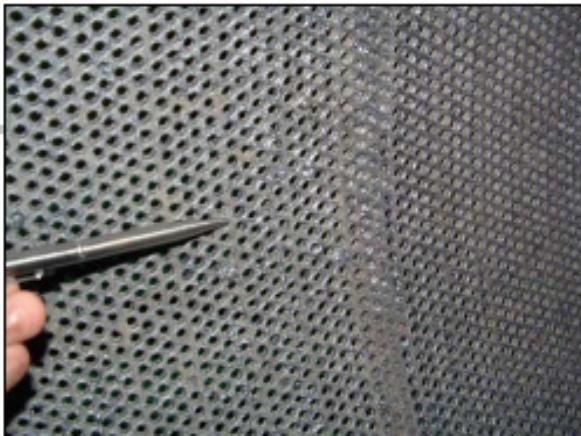
This deposit became the number one suspect for the cause of the de-rating problem. Further investigation was carried out to figure out the origin of the deposit. The first deposit origin suspected was the steam strainer. Figure 6 shows blocking deposits on the steam strainer. The steam strainer's main function is to filter out solid particles that are carried in the steam. The steam strainer has a cylindrical shape with mesh all over its surface. In the inspection period, a relatively thin deposit with size of 1 mm was found on the interior side of the strainer. This deposit caused around 10% blockage of the entire strainer surface. This blockage could affect the main steam flow's gradual decrease. Quite different from the interior side, the exterior side did not have such deposition and was considered clean.

Figure 6: Steam strainer mesh with some blocking deposits on its interior side.

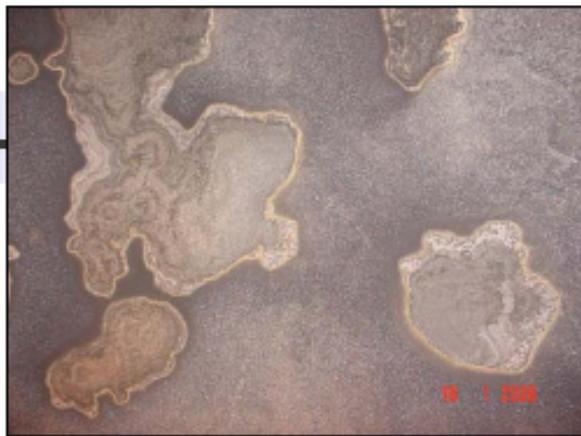
Figure 7: Demister top (steam outlet) deposit.

Figure 7 shows the deposit found in the top of the demister. The steam inlet side and inner shell had excessive deposit formation resulting in deposits that were around 4 mm thick. This part of the demister has an important role because it supports the centrifugal force of the steam. Centrifugal force is used to move heavy water particles in the steam to the outside. This water accelerates deposit formation. Beside the deposit, severe surface corrosion was found on the demister elements holder (Figure 8). However, there were no broken or plugged demister elements.

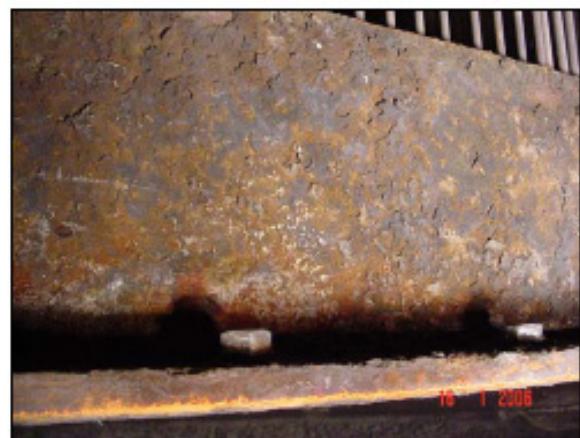
Figure 8: Corrosion on demister elements holder damaged some demister elements.

The main improvement applied to the demister was the change of the holder material, which was corroded by steam. The original holder material was SS420 and 6 mm thick. Modification consisted of adjustment of holder thickness. It was changed to 8 mm thick without any material changes.

The result was quite satisfying. The demister element holder that experiences corrosion has decreased. Therefore, it assures that downstream of the demister is in a clean condition.

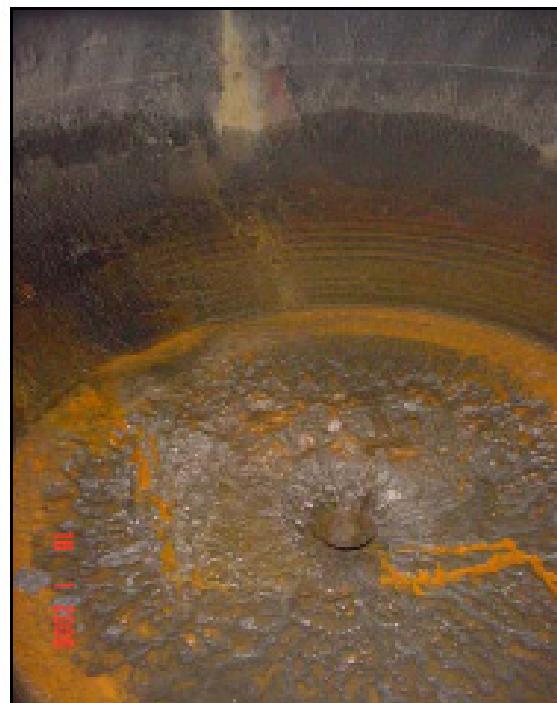
The upstream steam treatment equipment, the scrubber and separator, were also checked. The deposit found here was quite similar to that found in the demister. There was a large amount of deposited material on the inlet, outlet, inner shell, bottom side and internal element in both of these pieces of equipment. Figure 9 and 10 show the deposit on the scrubber and separator. The thickest deposit was on the bottom side and was about 3 – 4 mm.

Figure 9: Deposit on scrubber bottom.

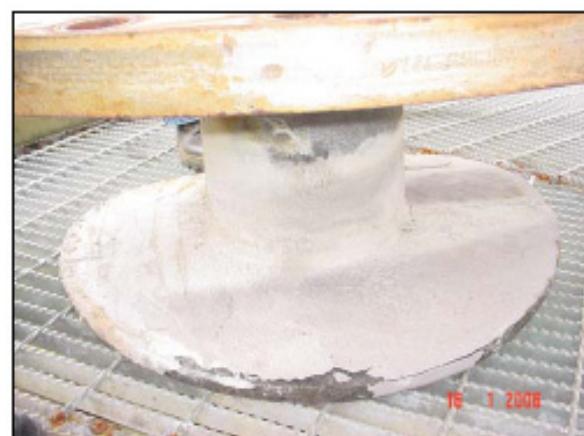
Figure 10: Deposit on separator bottom.

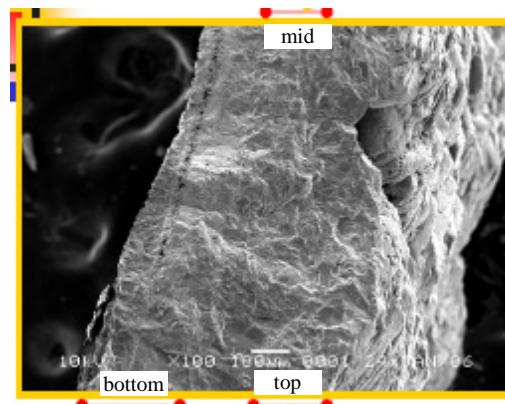
SEM showed that the deposit was in the form of layers. Figure 12 and 13 show SEM images from the 1st and 2nd stage rotor blades. These layers had quite different morphology and composition. It proved that the deposit is not a corrosion product. If it was a corrosion product, it would have the same morphology and composition. The most important information from EDS was that there was no indication of chrome element in the deposit.

Chrome is the main component of martensite stainless steel, the material of which the turbine blade was made. If the turbine blade had experienced corrosion, EDS would detect elemental chromium. The absence of chromium indicates that the deposit was not a corrosion product, but rather the result of deposition of steam-carried particles. Figures 14

Figure 12: SEM result on 1st stage rotor blade.

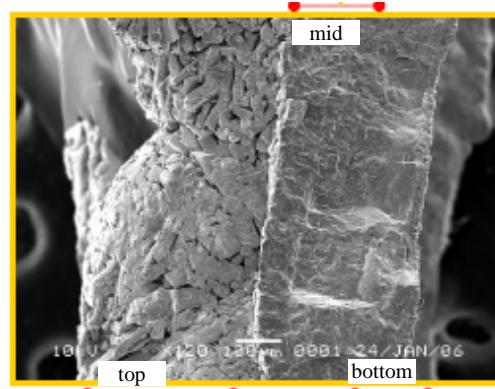
Figure 13: SEM result on 2nd stage rotor blade.

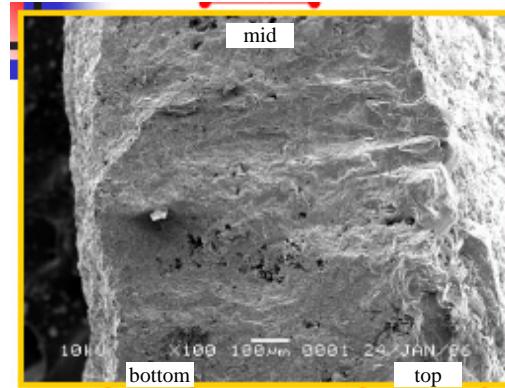
Figure 14: SEM result on 1st stage diaphragm.

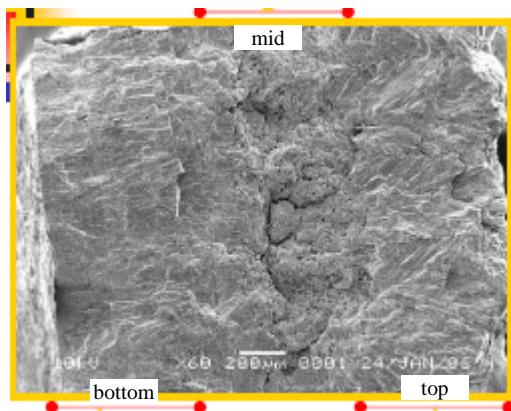
Figure 15: SEM result on 2nd stage diaphragm.

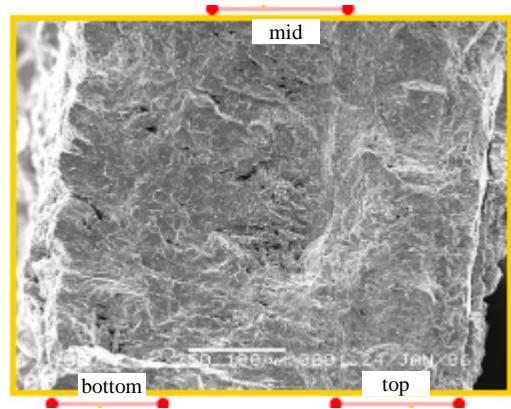
Figure 16: SEM result on 3rd stage diaphragm.

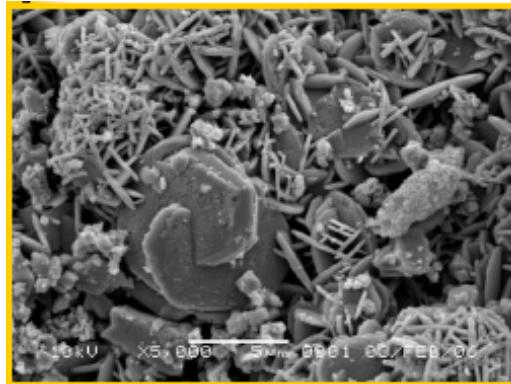
Figure 17: SEM result on demister deposit.

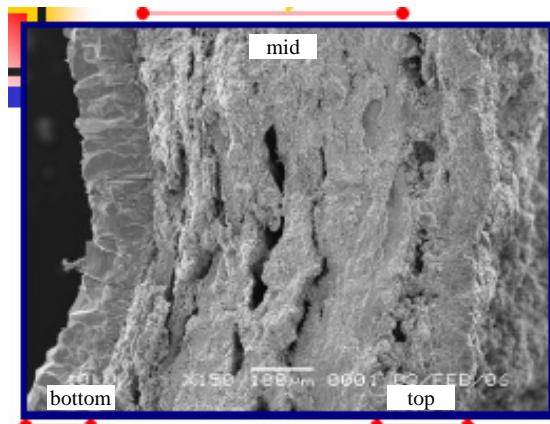
In the scrubber deposit (Figure 18), morphology and chemical composition varied greatly between layers. The bottom layer and the next overlying layer had different deposit types and elemental composition based upon EDS analyses. The result of this test indicated that the blade surface deposition constantly changed over operation time. This data corroborated the idea that low scrubber performance is responsible for deposit formation.

Figure 18: SEM result on scrubber deposit.

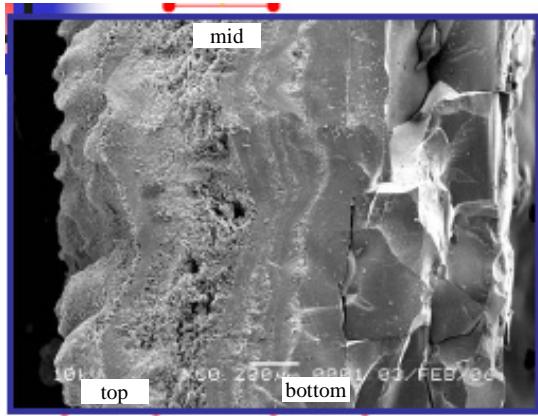
XRD showed the composition of deposits in the separator. Some of them were SiO_2 , NaCl and FeCO_3 . It supported the results of EDS that indicated the separator was unable to effectively remove Si and Na.

Figure 19: SEM result on separator deposit.
