Corrosion of Cu-Base Alloys in Geothermal Condensates

M. Ko and K. A. Lichti

Quest Reliability Ltd., Gracefield Research Centre, Lower Hutt, New Zealand

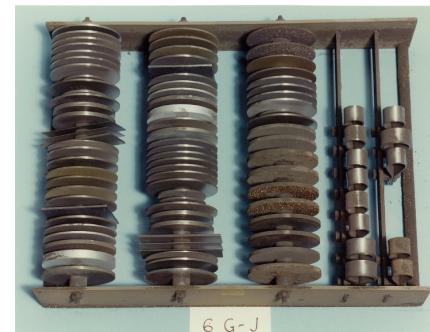
b. Pictures of coupons on a loaded rack for exposure inside Vessel 6, Cold Condensate.

Figure 1: Schematic diagram of corrosion rig in Broadlands, New Zealand. Vessel 6 coupons shown after 12 months.

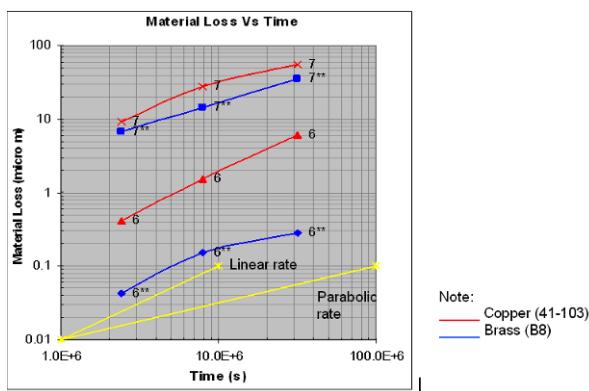
The results obtained suggested an approximately linear to semi parabolic corrosion rate for both materials as illustrated in Figure 2. Linearly increasing material loss was observed for copper material in cold condensate (Vessel 6) and brass material in the aerated condition (Vessel 7). The linear rate loss suggests a minimum of protective film was formed. The material loss of copper in the aerated condition was at of an order of a magnitude higher than that found in the non-aerated condition.

In the non-aerated condensate environment, the addition of alloying elements significantly decreased the rate of corrosion by about an order of a magnitude. The same effect was not observed in the aerated condition. The material loss of brass in the aerated condition (Vessel 7) was at least two orders of magnitudes higher than those found in the non-aerated condition (Vessel 6).

Brass material in the cold condensate environment, showed two different corrosion mechanisms, initially showing a linear rate loss which then changed to a parabolic rate loss at longer exposure periods. It can be argued that some protective film was formed.

Figure 2: Graph of material loss of Copper and Al Brass in geothermal condensates for 4, 13 and 52 weeks. 6 and 7 = Copper. 6'' and 7'' = Brass.

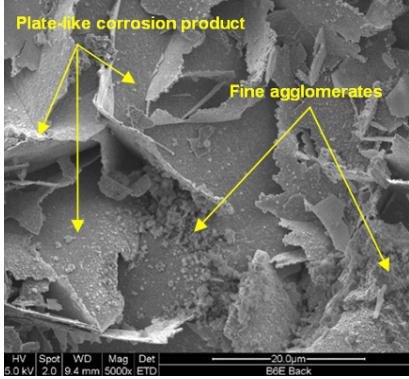
SEM examination revealed that after the 13 weeks exposure period, the corrosion products were mainly in the form of plate-like structure and fine spherical agglomerates (Figure 3). The fine spherical agglomerates appeared to have been precipitated out of solution, which then deposited on the top of the plate like corrosion product. The glassy plate like corrosion products showed predominance of copper (Cu) and sulphur (S) with a lower level of oxygen (O) and iron (Fe), suggesting copper-sulfide compounds. Analysis of the fine spherical agglomerate (Figure 3) showed a higher level of iron (Fe). Trace amount of arsenic (As) and antimony (Sb) typical of geothermal solutions were also detected in some areas. It should be noted that the presence of iron in the corrosion product was not originally expected. Iron was attributed to the corrosion of the test vessel itself.

Figure 3: SEM image of CuB6E surface corrosion product.

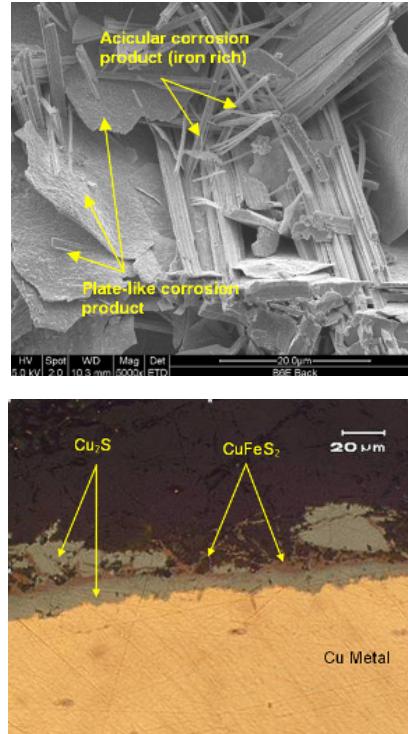
At 52 weeks, the sample generally had larger particles than those observed in the 13 weeks exposure (Figure 4). The corrosion products observed were in the form of plate like and acicular needle structures. The plate like material showed a similar composition to that found in the 4 week sample, with predominance of copper (Cu) and sulphur (S). Analysis of the acicular corrosion product revealed a high iron (Fe) content (similar to the fine spherical agglomerate structure found in the 13 week sample).

Cross sections of sample CuB6H showed three distinct layers of corrosion product (Figure 4). Over time, a significant increase in the thickness of the corrosion products was observed. The thickness of the first layer of corrosion product next to the copper metal interface was measured to be between 9 to 15 μm. The light grey areas appeared to be mainly copper sulphides (Cu_2S). The brown areas observed in the next layer were analysed to contain a

high level of copper (Cu) with almost equal amounts of sulphur (S) and iron (Fe) which predominantly suggested a copper iron sulphide (CuFeS_2).

Figure 4: SEM images of the surface morphology and optical image of cross section of sample CuB6H.

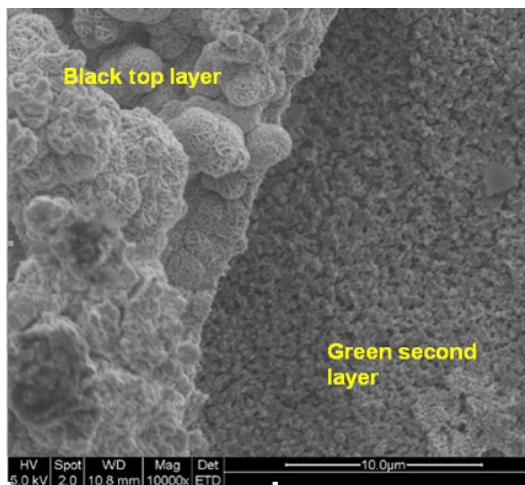
At 4 weeks exposure to the aerated condition, the corrosion appeared to be crystalline (Figure 5) with fine particles on the second layer (Figure 5). SEM analysis on the black top layer of the corrosion products showed high levels of copper (Cu) and sulphur (S) with a lower level of oxygen (O) detected. The green second layer of the corrosion product showed presence of mainly copper (Cu) and oxygen (O). Low levels of iron (Fe) were detected in some spots.

The cross section showed areas where corrosion products were detached or completely flaked off from the copper metal and newly formed thin corrosion product observed on the metal surface. Where corrosion products were adherent, cracks on the interface were commonly encountered evidencing the non-protective properties of the formed films.

Figure 5: SEM image of CuB7B (4 weeks exposure) sample showing surface morphology.

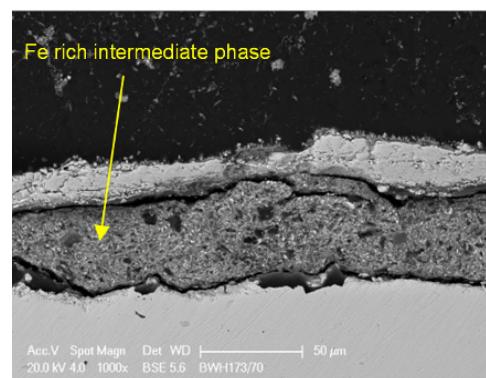
In some areas, a layer of dark grey corrosion products formed in between the top light grey corrosion layer and the copper metal (Figure 6). This layer ranged from 50 to 100 μm in thickness and was rich in iron and contained traces of impurities such as chromium (Cr), aluminium (Al), silicon (Si), nickel (Ni) and manganese (Mn). These impurities were thought to have come from the solution having originally come from the geothermal source fluid or from the corrosion of the vessel or other test materials. The dark region appeared to be the intermediate phase in the corrosion process and was thought likely to be copper carbonate (CuCO_3), iron carbonate (FeCO_3) or iron carbide (FeC_3). However, these compounds are often amorphous and were not detected by the XRD analysis.

Figure 6: View of the cross section of sample CuB7D.

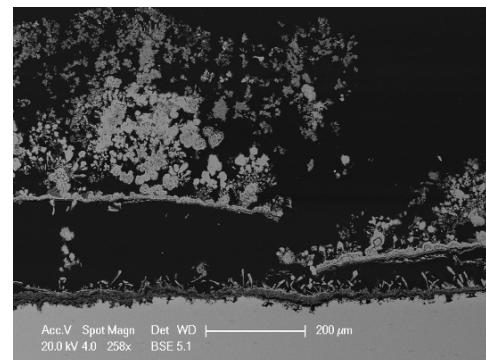
The CuB7H corrosion sample showed extensive flaking (Figure 7) and wasn't analysed in plan view. The cross section showed a voluminous corrosion product layer with most of the area flaked off from the metal substrate. The copper metal interface to the corrosion products was also attacked to give an open structure.

Figure 7: SEM image showing the cross section of sample CuB7H.

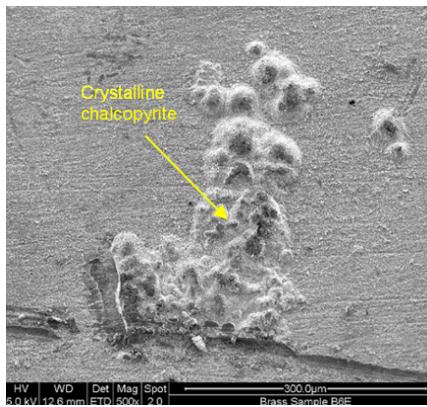
At 13 weeks exposure the surface of corrosion product was mostly fine grained and contained mixtures of copper (Cu), zinc (Zn), sulphur (S), oxygen (O), aluminium (Al) and iron (Fe). The corrosion product structure was completely different to that seen on the pure copper sample. It formed one continuous layer of corrosion product of around 2 to 4 μm in thickness. In some areas, thicker corrosion product deposits were observed; up to 25 μm in thickness (Figure 8). The surface of the "lump" contained high levels of carbon (C), sulphur (S), copper (Cu) and iron (Fe). No zinc (Zn) or aluminium (Al) were detected. Cross section analysis of the "lump" area was conducted and showed predominance of sulphur (S), copper (Cu) and iron (Fe) which appeared to be mainly chalcopyrite. This deduction was supported by the XRD analysis.

Figure 8: SEM images showing the surface and cross section of sample B8B7E.

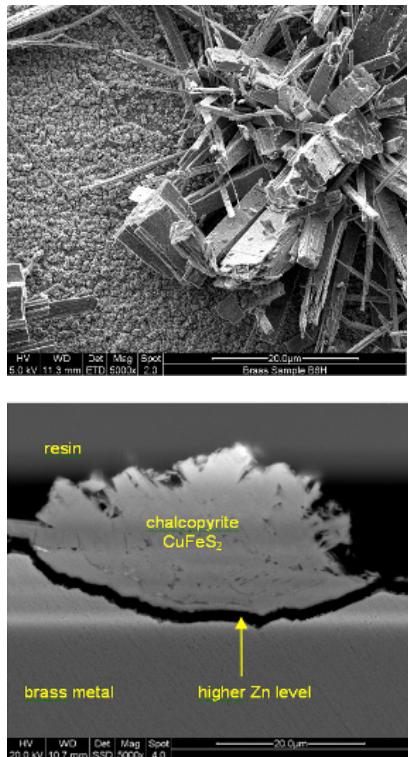
After 52 weeks exposure, the corrosion product had changed to a fine-grained structure with many crystal growth areas (Figure 9). The fine-grained corrosion product (Figure 9) contained mixtures of copper (Cu), sulphur (S), zinc (Zn), oxygen (O), iron (Fe) and aluminium (Al), similar to those found in the 13 weeks sample. It was believed that after the longer exposure period similar chalcopyrite deposits to those observed in the sample B8B7B (13 weeks exposure) had modified into a more crystalline “spiked” structure.

The cross section analysis (Figure 9) showed a black layer in between the brass metal surface and the chalcopyrite crystals, which contained a high level of zinc.

Figure 9: SEM images showing the surface and cross section of sample B8B7E.

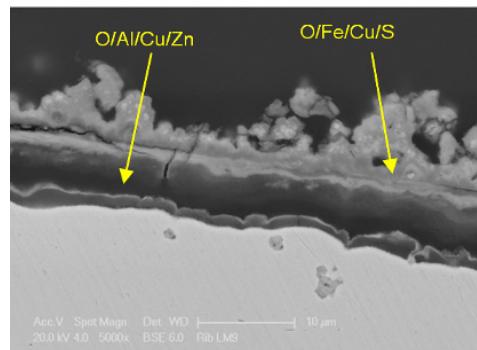
At 4 weeks exposure, the inner most layer (one closest to the metal surface) was dark grey and contained a high level oxygen (O), aluminium (Al) and copper (Cu) with a lower level of sulphur (S), iron (Fe) and zinc (Zn). It is interesting to note that exceptionally high aluminium (Al) content was observed in the inner most layer (Figure 10). Aluminium (Al) was concentrated at the metal surface and formed a stable corrosion product layer. Mattsson (1980) reported that such occurrence is widely encountered for any copper alloys containing aluminium. The next layer was black coloured and contained a mixture of copper (Cu), sulphur (S) and low level of oxygen (O) and iron (Fe). This layer was less stable and had flaked off considerably. In some areas golden coloured corrosion product was observed, which contained a higher zinc (Zn) level.

The thickness of corrosion product at 4 weeks exposure was between 6 to 16 μ m and was mostly adhered to the metal surface. The cross section showed two distinct layers, a dark grey layer closest to metal surface and the top light grey (and sometime porous) corrosion product (Figure 10). The dark grey layer contained an exceptionally high level of aluminium (Al) which coincides with the surface analysis. The top light grey corrosion product contained higher levels of iron (Fe), copper (Cu) and sulphur (S). However, this layer had flaked off in some areas. The high level of iron observed in the light grey layer was thought to have been deposited from the condensate solution itself due to the corrosion of the test vessel. Again, the occurrence of iron in the solution is similar and consistent to previous analysis. EDX analysis showed a high concentration of carbon throughout the cross section, likely from the formation of copper carbonate corrosion product, however, this could not be confirmed by the XRD analysis due to the poor crystallinity of the materials.

Figure 10: SEM image and elemental map of cross section of sample B8B7B.

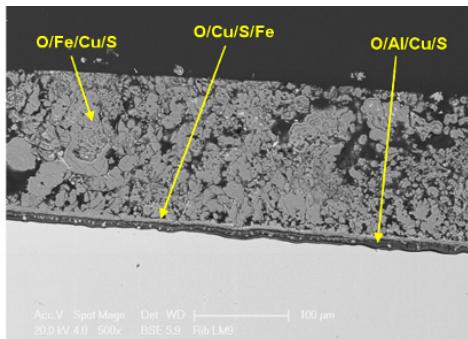
The maximum thickness of the 13 weeks exposure corrosion product was around 170 μm (Figure 11). It was mainly due to the brown porous corrosion product as observed in the surface analysis (light grey in the SEM images). This layer contained a high level of iron (Fe), similar to those found in the 4 week sample. However, most of this thick layer had flaked off. The dark grey corrosion product adherent to metal surface was measured to be between 10 to 15 μm with the full layer of up to 170 μm thick. The thickness of the adherent layer did not change significantly between the 4 and 13 week exposures.

Figure 11: SEM images of the cross section of sample B8B7E.

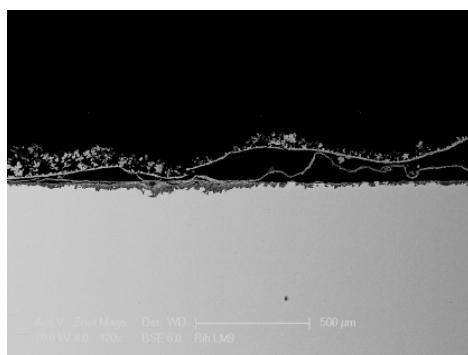
The overall corrosion product structure was non-adherent and had lost its integrity due to the prolonged exposure (Figure 12). However, two distinct layers were observed in the cross section. High aluminium (Al) content was detected in the dark grey bottom layer and it had grown to thickness between 30 to 100 μm .

Figure 12: SEM images of cross section of sample B8B7H.

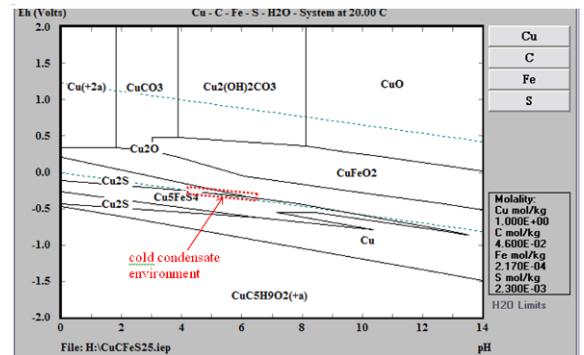
analysis used the conditions specific to the cold condensate environment in the Broadlands field (NZ). Only the major species found in the solution, namely copper, carbon, iron, sulphur, oxygen and hydrogen (at concentration as shown in Table 2) were inputted to the software. The free energy values used in the software's database were independently verified using available correlations. Temperature of 20°C, pressure of 300kPa and a pH range of 3.5 to 6.5 were used to simulate the condensate solution. With no oxygen leak into the system, the solution's potential would lie at the bottom limit of the $\text{H}_2\text{O}/\text{H}_2$ equilibrium line (green parallel dotted lines). The Pourbaix diagram (Figure 13) showed within the range considered, stable copper corrosion products formation would be chalcocite (Cu_2S) and bornite (Cu_3FeS_4) which is consistent with the experimental result. However, it did not predict chalcopyrite. This could be explained due to the non-uniform species' concentration inside the test vessel. Localised variability was often found, especially in crevice areas or near corroded surfaces.

Figure 13: Pourbaix diagram of copper using the Broadlands condensate water chemistry.

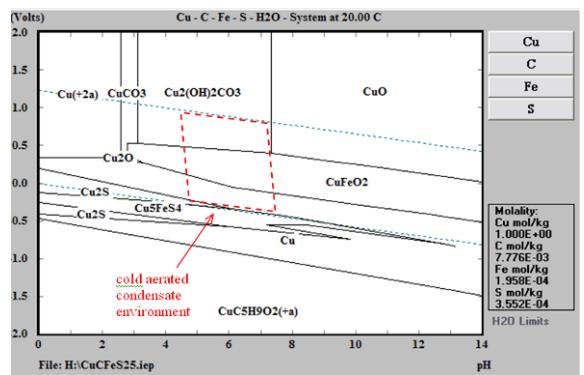
Figure 14: Pourbaix diagram for copper in the Broadlands aerated condition environment.

For the aerated conditions, a temperature of 20°C, a pressure of 135kPa and a pH range of 4.5 to 7.5 was simulated. The presence of oxygen in the system increases the potential (Eh) of the solution. It ranges from the two limits of the H_2O equilibrium line (green parallel dotted lines) as shown in Figure 14. Within the range considered, stable copper corrosion products such as chalcocite (Cu_2S), bornite (Cu_3FeS_4), cuprite (Cu_2O), malachite ($\text{Cu}_2(\text{OH})\text{CO}_3$) and cuprous ferrite (CuFeO_2) may be formed. The diagram only accurately predicts the formation of cuprite and copper sulphides. The inaccuracy is due to the local variability in the solution's concentration and the non-crystallinity of corrosion product, hence was undetected in the XRD analysis.
