## Challenges of Executing a Plug and Abandonment Operation of a Geothermal Well in a Forest Reserve

Christopher O. Diaz

Chevron Geothermal Services Company, 5F 6750 Building, Ayala Avenue, Makati City, Philippines

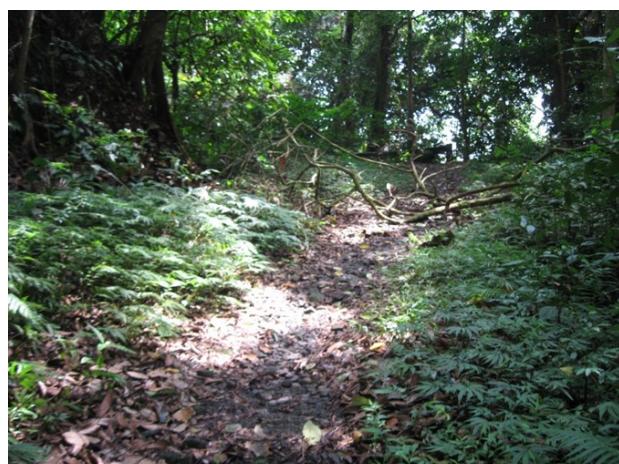
One of the challenges due to the location of the well was repairing the roads leading to the well site (Image 3). The road repairs involved rehabilitating 3 kilometers of rough and narrow road terrain. In the design of the road, the company considered making repairs that would allow a minimum load capacity in order to minimize the rehabilitation cost. By understanding the type and weight of equipment for the P&A operation, the company was able to successfully rehabilitate the road fit for the equipment to travel on. Also, the road repairs were scheduled at a time when the weather was fair to prevent additional costs of repairing the road due to damages brought about by typhoons and heavy rains.

**Image 3: Road terrain leading to the well site.**

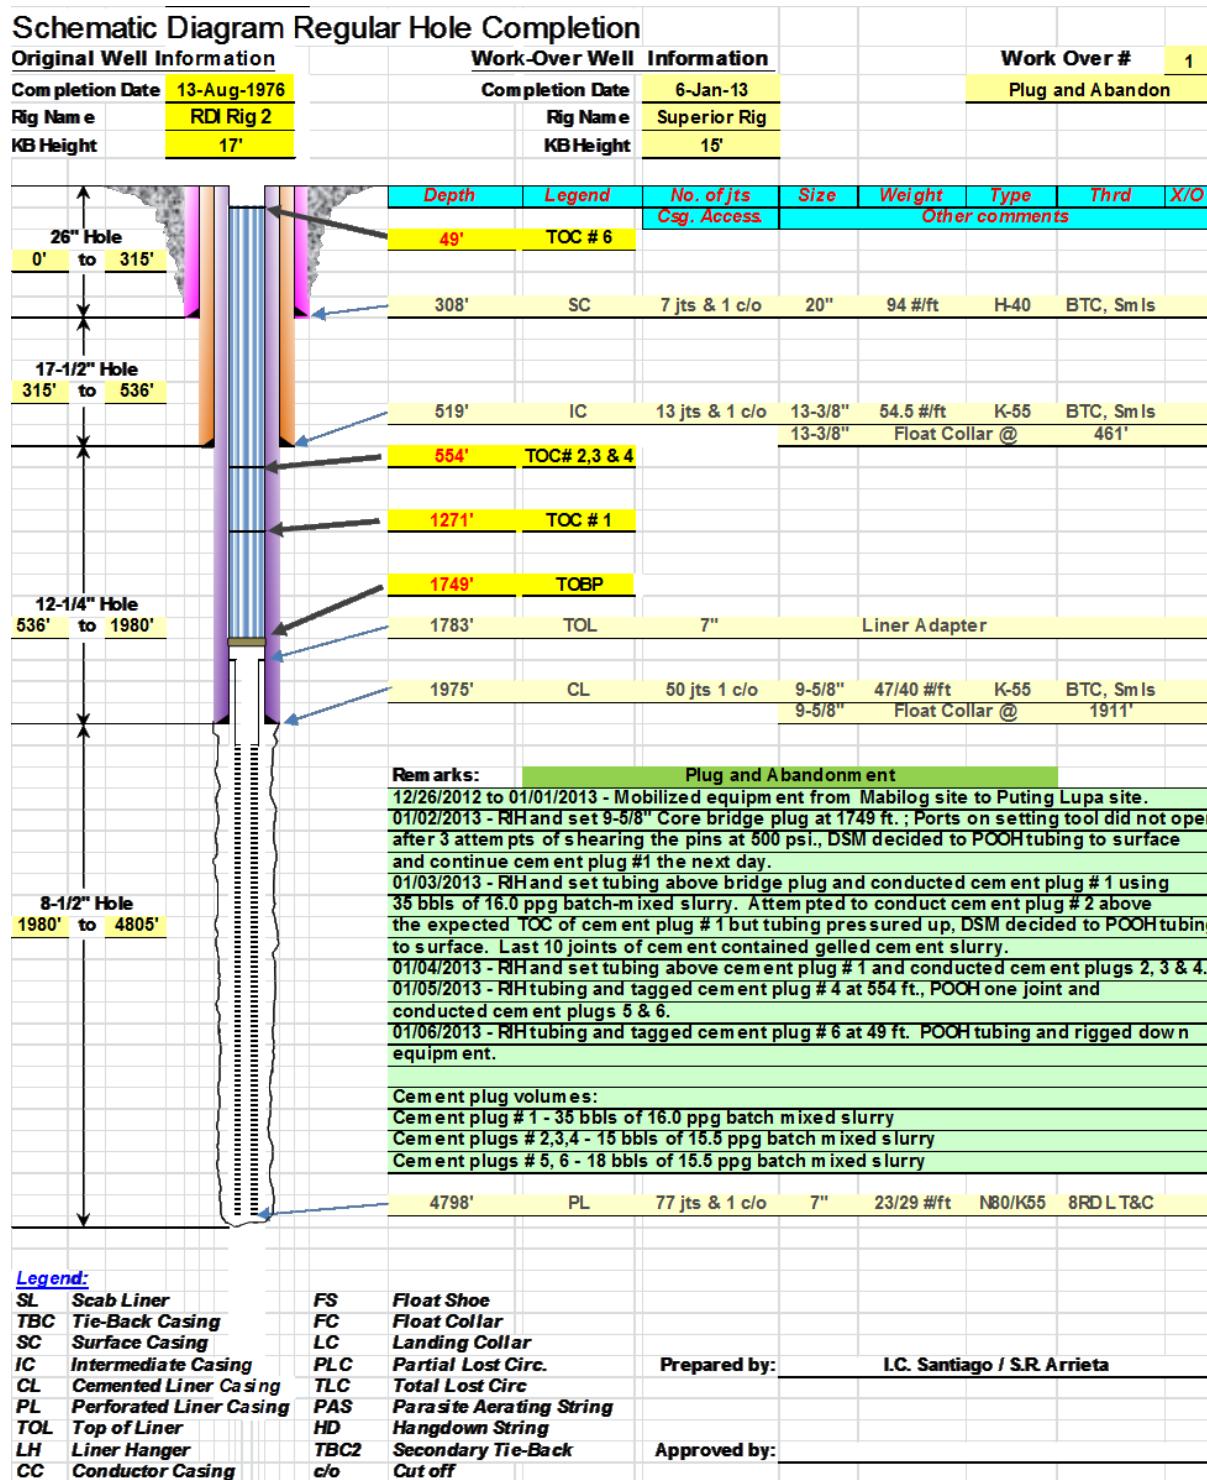
Puting Lupa-01 was drilled in June 1976 as an exploratory well in the Los Banos area. Richter Rig 2 was used to drill the well from the surface to a total depth of 4,805 feet. The well was completed with an external pack-off wellhead completion design. The well did not produce any steam after it was completed in August 1976 and because of zero steam production, the well was never used. In 2011, the well was recommended for abandonment to ensure it did not cause safety or environmental hazards. The abandonment activity included sealing the well with a bridge plug and cement plugs (Diagram 1).

Diagram 1: Final wellbore diagram of Puting Lupa-01 after the P&amp;A operation.

Following the initial isolation job, the tubing work string was run in hole to tag the top of the isolation plug and then a Class G Cement recipe was mixed and pumped to a pre-determined depth. The weight of the cement slurry pumped was 16.0 ppg, with 0% free water and low fluid loss properties to prevent trapped water which could boil or flash due to the geothermal heat and cause the casing to burst.

Since geothermal wells are drilled in a lost circulation environment, it is difficult to see cement returns on primary cement jobs. An in-house risk management process identified four critical sections that required the 16.0 ppg cement slurry as follows: (1) an initial cement plug on top of the reservoir, (2) all perforation zones, (3) the liner lap, and (4) the surface plug. To ensure that the reservoir fluids could not travel up the annulus, perforations are placed just below the surface casing shoe to allow a cement squeeze job to plug any potential voids behind casing. In most cases, a liner tie-back lap also existed close to the surface shoe which was covered with good quality cement to prevent a future leak path. Cementing was then continued to the surface. The well did not undergo any cycling loading as a result of steam production and the drilling history data showed good primary cement jobs. With this information, it was determined that there was no need to perforate the casing below the shoe to squeeze cement. The well was cemented with a full column of cement from the top of the isolation plug to surface using a total of five batch-mixed plugs pumped through the CS Hydril tubing.

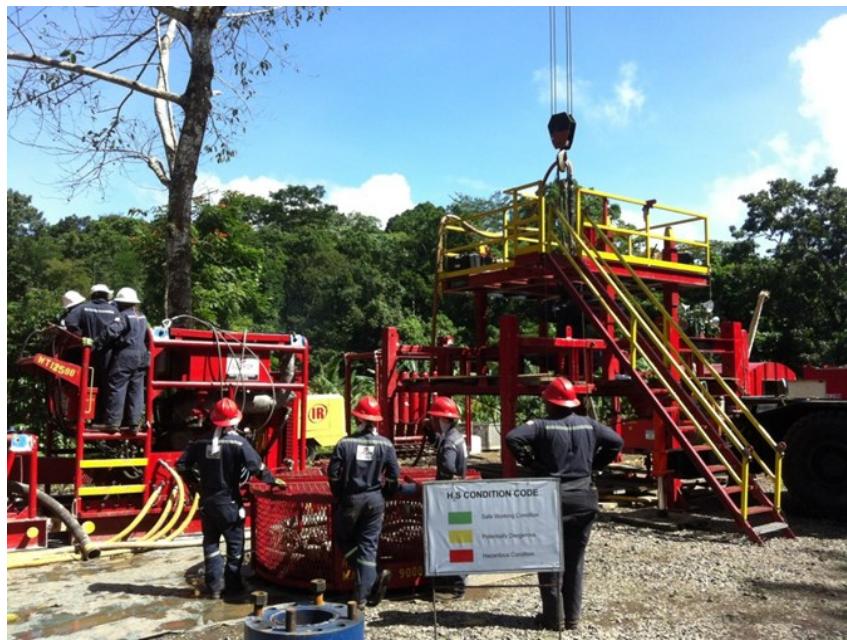
The forest reserve is popular to tourists and the well site is a camping ground for campers. The company had to identify the safest way to position the equipment to minimize the footprint it would leave behind after the P&A operation. The company wanted the site to be the same for the tourists and campers to visit after the operation. In one instance, a tree located near the wellhead was not removed. The crane had to position itself in such a way that it could perform its work and at the same time minimize its environmental footprint (Image 4).

**Image 4: Work basket and pumping setup at the site in preparation for the abandonment operation.**
