Geothermal Turbines – A Maintainer’s Perspective

Chris Morris^{1*} and Alan Robinson²

¹Wairakei Power Station, PB2001, Taupo 3330, New Zealand ²ProGen, PO Box 271, Hamilton 3214, New Zealand

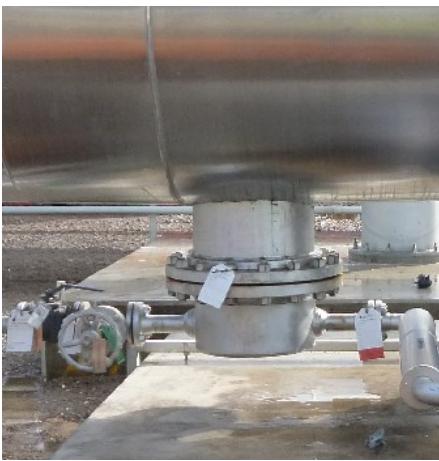
Figure 5 Small drainpot common on many new steam pipelines. Proven as ineffective at removing pipeline condensate.

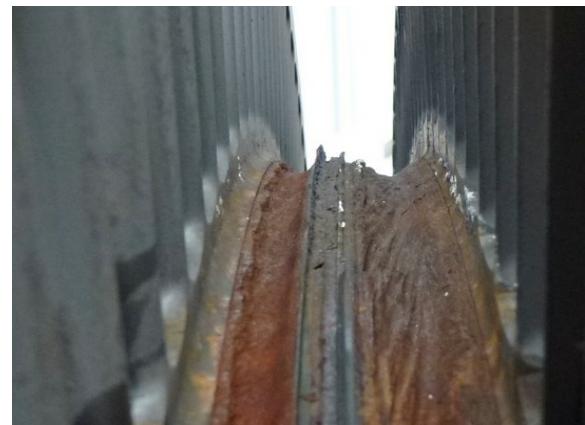
Figure 6: Rotor erosion from water trapped in the interstage area. There were originally thin stainless iron sealing strips in this region to prevent steam bypassing the fixed blading, of which only the remnants of two remain.

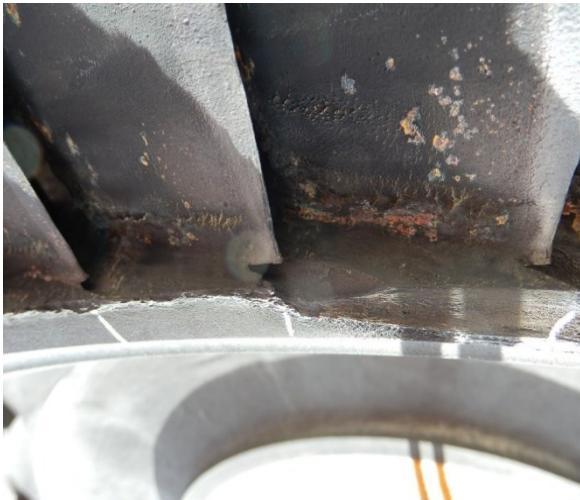
Figure 7 Water erosion damage on exhaust side of first stage nozzle inner port wall. This region is supposed to be superheated steam.

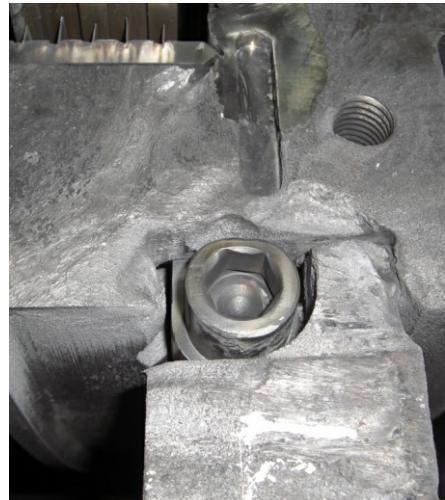
Most of the damage normally associated with steam is actually from the water entrained in it, as described in the previous section. If the steam is clean, then there is usually only a generalised slow erosive wear. The main problem is where the sealing between areas at different pressures is not effective because of misalignment, distortion or excessive clearances. As well as the axial and half joint sealing faces on diaphragms and casings, this includes the interstage seals themselves. These seals are on the inner side of diaphragms and are the major barrier to interstage flow. The wet steam passing through any of these poorly sealed areas can rapidly cause cuts, wiredrawing or generalised erosion defects (Figure 8).

Figure 8: Steam damage across halfjoint sealing faces of the stationary blading sets. Steam flow right to left.

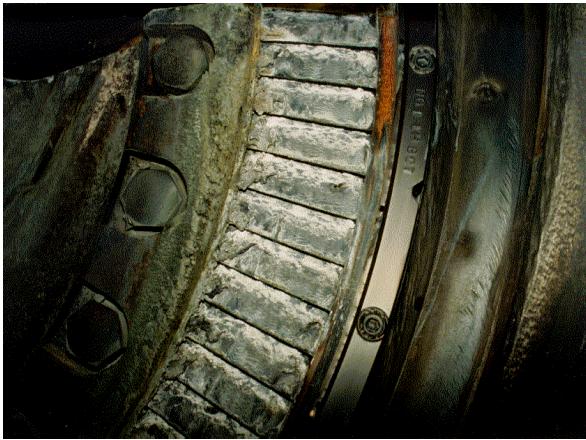
The dynamics of the steam sets the actual locations of the deposits. The particles accumulate in the relative low velocity region on the convex side of the port vanes close to the inner port wall. Figure 9 shows a typical deposition in the first stage nozzles. Once deposition starts, then the increased turbulence and the bigger boundary layer allows more to accumulate. The pressure drop across the port increases, which generates more superheat, so more deposition. This means that the combination of increased pressure drop and reduced massflow through the restricted ports can cause a rapid deterioration in the machine's output. The deposition can also occur in regions that thermodynamics indicate should be wet. This is because local circulation and heat flow from hotter components give drying conditions. One of the authors has even found high chloride deposition in the roots of the last stage blades – a region that should be very wet and not allow the highly soluble material to deposit.

Figure 9: Scale deposition in turbine nozzles.

Turbine washing or desuperheating can reduce or even eliminate the deposition and subsequent generation loss. Morris and Bacon (1981) describe one such installation and system. However, washing is a palliative operation, not a solution. The major undesirable consequence of the scrubbing water is to increase water damage, often as abrasive slurry, so operators can be exchanging one problem for another. The washing debris can cause abrasive erosion damage, particularly on exposed components like the tenon tips of the rotating blades (Figure 13). Because as discussed above, a concentrated brine solution can form, there has to be enough wash water present to guarantee the steam is well below the saturation line. Otherwise, the rotor erosion problem previously described will occur. There also has to be suitably sized interstage drainage on the first and second stage. To make washing worse, some stations use wash water that has not been deoxygenated, so aggravated corrosion will be added to the damage mix.

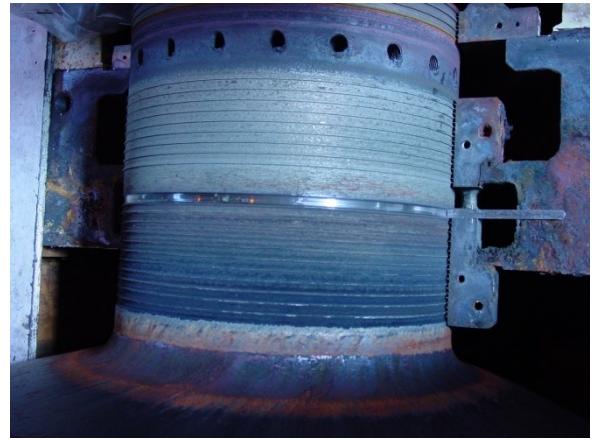
Figure 10: Rotor eroded from scale deposition in glandbox. 150mm ruler for scale.

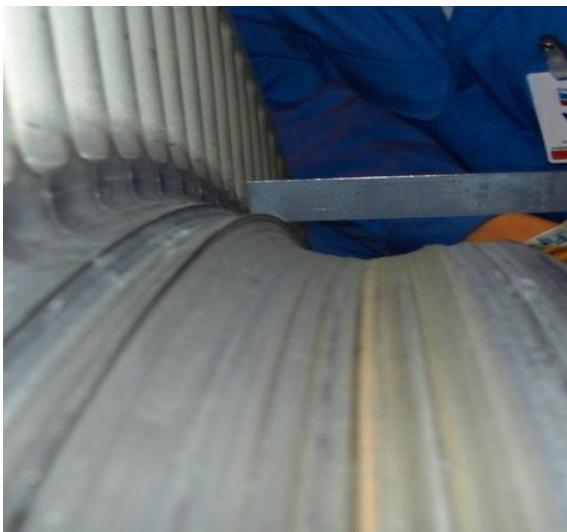
A problem that is being seen nowadays is where the rotor upstream of the first stage blading has deep erosion (Figure 11). This is caused from the fluid exiting the first stage nozzles being just below saturation rather than in superheat. The heavy mineralized water flows on the inner port wall. It then accumulates in the annular cavity upstream of the first stage blades. Heat flow through the diaphragm evaporates the water, leaving behind the silica (Figure 12). The rotor rubs against this very abrasive accumulation. Significant amounts of metal can be removed quite quickly. It can result in the rotor being derated because of blades having to be removed for lack of blade root support.

Figure 11: Rotor abrasion caused by deposition from mineralized water flow through the first stage nozzles.

The only real solution is having a clean steam supply. This means improving steamfield separation efficiency and scrubbing as discussed earlier. The design needs adequately sized piping to reduce steam velocities and allow pipeline scrubbing. For in-service plant, many operators don't consider this a viable option because of the cost. However, the capital savings from not addressing the problem are inevitably swamped by the increased downtime, maintenance costs, loss of generation and reduced life of plant. It is the "pennywise, pound foolish" philosophy writ large.

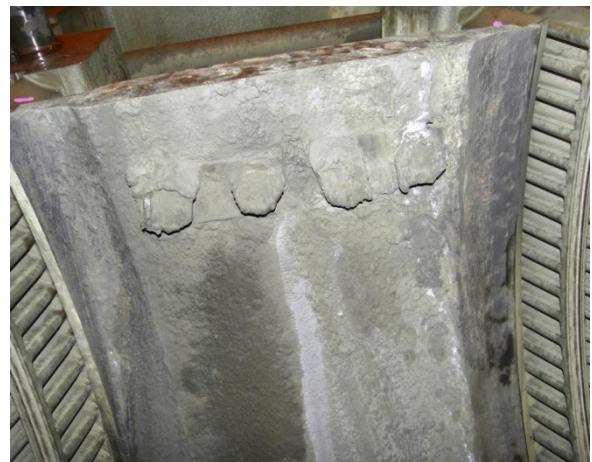
Figure 12: Rotor damage in figure GG caused by deposition on the annular cavity like that shown here. The steam is generally so wet that there is little if any deposition in the nozzles. The rotor damage root cause is poor separation coupled with excessive wash water flow and ineffective demisters.

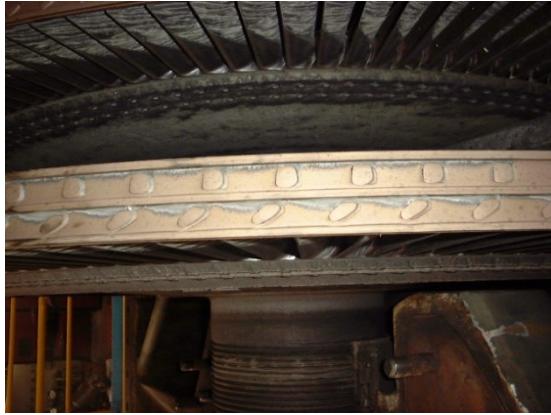
Figure 13: Blade tenon leading edge erosion from silt laden condensate. The rotor turns left to right. Wash lines of deposition can be seen on the upstream blading.

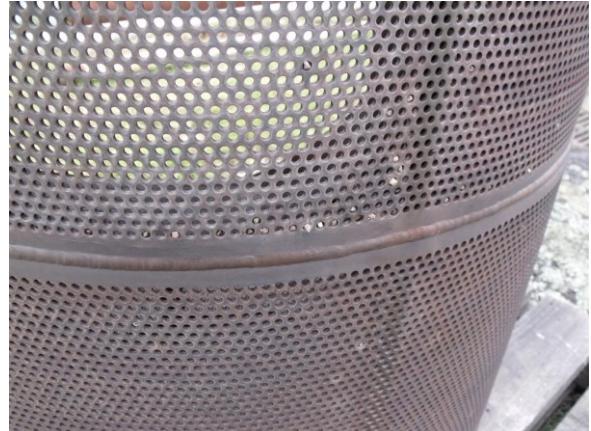
However, much of the damage is from the steamfield and “normal” operation. Dry steam wells feeding directly into steam lines can bring formation into the turbines. Figure 14 shows a turbine’s steam strainer with the debris in while Figure 15 shows the debris. Most of it is rock but there are also rust flakes. The nearest well is over two kilometres away and there are several major elevation rises in the pipelines that the steam passed through. Steam velocity in the line was about 50m/s. This steam had also passed through a Z plate demister where the velocities would have been halved.

Figure 14: Rocks jammed in a steam strainer. This was downstream of a demister.

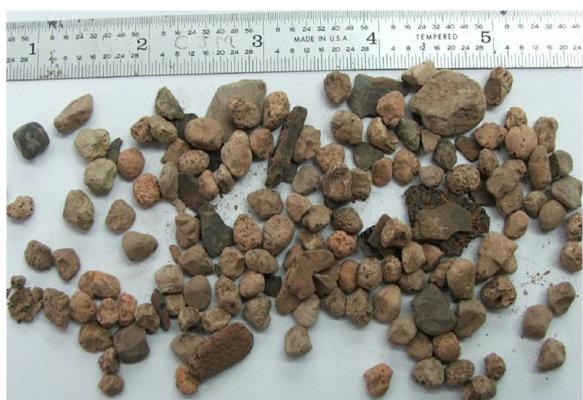
The rocks in the picture are only those big enough to be caught by the strainers. Smaller ones would have passed right through the mesh and into the turbine. These rocks can cause impact damage on the convex face of rotating blades. This may be seen as a mottled or peened appearance, but it is usually masked by the accelerated wear. The shock of the initial impact normally causes the rock to shatter into dust sized particles. These are abrasive and can damage the components, particularly the thin trailing edges of the diaphragm vanes like shown in Figure 16.

Figure 15: Rocks and debris retrieved from strainer in Figure 14. Note the ruler is in inches.

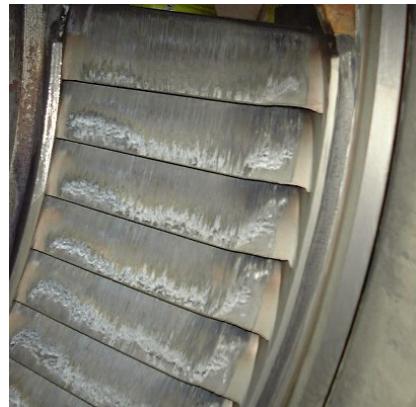
Figure 16: Erosion of trailing edge of diaphragm vanes caused by debris in steam. The rear edge should be straight
