## Unit 1 Turbine Rotor 110 MW Replacement

Star Energy Geothermal (Wayang Windu) Ltd, Tromol Pos 1, Pangalengan 40378

Unit 1 steam turbine of Wayang Windu geothermal power plant with capacity 110 MW has been operated since plant commissioning in 2000. A periodic Turn Around (TA) program such as turbine inspection and overhaul was conducted at a 3 year interval. During the 2006 turbine inspection program, erosion damage defects were found on the rotor body between each of the reaction stages. Several of the “J” seal strips in these sections had been peeled off through the erosion from the parent metal surrounding the caulking groove. The erosion damage was found to have become worse during turbine inspection in the 2009. As a result, there was a high potential for the seal strip caulking being dislodged in the future after the rotor was returned to service with its current condition which could result in catastrophic damage to the turbine.

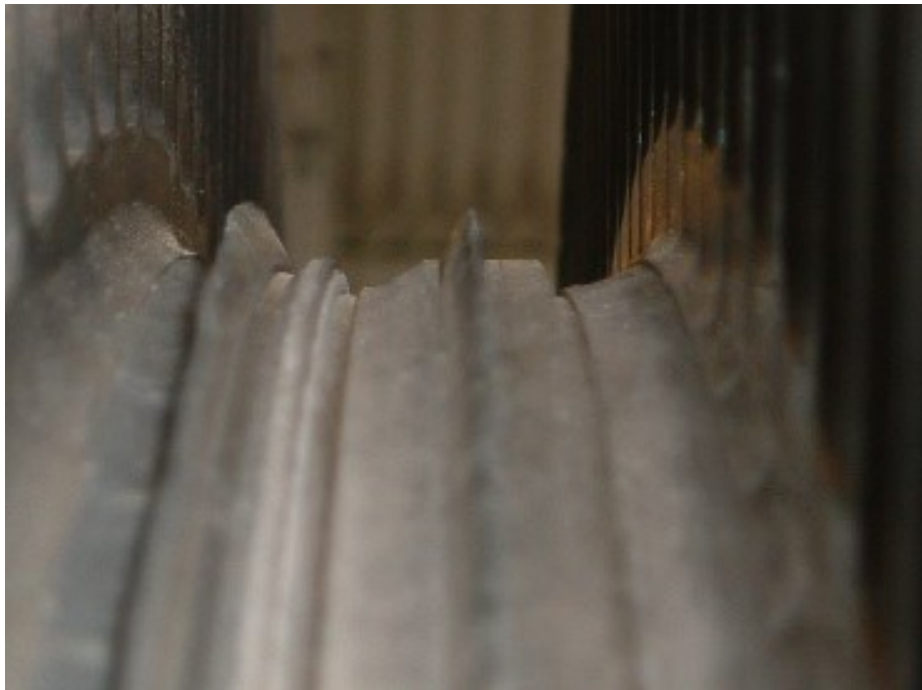
In 2006, the second Turn Around Program for Unit 1 was conducted from shut down on 1<sup>st</sup> August until start up on 12<sup>th</sup> August. The inspection of the turbine rotor revealed that the turbine blading was observed to be clean with only minor scaling. The Co-Cr alloy strip on the last rows of blades was found to be in excellent condition with very little signs of erosion damage. However, mostly, all “J” seal strip groove areas on the rotor, especially on the HP side of the rotor, were found to have heavy erosion. Each of inter stage seal #2, #3, #4 and stage #5 area were found to have seal strips missing and eroded heavily (see Figure 2 and Figure 3). With information from a Fuji Electric engineer about the anticipated power loss and the plant economics, it was determined not to repair this until the next major overhaul. Mostly all turbine disks showed signs of major erosion/corrosion on the turbine disks and shrouds of the blades. The journals, oil seal areas and thrust bearing collar had light radial rub marks. The gland packing areas had heavy erosion/corrosion pitting and major radial rubs.

Figure 2: Erosion and missing seal strips found at inter stage between stage 2 and stage 3 Turbine End side.

It was proposed to replace the existing turbine rotor with a new turbine rotor with the aim to avoid major problems and to provide long term reliable operation which would minimize cost and shutdown time, and to avoid risk of a major site repair. Based on the study, there were some improvements to the design of the new turbine rotor as follows:

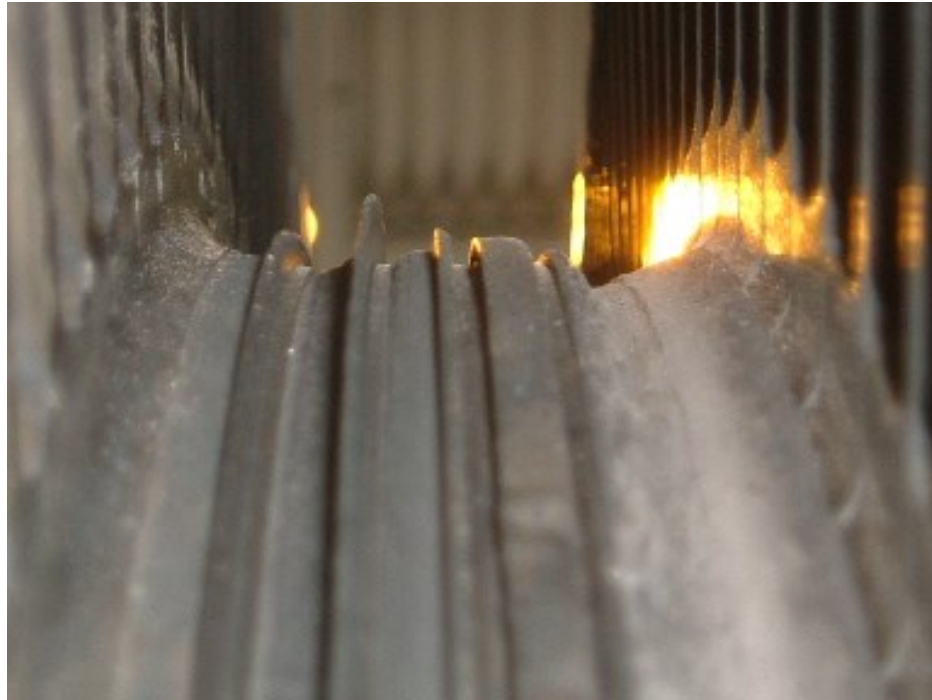
**Figure 3: Erosion and missing seal strips found at inter stage between stage 4 and stage 5 Turbine End side.**

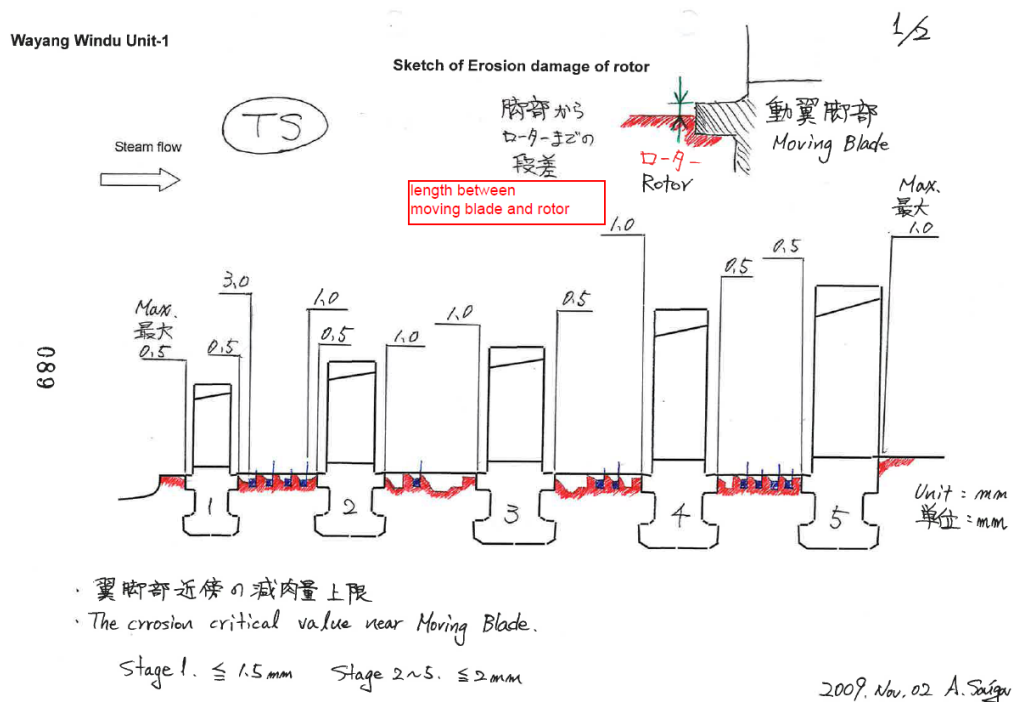
In 2009, the third Turn Around Program for Unit 1 was conducted from shut down on 28<sup>th</sup> October until start up on 11<sup>th</sup> November. The inspection of the turbine rotor revealed that the erosion and corrosion issue at each of inter stage seals of the HP side rotor had become worse. Mostly all “J” seal strips on the inter stage areas of the rotor were missing or damaged. This left few seal strips remaining. At the inter stage areas of the 1st and 2nd stages of the Turbine end side, it was found that the caulking wire had peeled off and only 1 seal strip remained at the inter stage area of the 2nd and 3rd stages and only 2 seal strips remained at inter stage areas of the 3rd and 4th stages. At the 4th and 5th stages only 1 seal strip was missing. On the Generator End of the unit, only 1 seal strip had torn at 3rd and 4th inter stage area. The Fuji engineer recommended to leave it “as it is” and only removed the broken/damage seal strips. Theoretically, the turbine could be operated safely unless the depth of the erosion-corrosion around the platform of the moving blades exceeded the corrosion allowance (ca.) of 2mm. Considering that erosion corrosion seemed to have rapidly progressed from 2006 to 2009, it was a matter of concern that the depth of the erosion corrosion could have reached the limit value of ca. 2mm in a few years. Sketches of erosion inspection mapping are shown in Figure 4 and Figure 5.

**Figure 4: Sketch of erosion mapping at Turbine End side.**

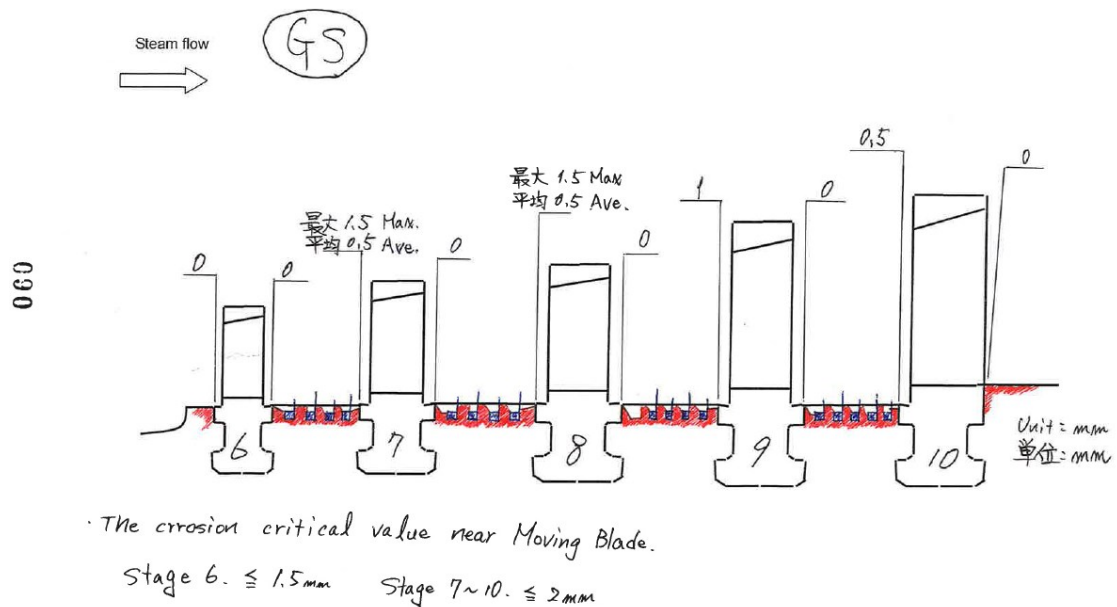
**Figure 5: Sketch of erosion mapping at Generator End side.**

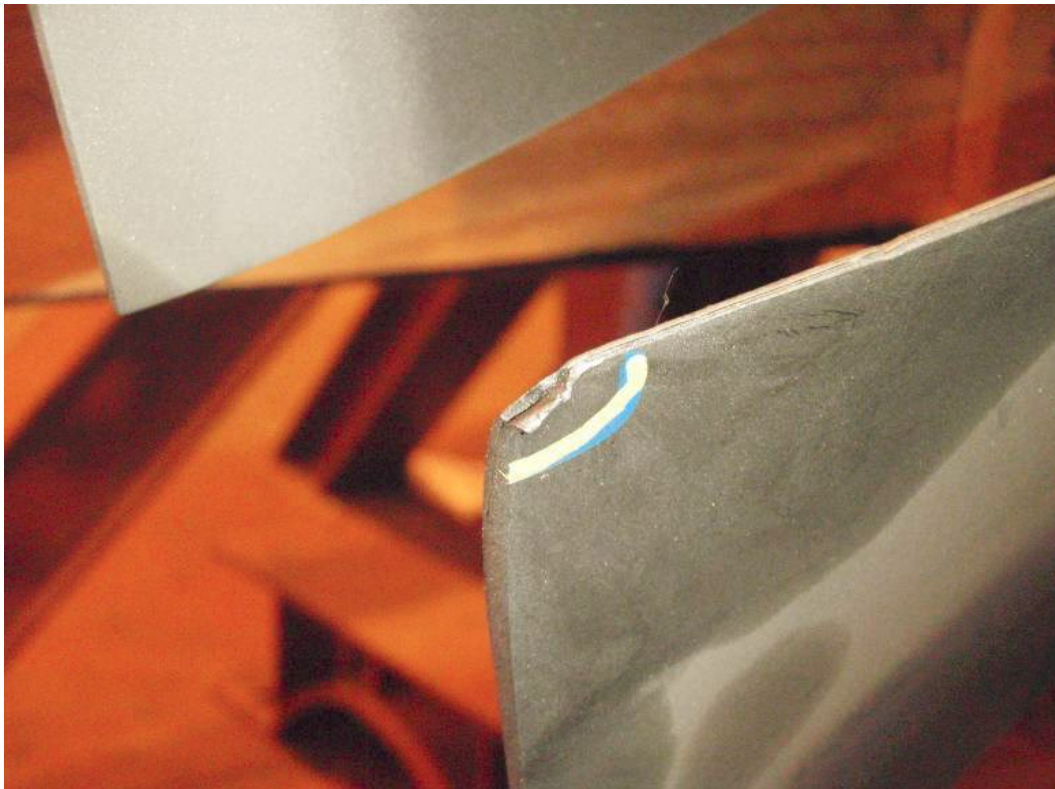
Another inspection result revealed the Co-Cr alloy strips on the last rows of blades (stage 8) to be in good condition with slight erosion on the leading edge and light pitting on the blades. A light dent by foreign object damage (FOD) was also found on the leading edge with missing material on the blade tip (stage 8). Fuji recommended to conduct polishing by sandpaper. Figure 6 shows a small dent found at a stage 8 blade tip of turbine end side caused by FOD.

**Figure 6: Small dent on stage 8 blade tip of turbine end side**

Further engineering review and discussion with other geothermal plant operators and turbine engineers were conducted to study the condition of the Unit 1 turbine rotor. There were some potential causes revealed as common causes to the deterioration of the geothermal turbine rotor. One of the causes was erosion corrosion. Erosion corrosion is a kind of the corrosion accelerated by the steam flow. The degree of the erosion corrosion is affected by many factors such as amount of corrosive impurities, pH of the steam, wetness of the steam, etc. Erosion corrosion is one of the inevitable deterioration mechanisms observed in geothermal steam turbines that have been operated for a period of years. Another potential cause is foreign object damage (FOD). It was suspected that losing materials from the rotor caused the FOD on the blade or turbine rotor parts (as shown in Figure 6) as rocks or hard materials were not found in the main strainer during inspection.

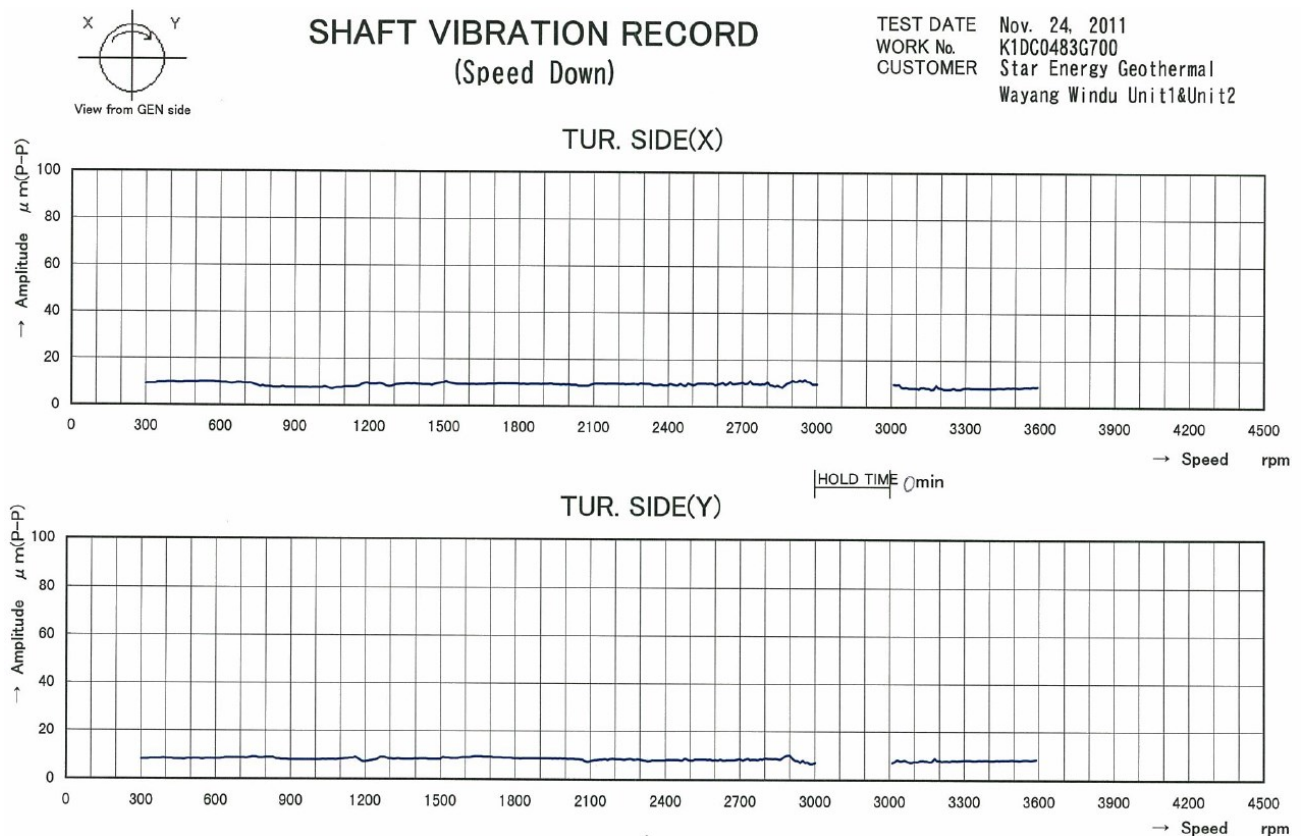
Work Progress and QA/QC for this project were conducted closely and reported by the FE team in the monthly report. For the final acceptance test, dynamic balancing test and over speed test (111% rpm & 120% rpm) was conducted to assure the turbine rotor integrity. The test result showed the vibration level is still far below maximum allowable vibration level limit (80 $\mu$ m P-P) in accordance with ISO 7912-2 standard. Figure 9 shows turbine shaft vibration record measured at turbine end side and Figure 10 shows the new turbine rotor in Wayang Windu Geothermal Power Plant.

**Figure 9: Turbine shaft vibration record measured at turbine end side.**
