Failure Mechanisms Encountered in Geothermal Steam Service

Stephen Rowbotham, Olivia Chung, Monika Ko and Jessica Wong

Quest Integrity NZL Ltd., PO Box 38096, Lower Hutt 5045, New Zealand

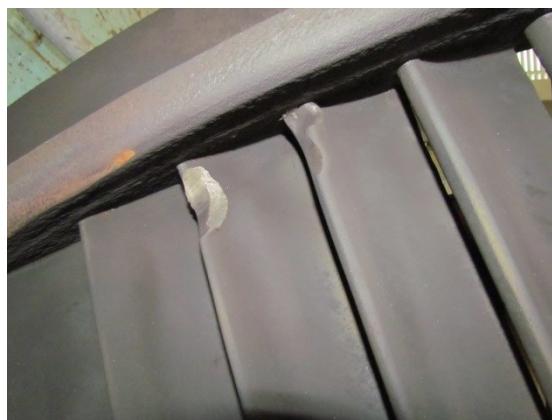
Figure 2: a) Domestic Object Damage. Leading edge of stationary diaphragm vane shown and b) rupture/ cracking associated with foreign object damage.

If the debris is associated with the failure of a component on the rotor with a section of the component released (domestic) the piece is likely to be large and may produce significant damage to the impacted part, see Figure 2.

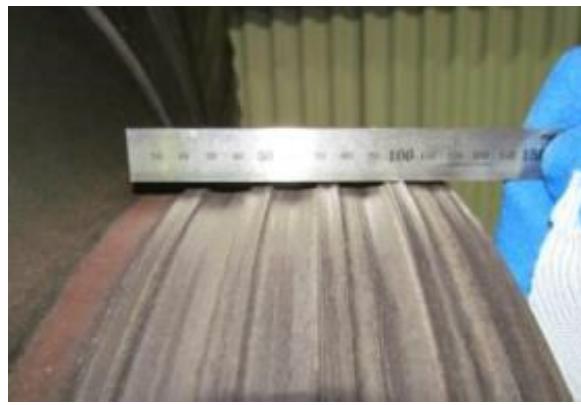
Figure 3: Solid particle erosion to gland seals.

The particulate deposits can lead to blockages to drains which can adversely affect the gland seal areas. If material is lost from the trailing edges of stationary vanes, the steam discharge angle can be affected changing the dynamics of the subsequent blade row together with a loss in efficiency.

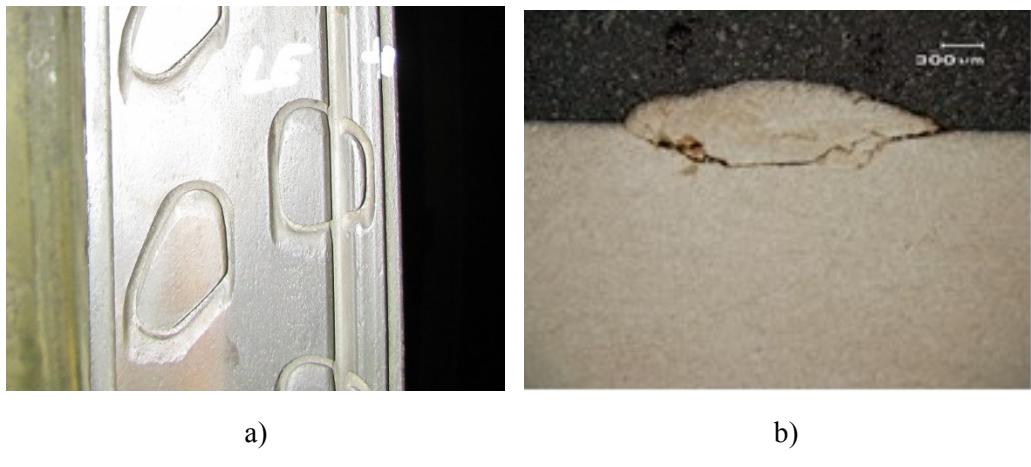
Figure 4: a) Groove cut into coverband by diaphragm seal and b) area of material stiction and subsurface cracking

It can be seen on the lacing wires on the later stages in the steam path where the lacing wire passes through a drill hole in the aerofoil section of the blade. It can also be seen on blade root load bearing surfaces and on the vertical side faces of blades as they move between each other leading to areas of stiction and cracking, see Figure 4b. This mechanism can be the cause of significant damage as failure of the latter stages of blades will liberate larger debris into the steam path (domestic object damage).

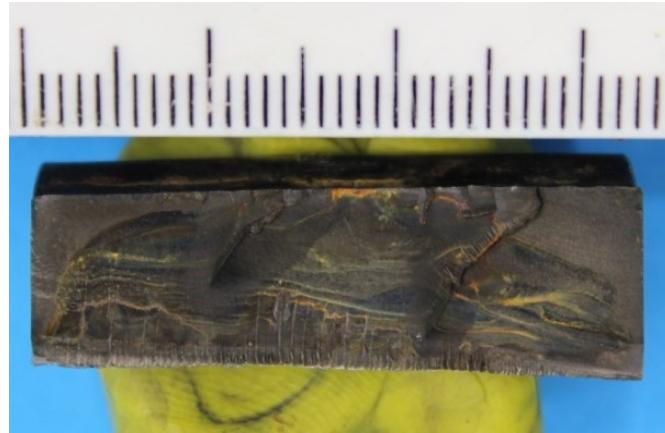
Figure 5: Fatigue failure of blade root fixing. Multiple initiation sites found.

When high cycle fatigue is the main damage mechanism the surface will exhibit a crystalline appearance with beach markings (arrest lines) visible indicating when the cyclic stress cyclic was stopped during operation, see Figure 5. Low cycle fatigue is designated as requiring less than 10,000 cycles to cause failure, it is most commonly found in conventional steam turbines and is associated with thermal gradient changes during start-up /shut down. It can be seen on geothermal turbines but due to the lower operating temperatures and the units being predominately base load the effect is reduced.

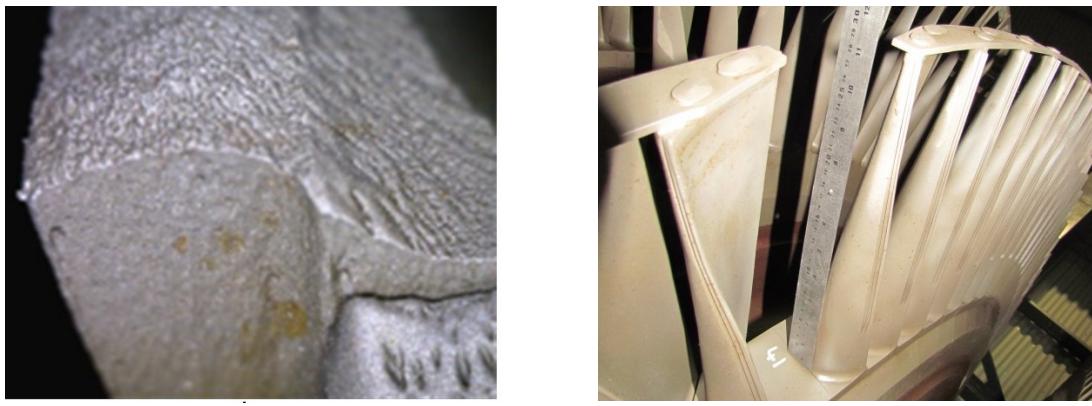
Figure 7: a) Water impact erosion on leading edge of rotating blade and b) water drainage grooves on suction side of leading edge.

After prolonged operation localised loss of material can remove the profile of the drainage grooves. Where this is likely to occur, the addition of an erosion shield (hard facing material inserts brazed into the leading edge on the suction side) should be considered. Erosion shields are normally specified for areas where the water content is such that drainage grooves would not cope with the loading. The erosion shield, normally extends down the leading edge on the suction side to a position where the tangential velocity for the blade is below the velocity where erosion is expected to be generated typically 240 to 250 m/sec, see Figure 8a. If erosion is found below the erosion shield extending the shield on replacement blades should be considered or changing the moisture flow patterns on the diaphragms upstream to alleviate the problem.

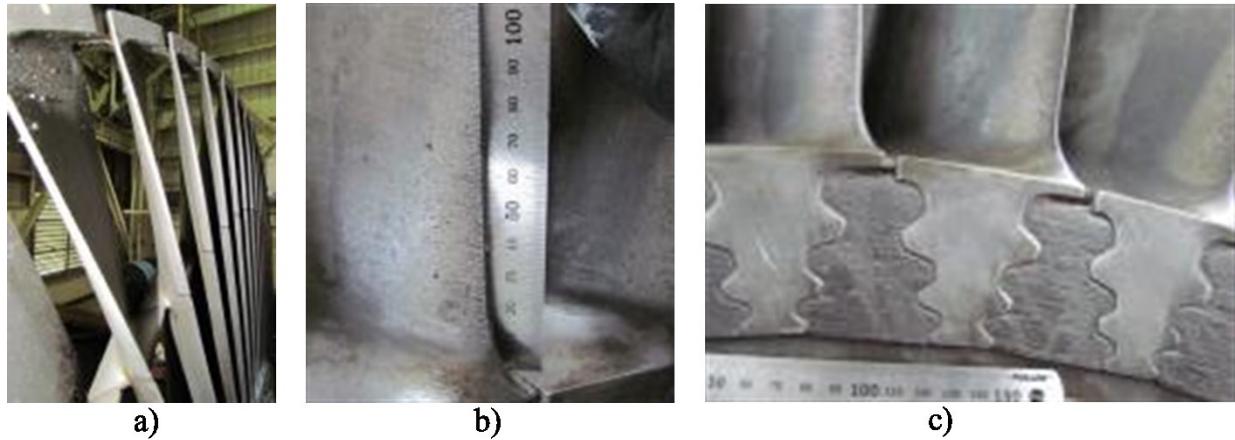
This is normally found on the last stage of blades and occurs on the discharge face of the lower half of the blade suction surface side. The damage is normally seen on the inner diameter a short distance from the root platform and set back from the trailing edge, see Figure 8b.

The erosion is typical of a gouging action, over time the discharge edge will become thinner introducing a stress concentration on the blade near the principal stress location on the blade aerofoil, which can generate a crack and subsequent blade failure. It is important that these areas are inspected to detect any changes in the pattern of erosion damage and the depth / extent.

This is a form of erosion which causes micro ruptures of the material surface as water flows over the metallic surfaces at high velocity. It can be seen on the rotor blade root fixings, see Figure 8c, coverband edges, tenon heads and diaphragm inner and outer ring surfaces. This can affect seals areas which will require repair work to be completed before return of the unit to service.

Figure 8: a) Erosion shield on leading edge suction side, b) trailing edge erosion and c) water wash erosion on rotor blade root fixing.
