Pipeline Failure Analysis of Bending Pipe on the Geothermal Production Well KMJ-X7 in Kamojang Geothermal Field, Indonesia

Achmad Sri Fadli, M.Achyar Karim, Rahmad Harahap¹; Ahmad Taufik²

¹Pertamina Geothermal Energy Kamojang Field, PO BOX 120, Indonesia

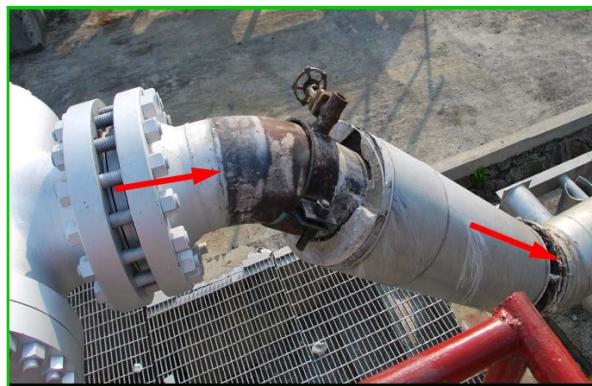
The results of field observations show that there has been a thinning of the elbow pipe rupture location. To overcome this problem the engineers in the field have put a mechanical clamp to reduce steam leakage due to the impact upon the production of steam. The impact is noise exposure, the possibility of losing steam and toxic gas exposure (H_2S). This can be seen in the Figure 4.

Figure 4 shows how the S-bend is located between the upstream and directly connected with the forty-five-degree elbow at the bottom, while Figure 5 shows a hole where the thinning occurred in the HAZ (Heat Affected Zone) and the weld area at the twelve o'clock position.

Figure 4: The figure above is temporary solution with mechanical clamp

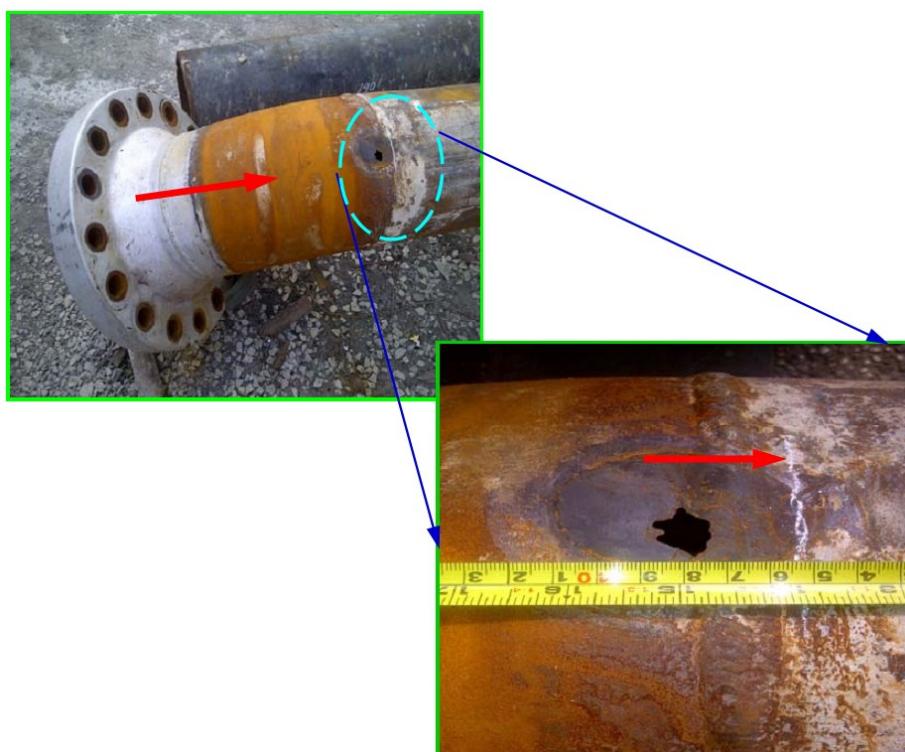
Figure 5: Close-up of the leak rupture

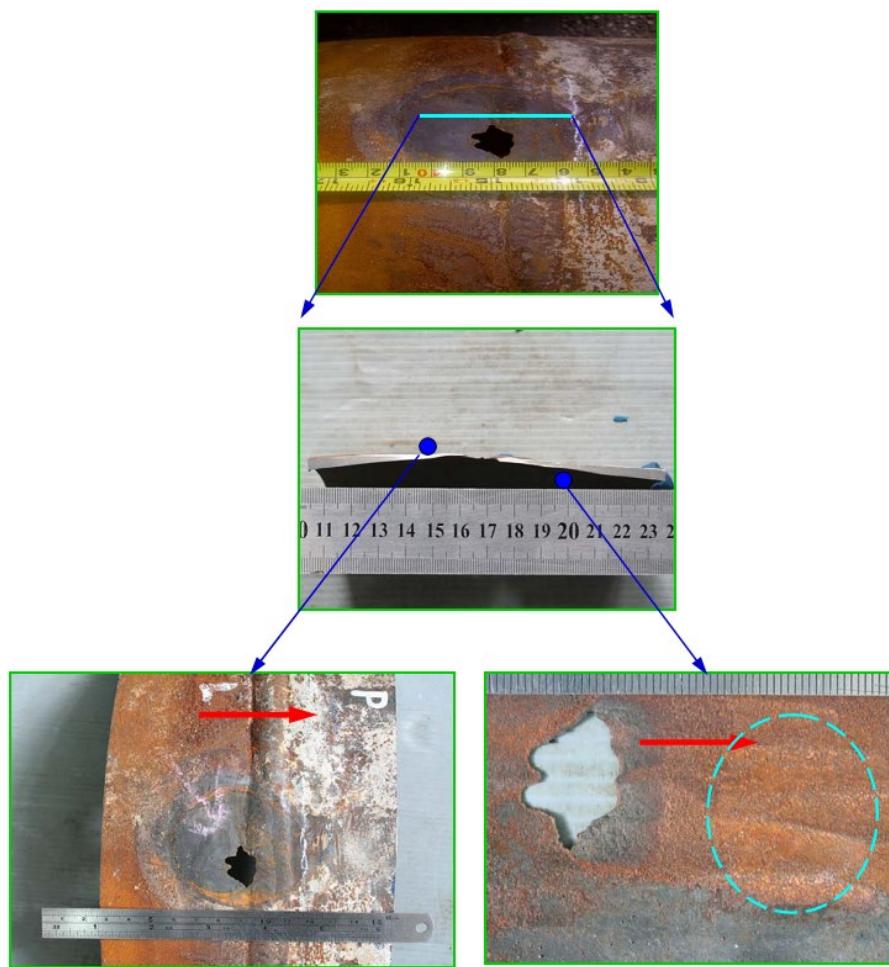
Visual inspection and documentation was carried out on the sample pipe leak in the location as shown on Figure 6, while further observations were carefully carried out in the laboratory.

Figure 6: In the figure above we can see the outer surface and the inner surface of the S-bend is leaking at the HAZ and weld area at the 12 o'clock position. The inner surface looks aside general corrosion is also no indication in the form of trail erosion groove deformation or worn out 10-15 cm to the right of the weld region downstream direction. Also visible is the indication of corrosion products of iron oxide, Fe_2O_3 and Fe_3O_4 yellow brownish on the inner elbow wall (arrows indicate the direction of flow direction of steam)

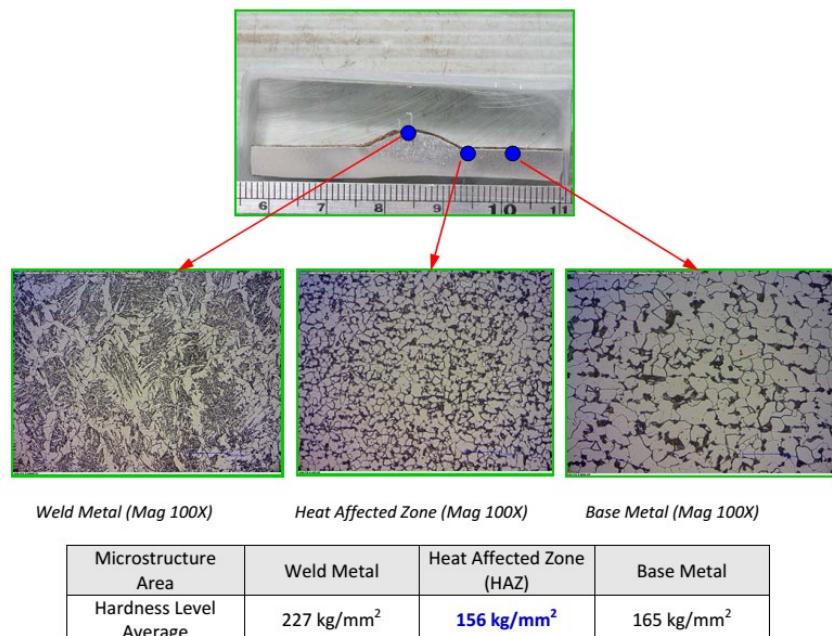
Figure 7. Various types of microstructure as a function of welds.

Weld metal consists of ferrite widmanstatten and acicular and perlite, the HAZ region ferrite looks fine granules and metal visible on the base ferrite coarse grains. Because of the differences in the microstructure of these, differences in mechanical properties were characterized by different values in the table above. It is seen that the structure of the low value of hardness is the value of 156 kg/mm² HAZ and weld metal is highest with value of 227 kg/mm². The metal base is about 165 kg/mm². From the test results, it can be expected that the HAZ is a location that is more convenient eroded by erosion. To see SMYS and test UTS and deformation response of the plastic material, tensile tests were performed and the results can be seen on figure 8.

From the analysis of the microstructure, chemical composition and mechanical testing (Figure 5, 7 and 8), the pipe material and the S-bend is according to the specification API 5L Gr B, so there is nothing wrong with the material and fabrication. The weakening of mechanical strength (hardness) in the HAZ is a logical consequence of any welding process. It is possible in this material to conduct post weld heat treatment (PWHT) after the welding process.

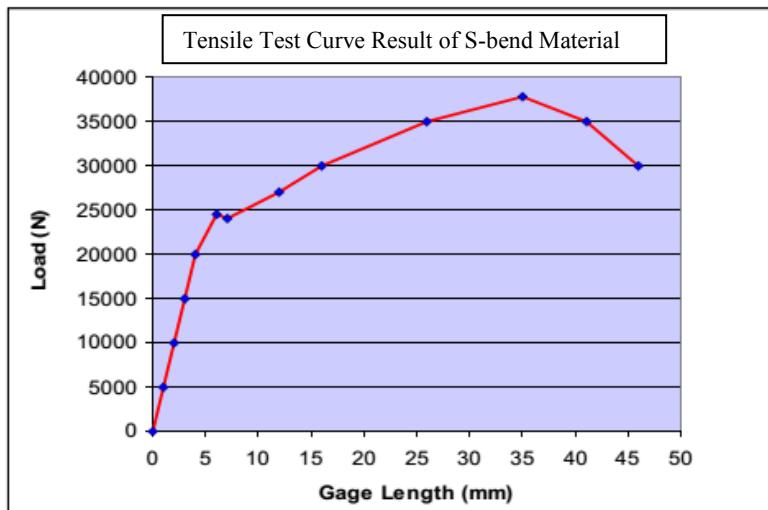
Figure 8. Shows the result of tensile test s-bend material on the elbow

The tensile test results show values of approximately SMYS 296.77 N/mm² (43,000 psi) and UTS around 456.56 N/mm² (66,000 psi) with 31.10% elongation. In general, the pipe material is still appropriate, even exceeding grade specification API 5L Gr B.

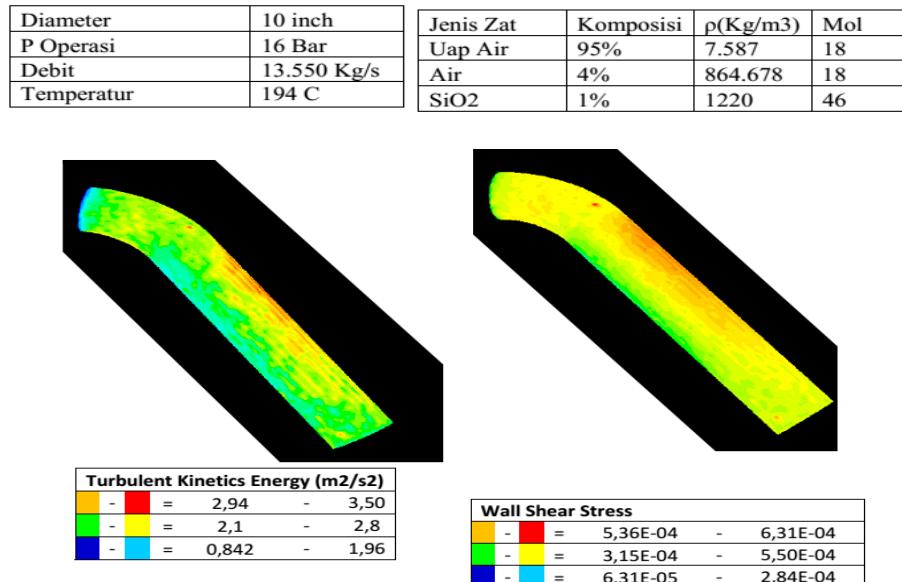
Figure 10. Fluid Flow Simulation Result using FLUENT

From the results of FLUENT program, the turbulent kinetic energy parameters seem to indicate maximum turbulent energy in the elbow area (see profile of the turbulent kinetic energy) with a maximum value of $3.50 \text{ m}^2/\text{s}^2$ and $0.842 \text{ m}^2/\text{s}^2$ minimum. This reflects an increase of 400% of minimum values. Fluent shear stress parameters appear similar to maximum turbulent energy in the elbow area (see profile shear stress), with a maximum value of $6.31\text{E-}04$ and $6.31\text{E-}05$ minimum. This marks a visible increase in the maximum shear stress, at 10 times the minimum value. Furthermore, the prediction of erosion can be seen in the following figure. Previous analytical calculations can be performed: speed vapor is 15.95 m/s , while the critical erosion velocity $V_e = 16.59 \text{ m}$

/ s. Because the fluid flow velocity approaches the speed of erosion, erosion is likely to occur in a very big event, especially the elbow area.

From the analysis of FLUENT, it can be seen that there has been erosion of the S-bend pipe wall, due to erosion of fluid flow as the fluid flow velocity approaches the speed of erosion. This is also supported by the high shear stress values, especially in the elbow area (4 times greater than the minimum value of shear stress). Additionally, the FLUENT analysis obtained a rate of erosion in elbow area of 1.04 mm / year. This value is very high and will lead to the rapid depletion in a relatively short time, resulting in a leak in the elbow area. Detailed finite element analysis and calculation of fluid velocity and erosion can be seen in part-7.

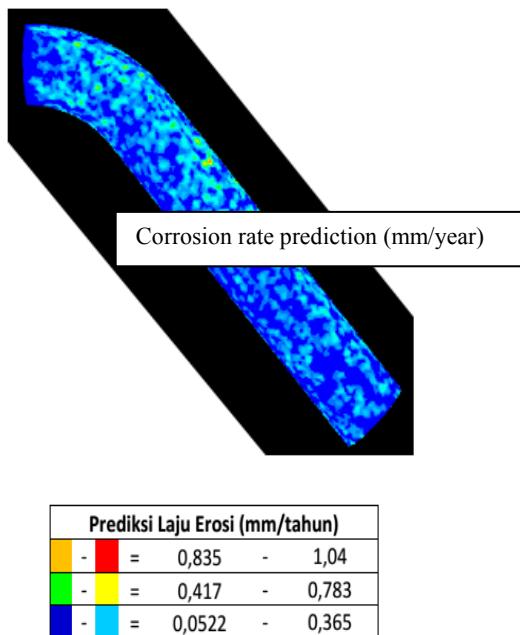
Figure 11. Fluid simulation for corrosion rate calculation in the pipe and elbow

As the results of the program FLUENT predict the erosion rate, it is seen that the maximum value occurs on the elbow area (see profile erosion prediction), with a value of 1.04 mm / year. Furthermore, to study the effect of the amount of sand on the rate of erosion, various silicate compositions were re-entered and the erosion rate was re-calculated. From the curve shown below, if the composition of the silicate sand > 1%, erosion will occur. This is because the fluid velocity > critical erosion velocity.

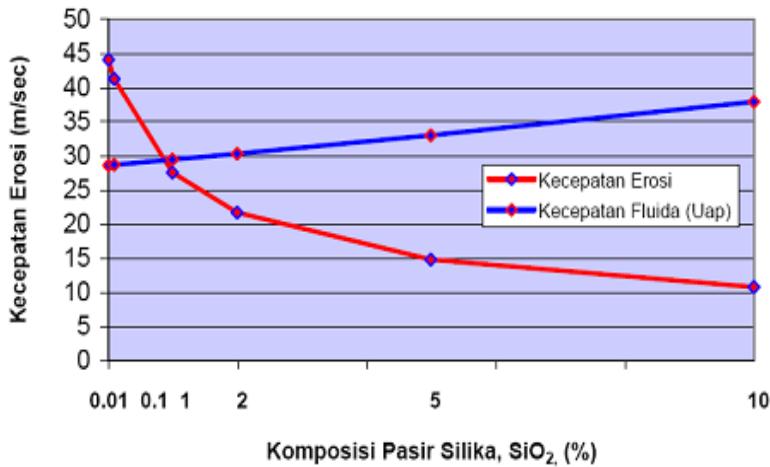
Figure 12. Predicted erosion rate as a function of the silica sand (SiO₂) composition.

The rate of scour is highly influenced by the amount of silica sand present, as well as the grain size of the existing geometry. The abrasive particles, in addition to having a high level of strength, also have a contour sharpness that can generate impact energy so that stress exceeds the strength of the material. FLUENT simulation predicts that the effects will not be felt if the silicate value exceeds 1%, at which time the critical erosion velocity decreased compared to the fluid velocity (Figure 12). Erosion only occurs when the fluid velocity > critical erosion velocity.

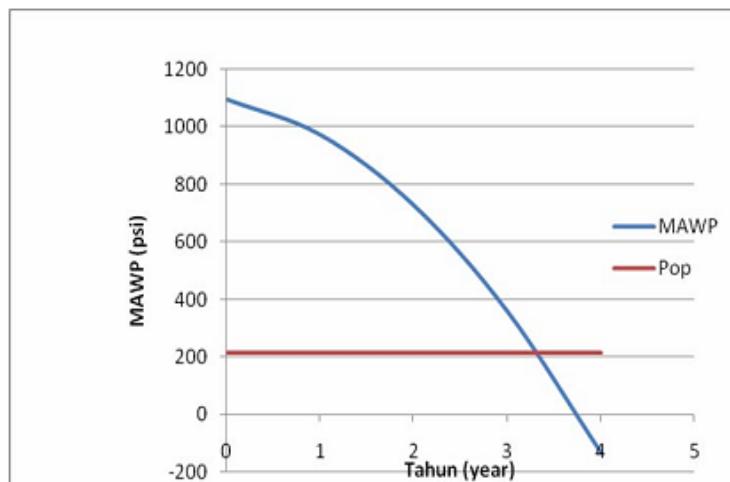
Figure 14. Graph of MAWP Vs Time (year) with Pop 213.3 psi.

From the figure 14 above we can conclude pipe age is about 3.4 years old. At that time operating pressure is already above the MAWP, which means the pipe is not capable of withstanding the vapor pressure, resulting in leakage.

The analysis of the composition of the fluid in the production well KMJ-X7 shows fluctuating SiO_2 content each month. Further information that describes the content of silicate alteration in particular from 2009 to 2011 is not available. However, it can be determined that the primary cause of premature failure (root cause of failure) of the S-bend is the presence of high content of silicate that may occur at the beginning of the pipeline operation. The presence of CO_2 and H_2S content played a role in weakening the material through corrosion mechanism, because the material erosion opened fresh material, thus speeding up the existing cathodic-anodic reaction, resulting in metal loss occurring more rapidly and pipes leaking within 2 years of operation. The presence of brownish yellow fine powder gives an indication of the presence of corrosion products of iron oxide, Fe_2O_3 and Fe_3O_4 on the wall of the inner elbow. So, from the finite element simulation and calculation of remaining life theoretically, it can be predicted that with the silica content of the existing remedy, the operating life of the S-bend of production wells KMJ-X7 is 3.4 years from the first operation (See Figure 14).
