Corrosion and Scaling in Habanero 4 Produced Fluids and 1 MWe Demonstration Plant

Ben Humphreys¹, Claus Christoffersen¹, Keith. A. Lichti², Jessica Wong², Monika Ko² and Robert Dudley²

¹Geodynamics Ltd., PO Box 2046, Milton, Queensland, Australia

²Quest Integrity NZL Ltd., PO Box 38096, Lower Hutt, New Zealand

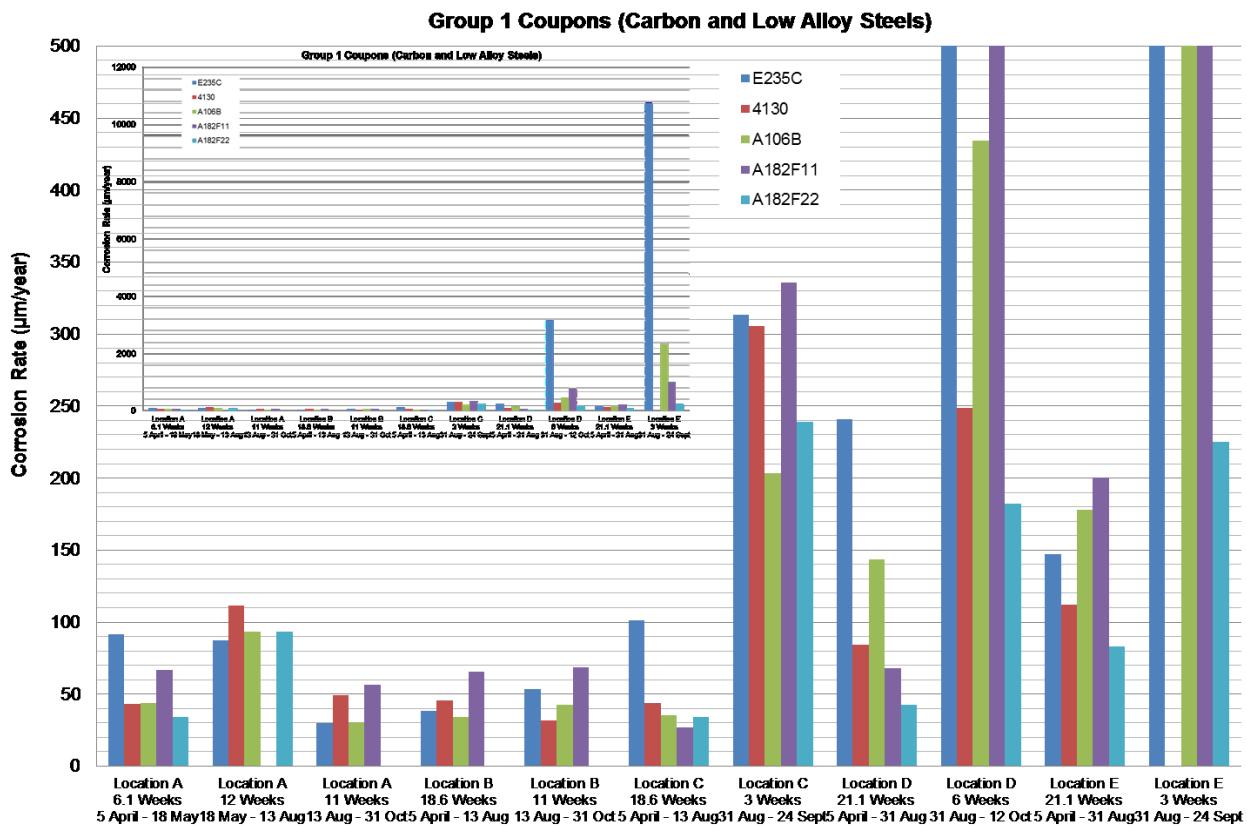
Coupon corrosion results, analysis and observations are summarized in Table 5. The mass loss corrosion rates and pitting corrosion rates are given in Figure 7 through to Figure 10.

Figure 7: Corrosion rates of Group 1 Carbon and Low Alloy Steel coupons. Blank areas indicate coupons that were retained for destructive testing.

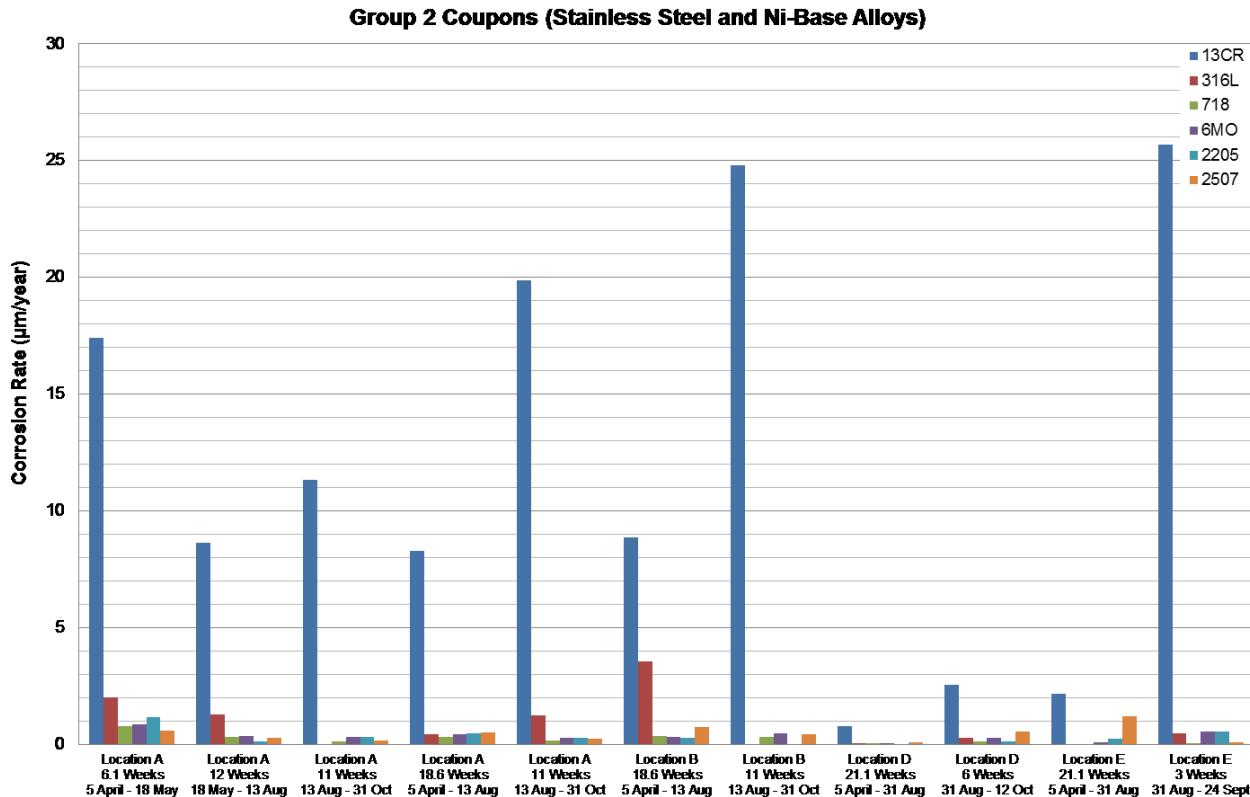
Figure 8: Corrosion rates of Group 2 Stainless Steels and Ni-Base alloy coupons.

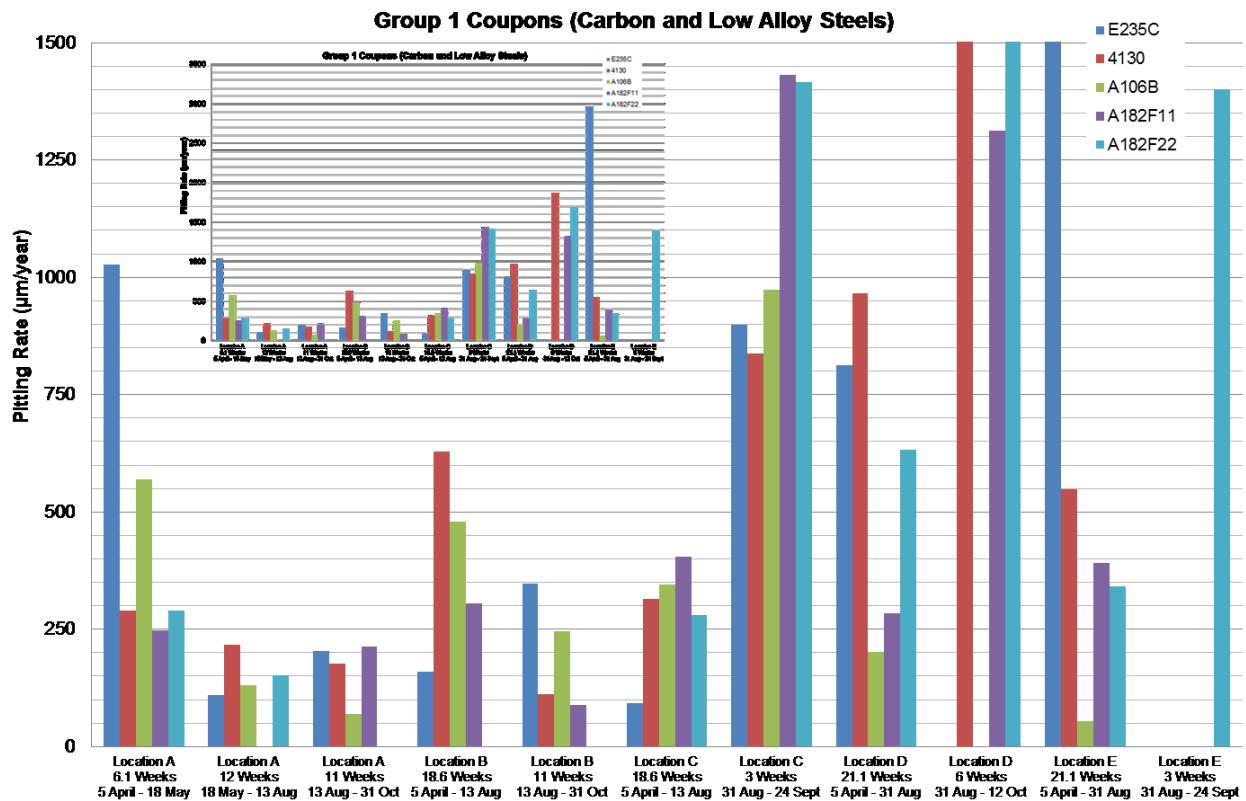
Figure 9: Pitting rate results for exposed Carbon and Low Alloy Steel coupons. Blank areas indicate coupons were retained for destructive testing and not measured

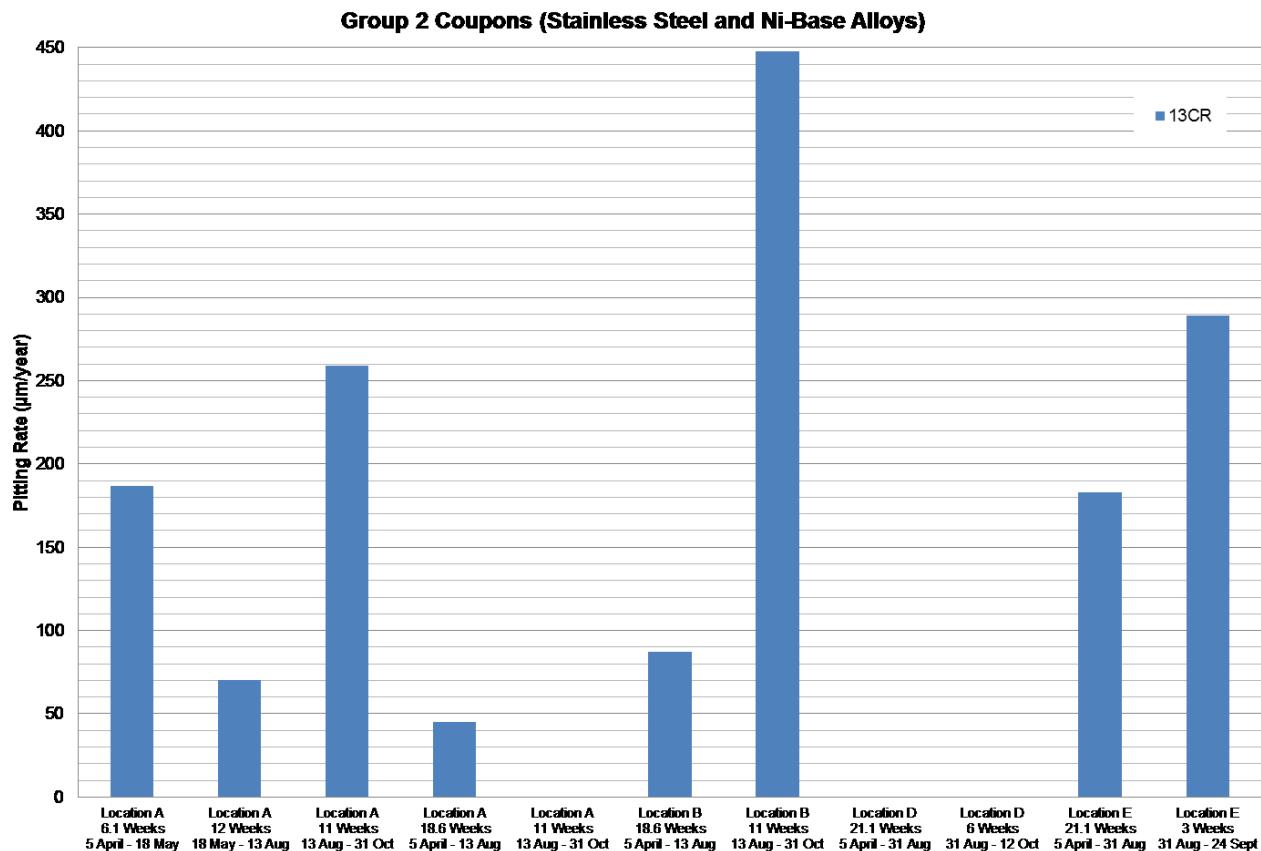
Figure 10: Pitting rate results for exposed 13CR alloys from Group 2 Stainless Steels and Ni-Base alloys. Blank areas indicate areas where no pitting was observed after exposure. Pitting was not observed on the rest of the exposed Group 2 coupons.
