## Discharge Testing of Magma Well IDDP-1

Kristján EINARSSON, Karl E. SVEINSSON, Kristinn INGASON, Vilhjálmur KRISTJÁNSSON, Sveinbjörn HÓLMGEIRSSON

Landsvirkjun, Háaleitisbraut 68, 103 Reykjavík, Iceland

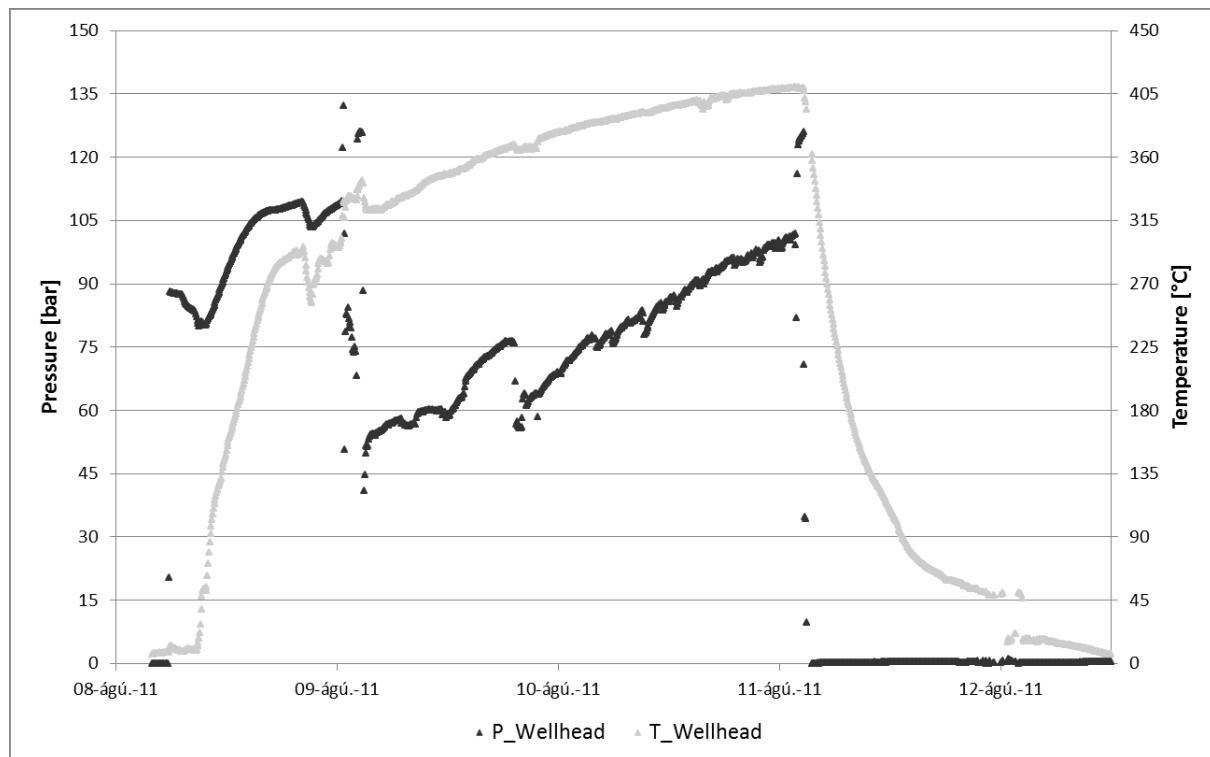
Discharge of Phase IV started on August 11 and lasted for 2 days (Figures 11 and 12). It revealed problems of discharging the well at full flow as the steam carried debris and corrosion residue from the sacrificial casing which resulted in clogged orifices and damaged valves.

Figure 11: Result of measurements in Phase IV. Rising pressure during discharge indicates blockage in the first orifice due to debris

Consequently a decision was made to restrict the flow to 8 – 12 kg/s for the next phase, Fig. 13. Size of valves used for discharge was reduced. Discharge of Phase V started in late September of 2011. Initial problems due to silica scaling in orifices were overcome and eventually led to the longest continuous discharge of the IDDP-1 well or for about 10 months. Results of measurement during the discharge of Phase V are shown in Figure 14 and 15.

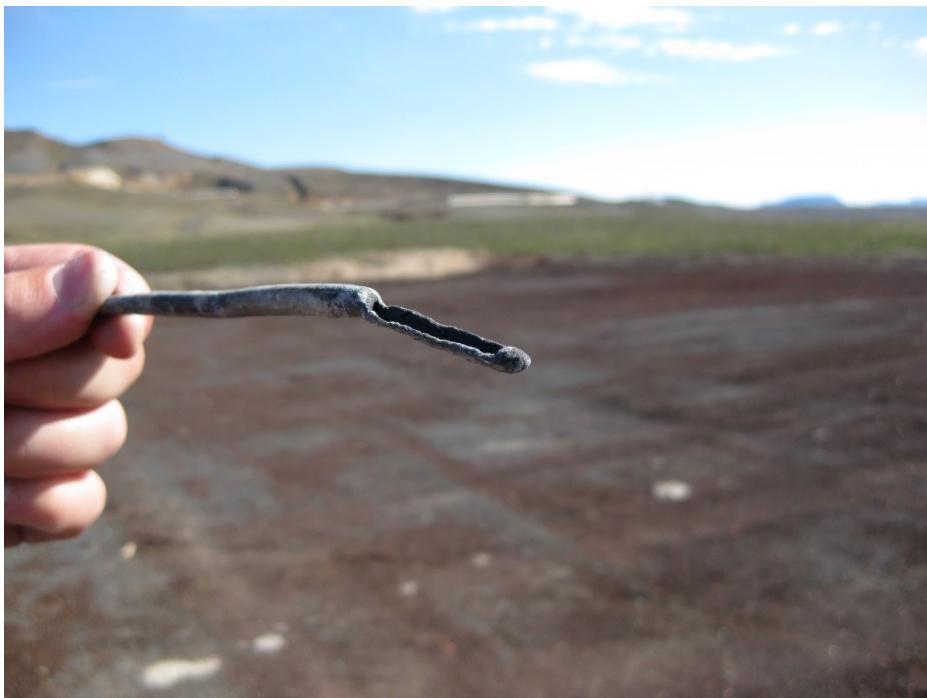
Well head temperature measurements were through a type Rtd Pt100 temperature sensor inserted in a SS316 housing into the stream on the well head. Erosion of the SS housing became a problem during the Phase II discharge testing, Fig. 18. Once temperature logging failed the housing was replaced with an identical one. Different protective housings for the temperature probe were later tried, including a ceramic housing and an Inconel housing with Stellite coating. The ceramic one was identified as a possible alternative to counter the effects of erosion. However, it broke early on probably due to solids entrained with the steam. The Inconel housing was used in the later stages on discharge testing and proved quite robust. For temperature measurements on discharge piping a Type K thermocouple was inserted into a stainless steel housing into the steam flow. Indirect temperature measurements were also used and calibrated using in-flow measurements. The type used was a type K thermocouple on the exterior of the discharge piping and well head.

Figure 18: Eroded temperature sensor housing.

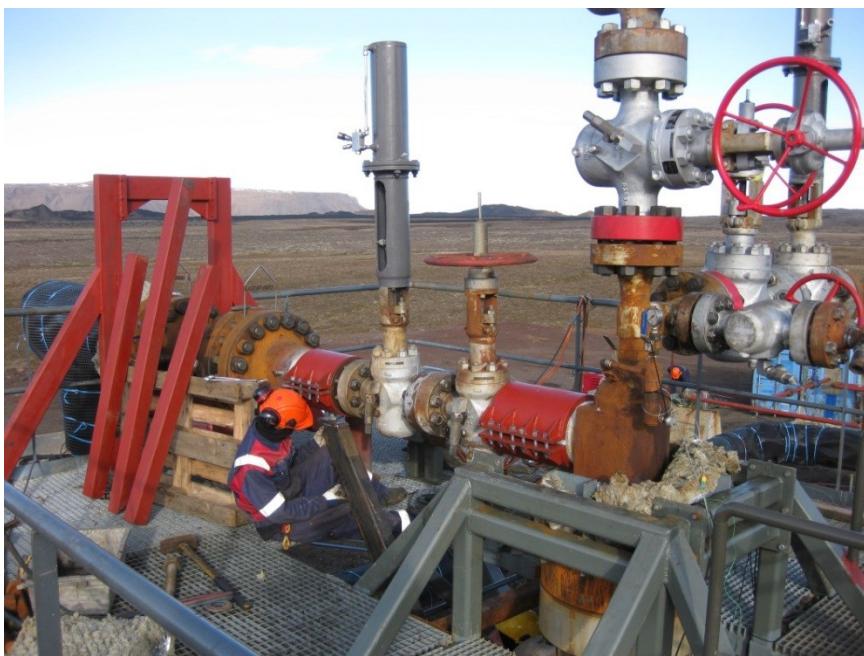
A comprehensive risk assessment was done for the discharge testing of the well. Risks not identified initially were later incorporated into the risk assessment. These included problems encountered with operating the main valve leading to the decision to have two identical master valves in series. After the Phase III and IV discharge testing it was also decided that all flow valves should be in pairs, one manually operated and the other with hydraulic ram. The hydraulic ram valves could be operated faster than the manual ones preventing the gates from eroding, while the valves were being operated. This was also a considerable safety improvement allowing operators to open and close the well from a distance, Fig. 19.

**Figure 19: Flow control valves in pair, one with handwheel, the other with hydraulic ram.**
