Application of Modified Inflatable Packer to Repair Production Casing Leak in Big Hole Geothermal Well

Ali Mundakir, Agus A. Zuhro, Budi Setiawan

PT. Pertamina Geothermal Energy, Jakarta 10340, Indonesia

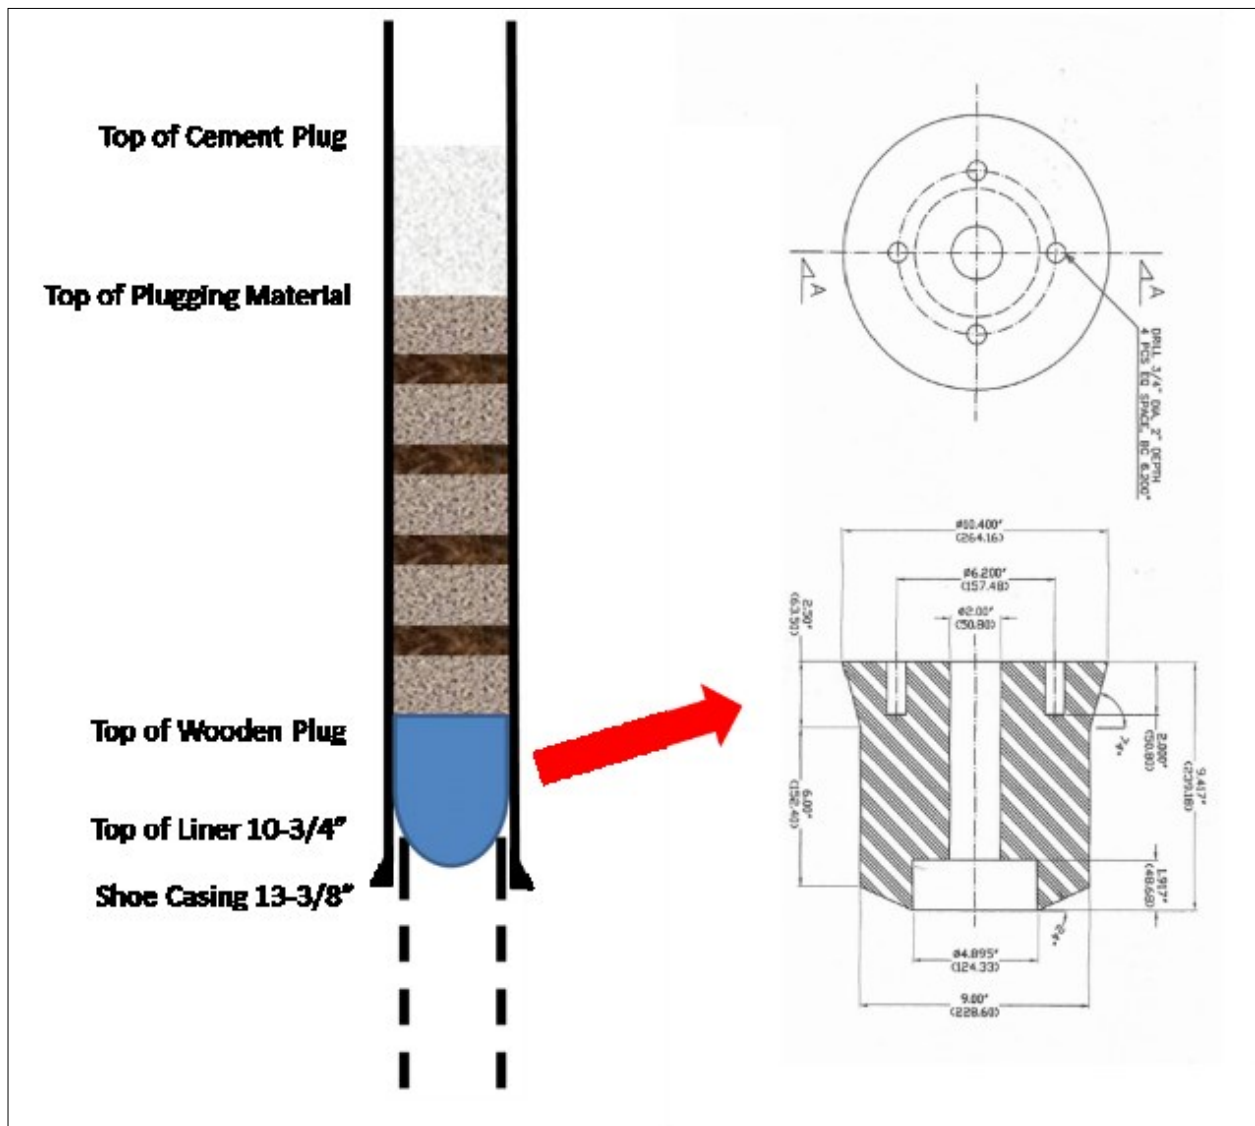
Figure 7. Setting Wooden Plug

However, for the use of wooden plug, there is a bigger risk when making sure that the reservoir zone has clogged by cement. Usually, after the wooden plug is set, then plugging material such as gravel and fine sand are dropped. Sometimes, those plugging materials are dropped between the gap of wooden plug and top of liner adapter 10-3/4". So, it causes the blockage of reservoir zone by plugging materials. The dropping of plugging materials can spend longer time until ideal condition is temporarily closed, and production liner is proved by the fluid level stabilization in production casing. If plugging materials are successfully set on the wooden plug and able to temporarily clog production liner, then another risk which can be raised is the possibility that cement will damage plugging material condition and drop into reservoir zone when cement plug is conducted, so it causes the deceasing or losing of well production capacity.

Besides that, wooden plug is set on Top of Liner 10-3/4" because the upper dimension has OD 10.4" (bigger than ID Liner)

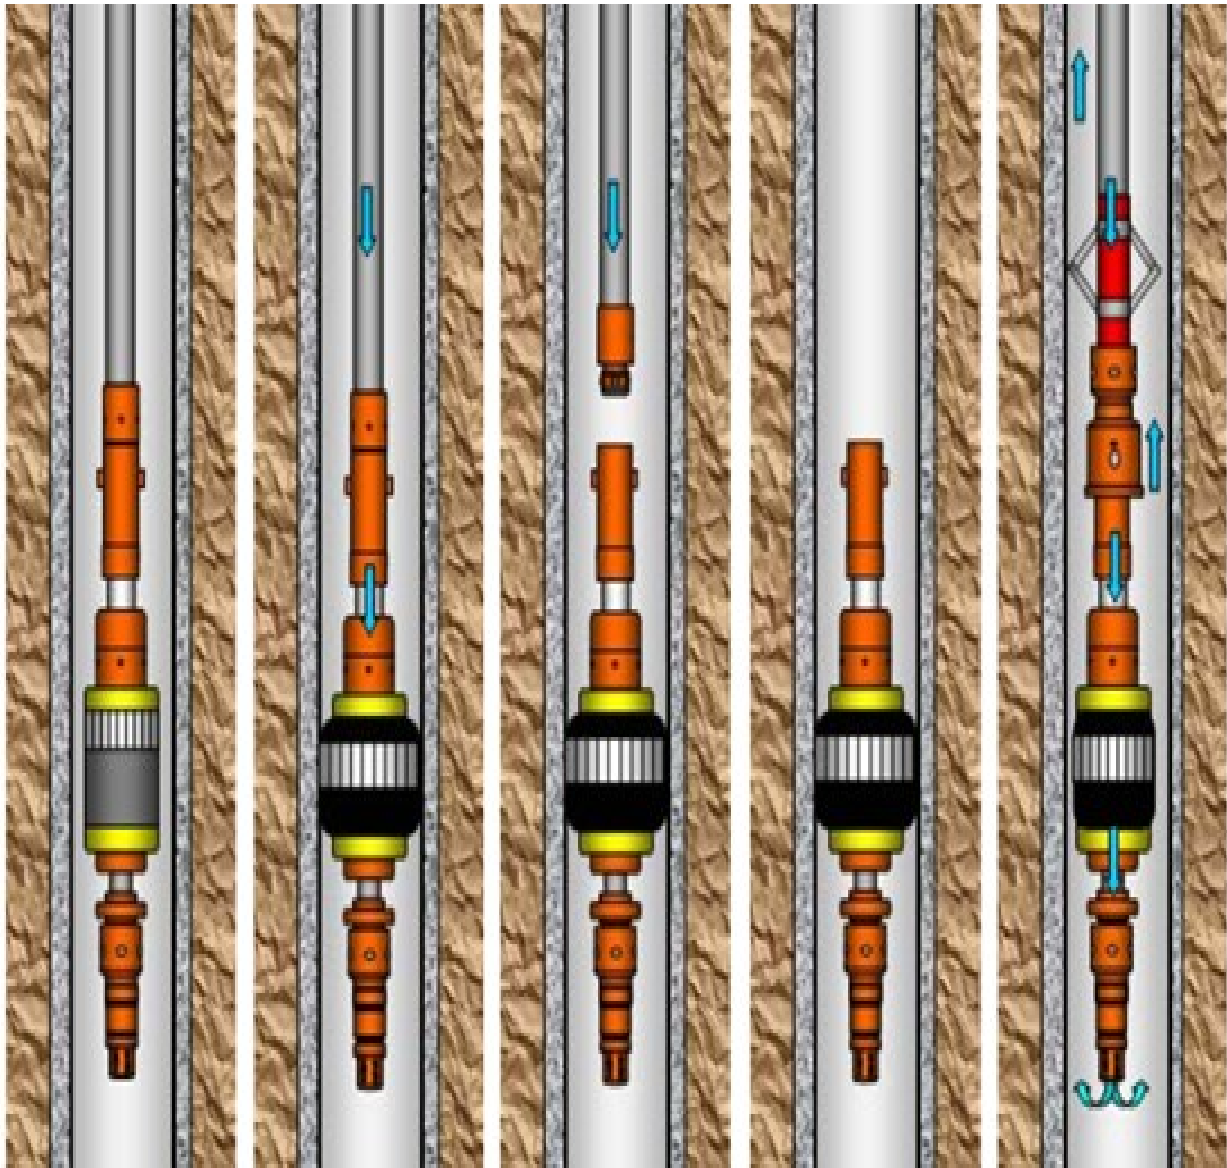
Figure 8. Running & Retrieving Inflatable Packer

The way inflatable packer works is similar to bridge plug, which needs higher pressure on setting, the difference is the bridge plug cannot be retrieved, but inflatable packer can be retrieved by deflating the packer.
