Stuck Pipe Prediction and Avoidance: Invocation of Basic Principle of Standard Methods, Pre and Post Sticking

Douglas MATI

785 - 20117 Naivasha, Olkaria/Kengen

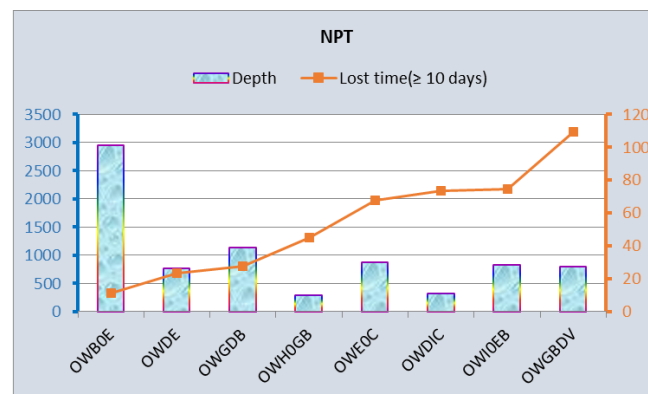
Fig. 10 NPT relative to stuck depth

The NPT arising from stuck pipe was found to range from as low as 1 hour to as high as 2616 hours. Some of the worst times of stuck situation in terms of NPT are as indicated in figure 10. At a depth of 793m, geothermal well referenced as OWGBDV incurred a total loss of 109 days, making it the worst case of stuck pipe situation.

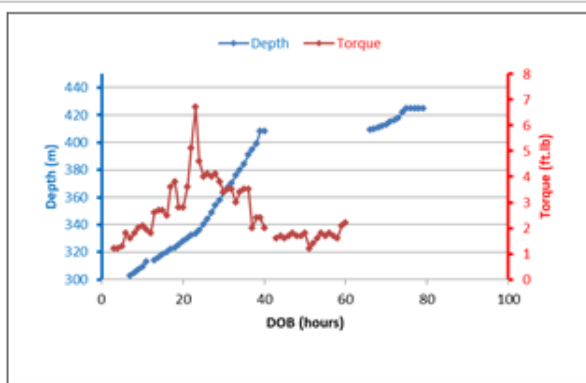
Fig. 11 Drilled depth vs. corresponding torque

The hole had been drilled to 303m and cased at 300.27m. The cement was tagged at 277m (26m above the drilled depth). The drilling on bottom (DOB) was continued to 408m after which the BHA was changed to reaming. The reaming process transcended to last phase of circulation before pulling out of hole (POOH) to change BHA to kick-off. There was no circulation returns for first 16 hours of reaming with water. After introduction of aerated water & foam, there was observed partial returns. After resumption of bottom drilling, the circulation returns was positive for the first 7 hours before the situation changed to partial returns. The

deviation survey was conducted at drilled depth of 425m and lasting for one hour. Soon after the end of deviation survey, it was then realized that the string was already stuck. After several unsuccessful attempts to free the drill string, a back-off was conducted after which running in hole (R.I.H) of 3 1/2" wash pipe was commenced. The fish was successfully tripped out of hole afterwards.

Figure 11 shows erratic but increasing operating torque during bottom drilling and reaming process. The torque developed while reaming the hole was an indicator that situation may get worse if non rotational drilling by mud motor was to be initiated. From figure 12, the average rate of penetration (ROP) was found to be 2.94m/h, an indication of a hard formation. Figure 13 indicates fairly high weight on bit (WOB) during formation drilling and slacked weight on string during reaming process prior to kick off. The flow line pressure indicates rising values (figure 14) shortly before well logging was commenced. That the string got stuck while logging was in progress, is a confirmation to hole pack off situation especially when other discussed factors are put into consideration.

Before running in hole new bit, there ought to have been wiper trip to casing shoe in order to confirm hole condition in terms of cuttings quantity. While tripping in new bit, reaming should have begun at least three stands to bottom. After well reaming, use of maximum circulation velocity was necessary in addition to sweeping the hole with weighted pills. Adequate circulation time and confirmation by use of hole cleaning chart could have changed the course of events. It is therefore very important to check at all times that the hole is cleared effectively by the mud. Monitoring cuttings at the shale shakers is also helpful [2].

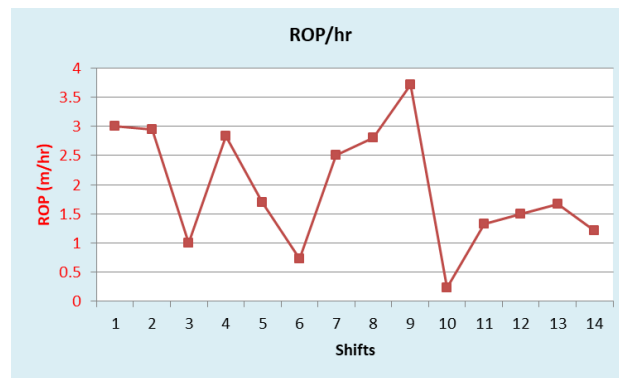
Fig. 15 Rate of penetration per 12-hour shift

This hole had been previously drilled to 453m with positive mud returns and cased at 444.31m. The drilling on cement (DOC) was conducted using slick BHA to a formation depth of 550m after which the BHA was changed to angle building. The wiper trip was run to sound hole bottom and confirmed the well to be free of cuttings. On formation drilling, the drill string got stuck at 568m. At this point, 124m had been drilled before the drill string got stuck and snapped in less than an hour while trying to free it. Figure 15 shows erratic course through which the bit penetrated different formations, a situation that was characterized by alternating high and low rates of penetration.

Between the depths of 450m to 570m, a range within which the drill string was stuck, the alternating medium hard and medium soft formation of basalt and tuff bearing clays, quartz, calcite and pyrite was depicted. Based on the drilling data and that of formation as described, it is indicative that dog legs could have developed as rate of penetration (ROP) erratically changed through varying rock hardness. The immediate failure of the drill string as soon as string pick up was attempted is another indicator to that fact as string over pull occasioned by dog legging of the hole was very likely. Excessive dog-legs cause key seats, rotating torque and trip drags among other hole problems. The occurrence of dog leg profile leads to rapid change of drill string tension and compression every 1/2 turn which accelerates fatigue wear [4].

When running in hole, it is essentially important to do so in such a manner that at no point is more than the BHA weight slacked off at a tight spot. In this case, the guidelines as prescribed by the stuck pipe handbook [2] are that, making use of minimal BHA configuration changes is critical. Frequent reaming of the hole section is highly recommended and avoidance of prolonged circulation across soft overlaid formations. In the planning of directional wells, dog-leg control programme should be included and dog-leg limits established to prevent drill pipe fatigue. The driller should be advised on the maximum dogleg tolerances at respective depth intervals [4].

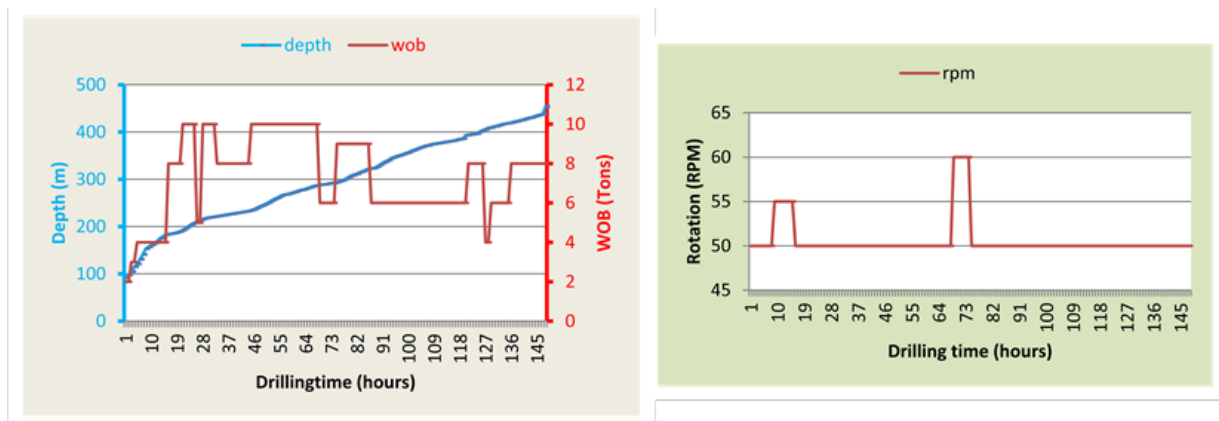
Fig. 16 Depth progression relative to WOB.

Figure 16 shows the continuous bottom drilling and the corresponding WOB which exhibited erratic behavior within the range of 10 tons at maximum and 2 tons on the minimum. This is seen to be in tandem with changing degrees of rock hardness as sampled through lithological analysis. The string rotation was largely constant at 50 rpm over the same period as shown in figure 17.

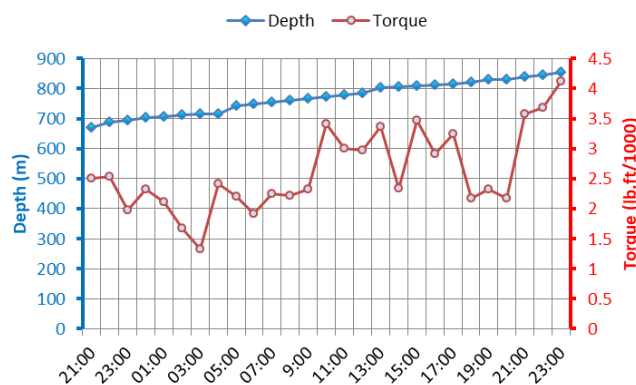
Fig. 18 Depth/ Torque relationship before stuck pipe

This hole had been drilled to 855m with full circulation returns and later cased at 852.59m. After cementing, the top of cement was tagged at 607m and DOC thereafter. A cement column of 248m had been drilled using water before changing to aerated water and foam on bottom drilling. At 871m, the drill string was stuck i.e. 18.4m below the casing shoe. In view of the cement column that had to be drilled, the hard cement blocks that had caked along the casing wall was possibly dislodged by the string vibrations and settled above bit, hence the cause to stuck string. Figure 18 illustrates the gradual rise of the string torque as the bottom drilling progressed to 871m. The instant rise of torque at or near the stuck point demonstrates the possibility of build-up load of uncleared cement and formation cuttings around the bottom hole assembly.

Application of the right cement slurry properties and accurate annulus volume calculations that limit the casing rat hole length to minimise the source of cement blocks. Sufficient curing time for cement before attempting to drill out must be strictly observed. Tripping in hole the slick BHA for drilling out cement should be conducted at relatively slow speeds prior to casing shoe depth or the plug depth. Reaming the casing shoe and open hole plugs thoroughly before drilling ahead is extremely necessary [6].

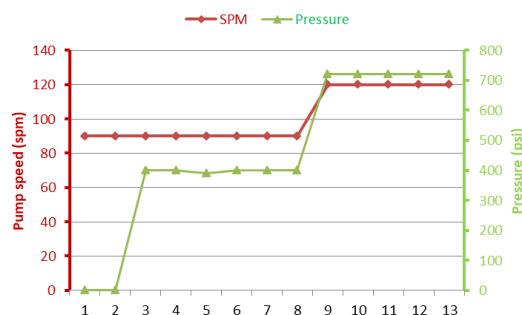
Fig. 19 Water pump speed and corresponding flowline pressure

This well had been drilled to 764m, after which circulation was conducted for three hours. While POOH, there was detected resistance to upwards movement of the string at 40m above bottom. Circulation to unload the wellbore was undertaken and constant fluctuations in pump pressure were noticed. One hour later, while still circulating, an over-pull of 40k lbs. was observed. As efforts to unstuck the drill string progressed, the aerated water and foam was introduced but no circulation return was achieved.

In this instance, drilling through chemically reactive formations which seems to be the case here required the right concentration of inhibition additives in oil-based mud (OBM) and water-based mud (WBM) such as salts (KCl, CaCl), glycol and polymer. [2] When shale absorbs water and swells into the well bore, it narrows down the hole diameter and make it very difficult to POOH. This happens when drilling with an incorrect mud specification. The use of inhibited mud system could have been helpful and consistently maintaining the mud properties. The addition of various salts (potassium, sodium, calcium, etc.) could have reduced the chemical attraction of water to the shale. Several wiper trips or reaming may have helped in the event that the shales started swelling. The frequency should be based on exposure time or warning signs of reactive shales and ensuring that the hole is adequately cleaned to remove excess clay balls and low gravity solids [2],[3].

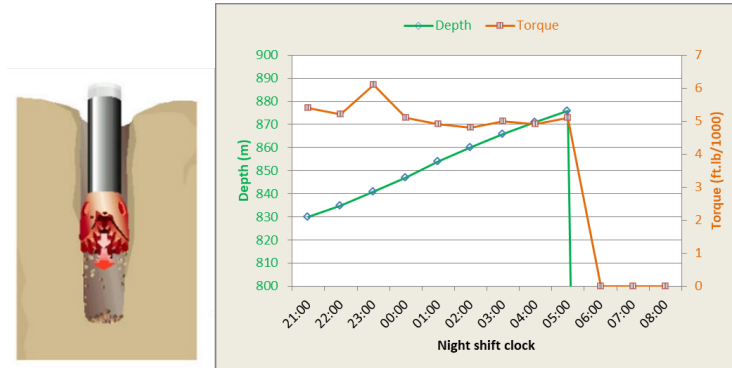
Fig. 20 Illustration of a tight hole [2]

After attaining 1275m, there was change of drill bit. The previous bit (re-run) had drilled 95m in 50 hours with positive circulation returns. While R.I.H new bit, there was experienced a sudden set down weight at 1208m and shortly after, while circulating prior to initiating reaming process, the drill string got stuck.

Drilling a long column of hole or drilling through hard abrasive rock wears the bit and the stabiliser gauge and results in a smaller than gauge hole. Figure 20 is an illustration of a tight hole. The working torque with respect to depth progression before change of bit is shown in figure 21.

Estimation of the possible occurrence of under gauge hole based on the bit condition as soon as it's been tripped out of hole is very important. Slow trip in of drill string before BHA enters an under gauge section is highly advisable. Reaming of the hole could have been initiated as early as possible from the point of projected under-gauge section. The use of under gauge roller reamer is worth consideration in such situations.

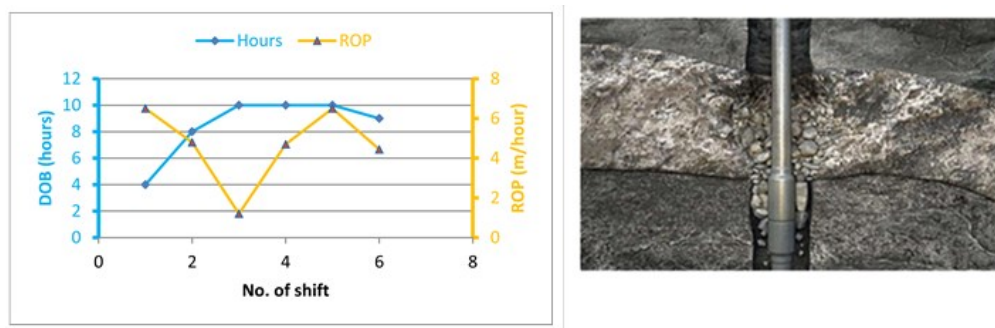
Fig. 22 Rate of penetration in relation to drilling hours

In the course of drilling of this well at the depth of 185m, the drill string got stuck while making up drill pipe. The crew managed to free the string after six hours of efforts. At a depth of 204m, there occurred another stuck pipe incident which lasted for one hour. The bottom drilling progressed with relatively high torques to 290m when the drill string got stuck again. There had been observed substantial amount of particles and sand with increased mud weight. While the circulation returns was partially received on the surface, there can be seen non uniform ROP possibly due to changing formation as seen in figure 22.

In the three instances of stuck pipe at 185m, 204m and 290m, the hole pack-off due to unconsolidated formation is the most probable cause. This usually happens when little or no filter cake is present as illustrated in figure 23. The un-bonded formation cannot be supported by hydrostatic overbalance as the fluid simply flows into the formation. Sand or gravel then falls into the hole and packs off the drill string [8].

Use of high vis/weight sweep to clean the hole off cuttings. The establishment of adequate filter cake to help stabilise the formation would have been a better approach. Seepage loss can be minimised with fine lost circulation material. There could have been controlled rate of penetration in the suspected zone to allow time for the filter cake to build up. Control of surge pressure by starting and stopping pumps slowly and slow working of the string is necessary too in such conditions [9].

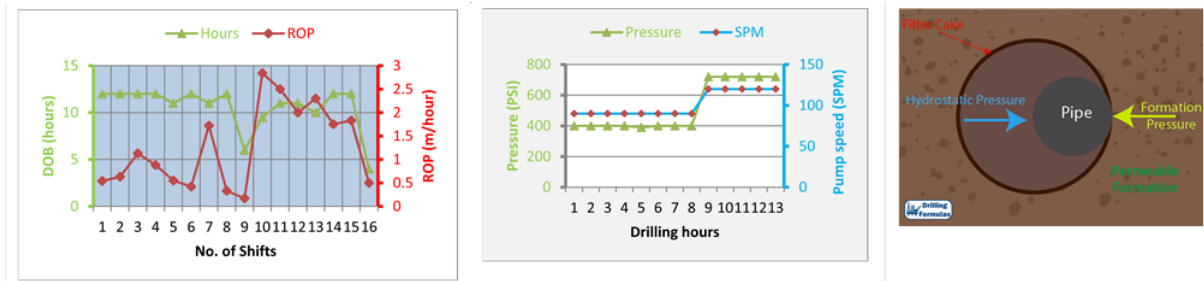
Fig. 24 ROP trend with shifts

In this case, the hole had been drilled to 748m with aerated water & foam. Circulation returns was received on the surface. Afterwards, the BHA was changed from kick-off to angle building, with new bit and two stabilizers. While tripping in hole new drilling assembly, an obstruction was encountered at 672m, i.e. 76m above the drilled depth. Reaming of the hole was proceeded with intermittent repair works of booster compressor for further 42 hours. The bottom drilling resumed and lasted for 13 hours with positive circulation returns. The drilled depth was 811m at rate of penetration (ROP) of 5.27m/hr. At a depth of 811m, the drill string got stuck immediately after the pipe connection. The string could not be rotated but could slightly be worked up and down. The string was suspended at 420 ton hook load, closed the pipe-ram and annular BOP and maintained the pressure at 600 psi in the drill string for three hours. After opening the rams, the well discharged and there was immediate drop in hook load from 420 tons to 160 tons. The string was finally free after 28 hours.

Figure 24 indicates the fluctuating but rising torque with drilling time. The pump strokes seems to have been increased at some point and corresponding rise in stand pipe pressure realized as figure 25 shows. Following the flow of events, differential sticking (mud weight in the hole being more than formation pressure) was the most likely cause to this stuck pipe incident. Having the drill pipe stationary during the pipe connection might have led to filter cake developing around permeable zones and the drill string, thus increasing the potential of getting differentially stuck as figure 26 illustrates. [2],[4].

Differential sticking occurs when the drill string is held against the well bore due to pressure difference between hydrostatic and pore pressure. At the first signs of the drill string torqueing up, the pump strokes should be reduced by half [8]. This leads to pressure drop in the event of hole pack-off. The weight of mud is best kept at the required minimum for hole stability and for reduction of filter cake thickness in high formation pressure zones, and reduction of down time while making up pipe connections and deviation survey runs[10],[11].
