Fitness for Service Assessment of Geothermal Steam Turbines

Stephen Rowbotham, Sean Norburn and Cole Davis

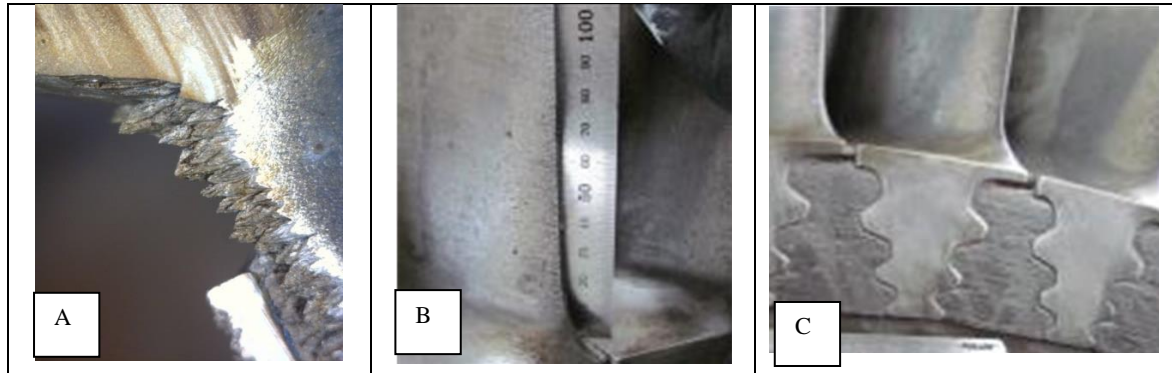
- Moisture -impact erosion. This manifest itself mainly on the leading edge (suction side) of rotating blades near the outer diameter of the blades. The damage is generated by impact of water droplets on the surface of the blade and is similar to cavitation attack, see Figure 1 A.
- Trailing edge erosion. During low load operation the dual phase flow (steam and water) can recirculate onto the trailing edge of the last stage blade from the exhaust casing. The damage is found just above the platform on the suction face of the last stage blade, see Figure 1 B.
- Water washing erosion. This form of damage is generated when water flows over the material surfaces at high velocities. It can be seen on the disc blade fixings while the 12 Cr martensite steel blades stand proud as these are slightly more resistant to the mechanism, see Figure 1 C.

Figure 1. A -Water Droplet Erosion on leading edge of blade. B-Trailing edge erosion. C- Water washing of disc steeples

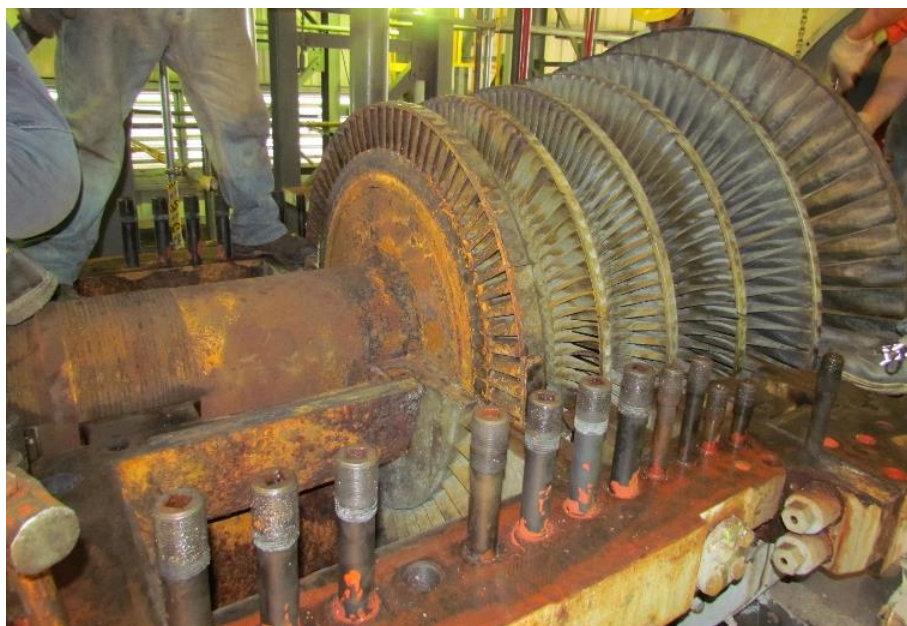
Typical appearance of a rotor after lifting of the top casing is shown in Figure 4. Condition assessment of this single flow rotor found material wastage on the crest of the disc fir tree of the last stage blade through an erosion/corrosion damage mechanism of the flash cavitation /wire drawing type, see Figure 5.

Figure 4. Typical appearance of a single flow turbine after lifting top casing

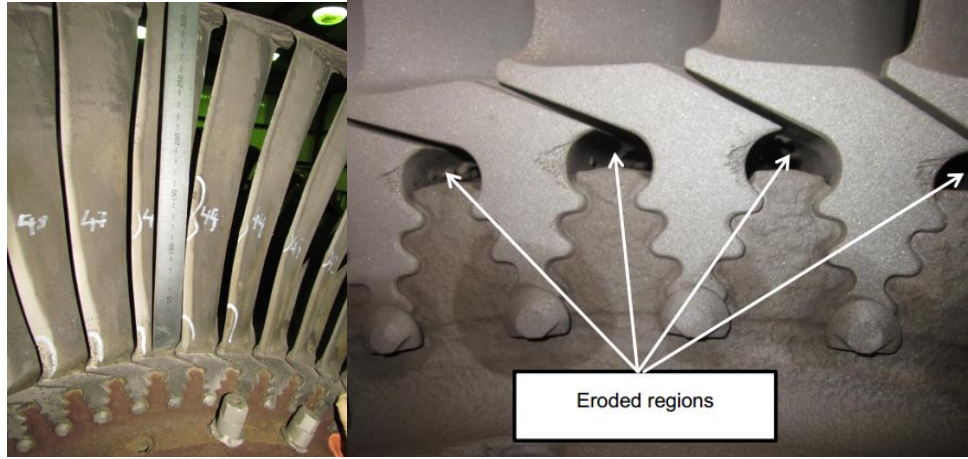
Figure 5. Appearance of rotor before (left) and after cleaning (right) showing material loss from top of disc blade fixing crest due to flash cavitation/wire drawing erosion.

Concerned that the loss of material from the top hook would compromise the blade fixing a fitness-for-service (FFS) was completed prior to returning the unit to service. The objectives of the FFS were to:

Comparing the degradation recorded during the condition assessment inspections the rotor should achieve the operating life required to enable a replacement rotor to be sourced, manufactured and installed.

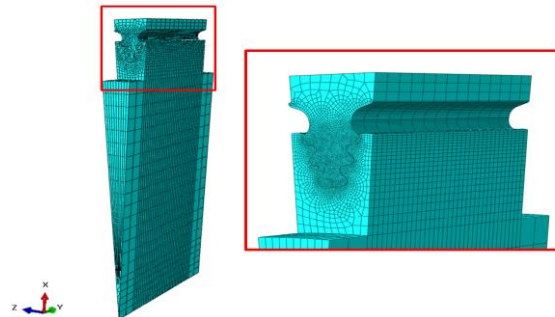
From the geometry model the disc in question was isolated and the degradation to the top crest input into the model. The objective being to determine how the stress state in the disc changes due to increasing presence of erosion/corrosion to the crest of the disc steeples and at what point the blade would be released. The model was meshed with a swept/structured mesh with second order hexahedral elements (20 nodes), with refinement at the areas of anticipated high stress (roots of the disc steeples hooks), see Figure 7. The analysis ranged from the current condition with remnants of the top hook to when the top hook was removed completely and all the loads were applied to the bottom two hooks.

**Figure 7. Modelled geometry with erosion damage taken into account.**

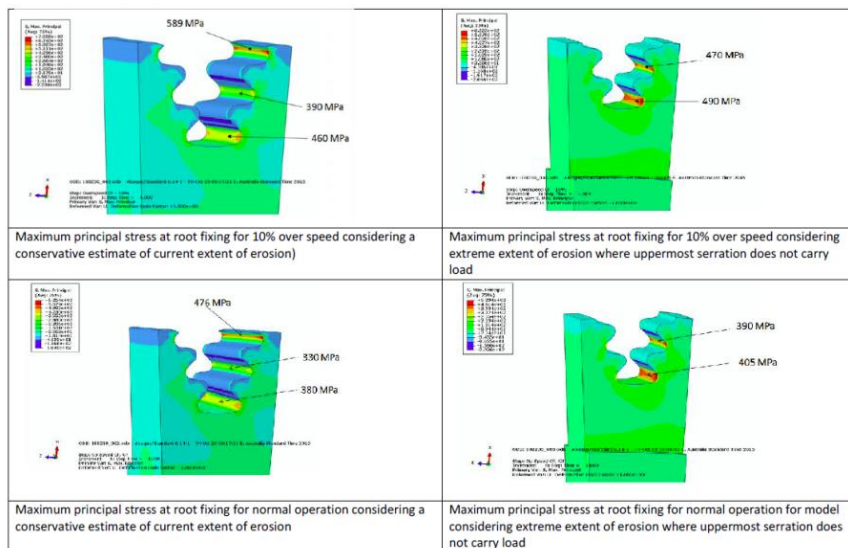
The peak stress calculated by finite element analysis using the generated model that considered a conservative estimate of the current condition of the top hook erosion/corrosion was 563 MPa (von Mises) and occurred at the uppermost serration of the blade root fixing, see Figure 7 and Table 5. This high stress was primarily due to the loss of material at this location.

Figure 8. Peak stress found at various erosion states of the top hook at 10 % overspeed and normal operation.

Given the material properties shown in Table 4 for the rotor material 3.5NiCrMoV and comparing the peak stress indicated by the analysis it is considered that the disc could be operated at normal operating conditions in its current condition even when the top hook was completely lost.

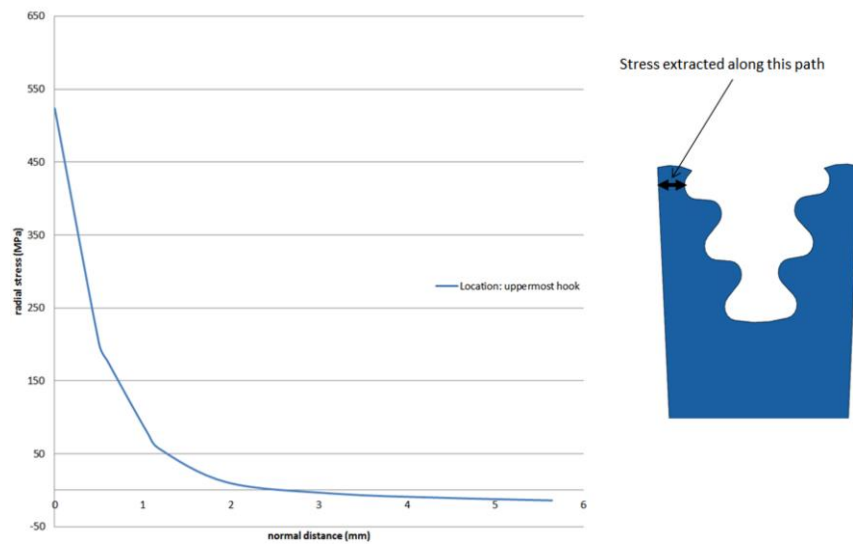
The stress profiles for the conservative estimate of the current state of erosion and the extreme state of erosion where the uppermost serrations have eroded away are shown in Figure 10 and Figure 11 respectively. It should be noted that only mechanical loading was considered for the fracture mechanics assessment. The assessment has not taken account of any thermal stresses that may be generated during a start.

Figure 10. Radial stress as a function of normal distance from peak stress concentration at uppermost fir tree hook for conservative estimate of current corrosion.

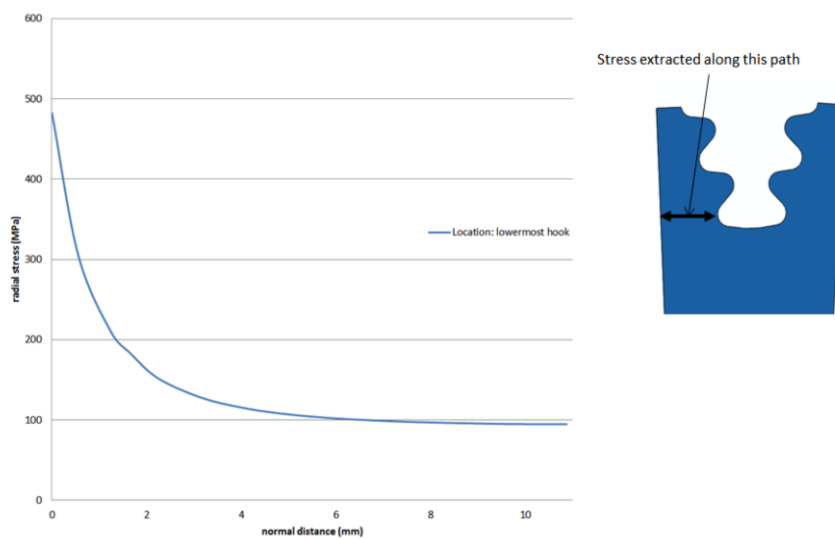
Figure 11. Radial stress as a function of normal distance from peak stress concentration at lowermost serration for extreme extent of erosion where uppermost serration is no longer present

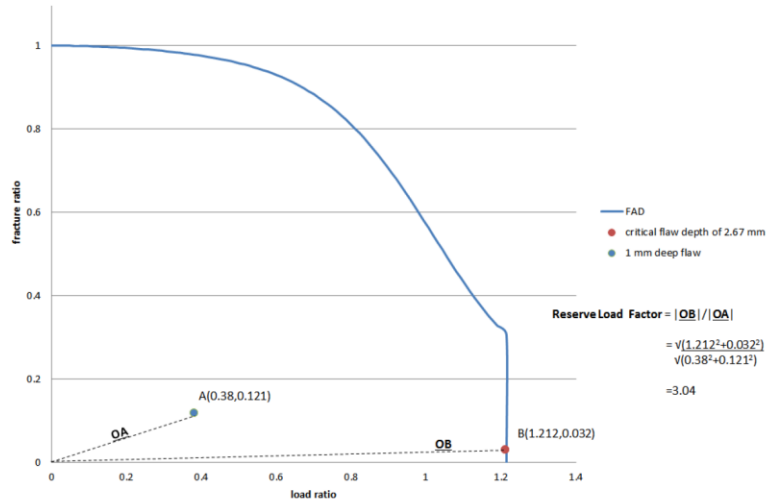
Figure 12. Illustration of reserve load factor calculation for the conservative erosion at the current state of corrosion (critical location at uppermost serration)

It is of interest to note that for the conservative estimate of the current state of erosion where the critical location is at the uppermost serrations, the FAD indicates that the failure mode is almost entirely ductile overload. This is shown by the assessment point being to the far right on the FAD with a low fracture ratio. This is expected as the critical crack depth is 2.7 mm compared to the assumed

It is seen from Table 8 that reserve load factors greater than unity are calculated for both the model that considers the current state of erosion and the model that considers the extreme state of erosion where the upper most serrations have eroded away, indicating sufficient margin on load in the context of the BS 7910 FAD.

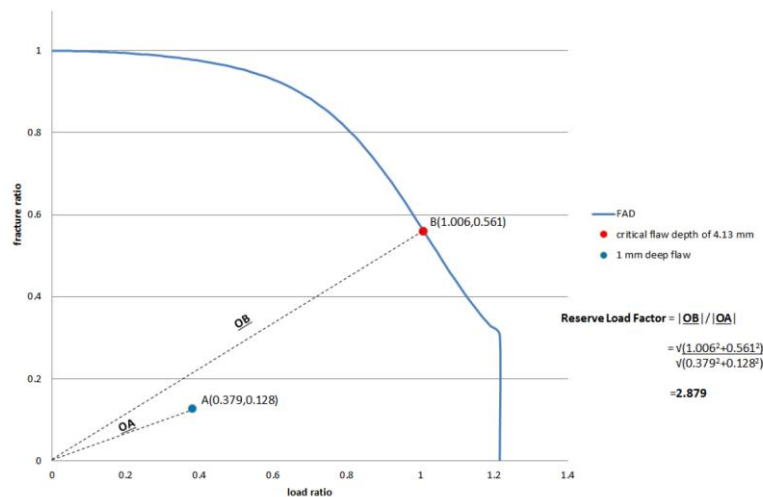
Figure 13. Illustration of reserve load factor calculation for the extreme case erosion for when the uppermost serration is not present (critical location at lowermost serration)

thickness of 3.8 mm, i.e. the remaining ligament is small and likely to suffer from ductile overload. For the extreme case of erosion where the upper serrations have been assumed to have eroded away and the critical location is at the lower most serration, the position of the assessment point on the FAD indicates failure from a combination of fracture initiation and ductile overload. This is to be expected due to the increased thickness of the lower serration compared to the upper serration.
