## Successful Repaired the Broken Rotor-Shaft of Darajat 55 MW Power Plant with Stubbing Welded Built-Up And Remove the 6th Stage Turbine Blades

Dwi HANDOYO, M. Hanafi NUR RIFA'I, Sugeng TRIYONO, Budi WIBOWO

PT. Indonesia Power, Centennial Tower fl 7 & 8, Jl. Gatot Subroto No.Kav. 24-25, Jakarta – Indonesia 12930

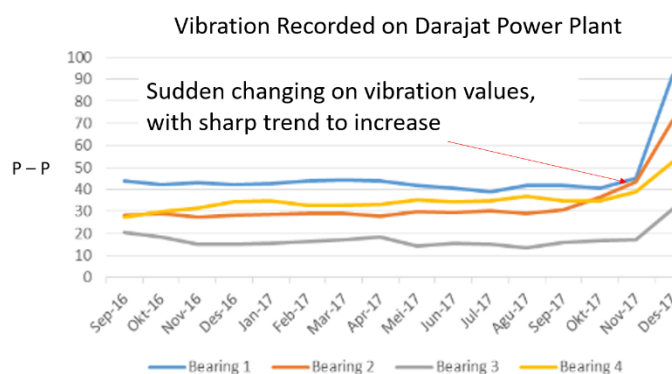
Figure 1: Vibration level at Darajat power plant (Bearing 4: Generator Bearing area) using peak to peak displacement sensor in  $\mu\text{m}$ .

Sudden changing on vibration for all bearing, start to increase with a sharp trend. Alarm value is set in 125  $\mu\text{m}$ . Peak to peak vibration in November 2017 was 50  $\mu\text{m}$  at bearing no 1, and trend to increase at a level of 92  $\mu\text{m}$  by Dec 2017.

To ascertain valid data of the risen vibration bearing abnormality, predictive maintenance team conducted data gathering with a portable vibration tool, and the result was the same. By using vibration spectrum, it found that the cause of the vibration is unbalance (1x rpm). In Dec 2017, Unit 1 was shutdown to find out the root cause of the unbalance itself.

During shutdown, the turbine rotor was sent to a local workshop for further serious inspection. There were some discoveries during the workshop inspection, which happened in December 2017. Rotor Bow was about 0.22 mm at Turbine End Side and heavy corrosion at gland seal area. The previous vibration data may have been caused by rotor bow.

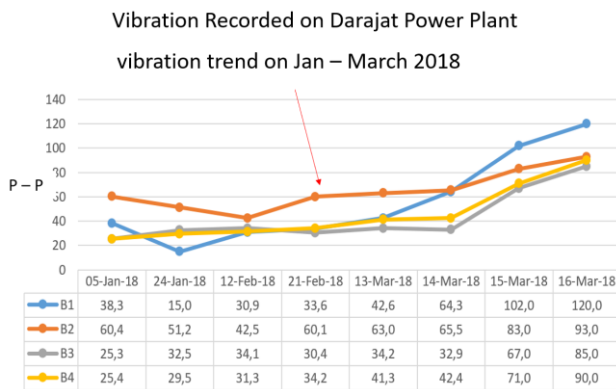
Figure 2: The 2<sup>nd</sup> Vibration problem at Darajat power plant 2 months after shut down, using peak to peak displacement sensor in  $\mu\text{m}$ .

Therefore within 5 days, from 13 – 16 March 2018, all bearing vibration increased almost 50% higher, bearing no 1, had double vibration increase from 40  $\mu\text{m}$  in March 13, jump to 120  $\mu\text{m}$  in March 16.

The dramatic increase of all bearings, it was decided to stop Darajat power plant immediately. Further detailed investigation was needed and its corrective action.

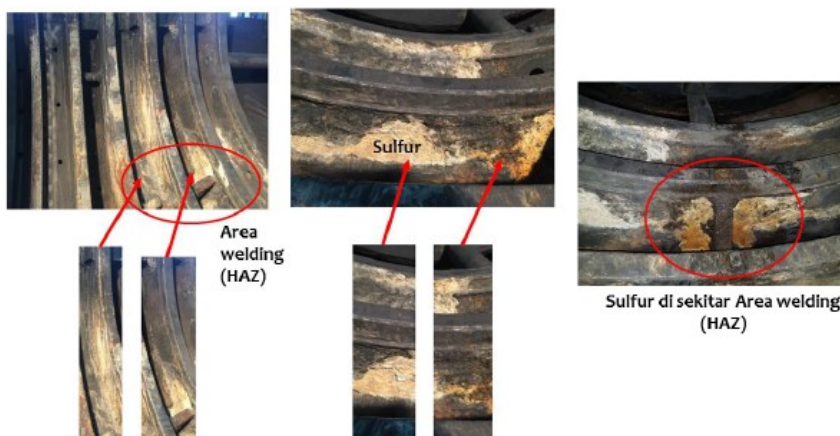
Heavy corrosion found mainly on the welding area, on the heat affected zone – HAZ.

Corrosion material product mostly sulphur and metal oxide.

Location of corrosion is in the lower casing, that may speculate driven by condensate in the area.

Figure 3: Corrosion at turbine's lower casing in HAZ area due to sulfur.

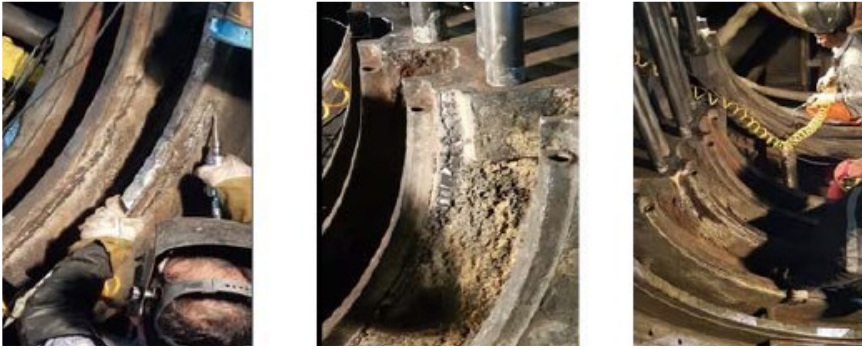
In this photo of figure 4, is showing heavy corrosion product located at lower casing turbine. Soft powder sticky material may conclude that corrosion has been happening for a long time.

Corrosion material product mostly Sulphur and metal oxide.

Figure 4: Corrosion product founds at lower casing Turbine.

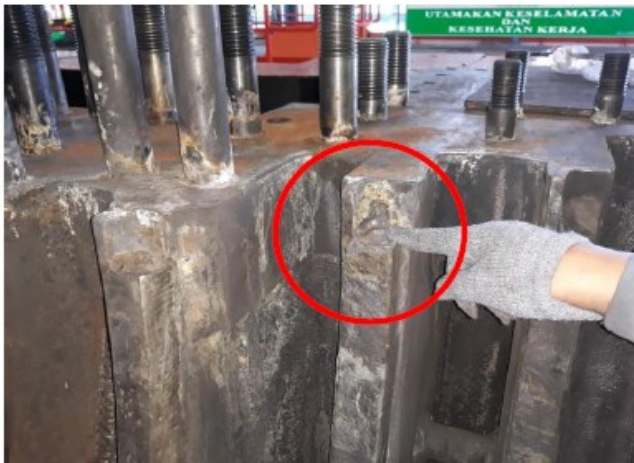
Corrosion also happened in the diaphragm that lead to loosening on the sitting area of the turbine diaphragm.

Corrosion made wear on the diaphragm area.

Figure 5: Corrosion at Diaphragm's support plate and Lock Pin. This corrosion makes wear in the diaphragm area.

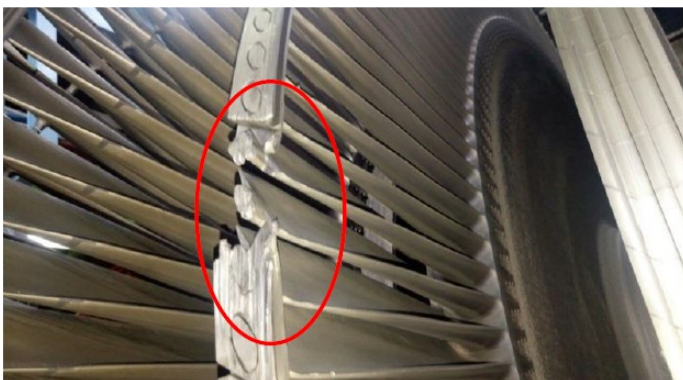
Damages on shroud number 4 of the turbine, because of rubbing between blades and casing. The damage rubbed area is about three tips of turbine blades.

Figure 6: Rubbing at Shroud #4 turbine.

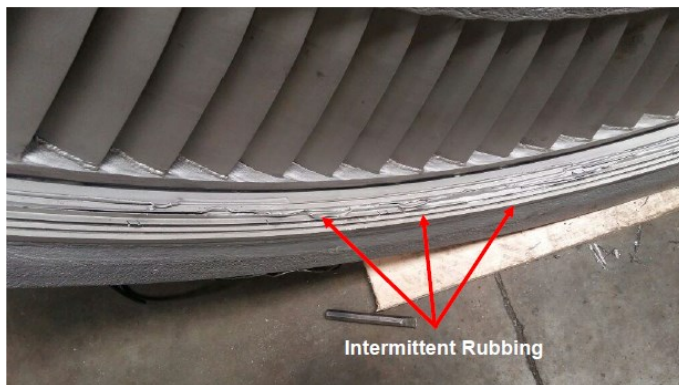
The intermittent rubbing also left rubbing tract on seal strip area.

Figure 7: Rubbing at Seal Strip area

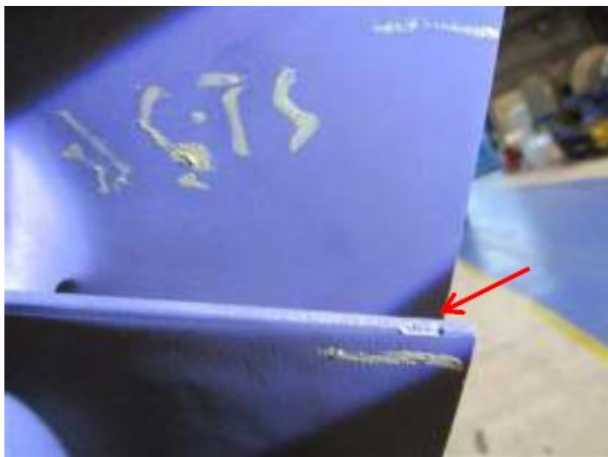
Minor damages on stellite blade row no 5 and row no 6, indicates water droplet in this area. The appearances of water droplet may indicate lesser efficiency of turbine after years of operation.

Figure 8: Erosion at Stellite Blade row #5 and #6.

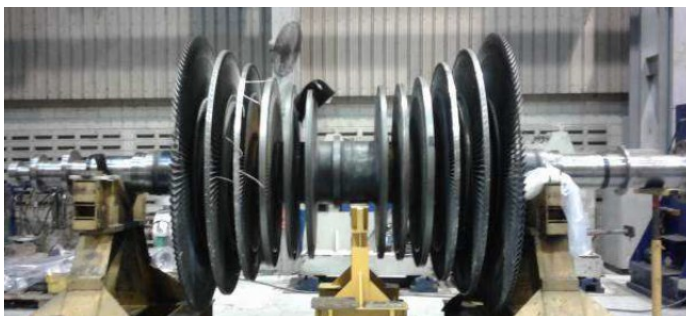
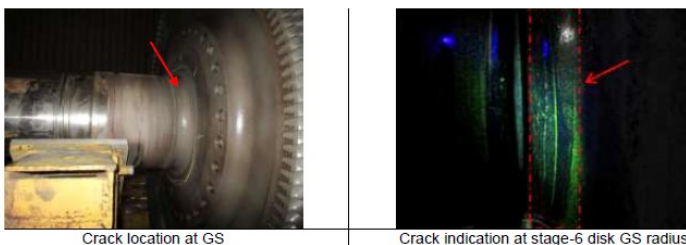
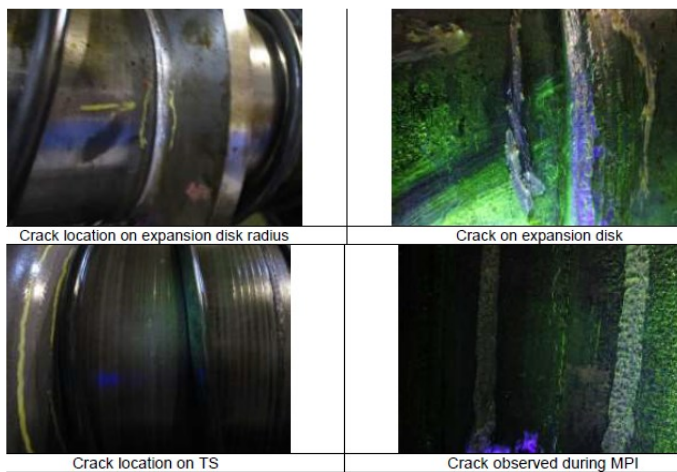
The major problem of the turbine rotor found during inspection was cracks on several areas of the turbine rotor, concentrated in radius between gland seal area and last stage disk at generator side.

Other crack indications are also appearing at the other side (Turbine side) at radius area between gland seal area and last stage disk.

Crack location at GS

Crack indication at stage-6 disk GS radius

Figure 9: Crack indications appear at several area at rotor.

- Stage 6 Generator Side Disk Radius with up to 130 mm depth
- Stage 6 Turbine Side Disk Radius with up to 40 mm depth
- Expansion Disk, surface cracks.

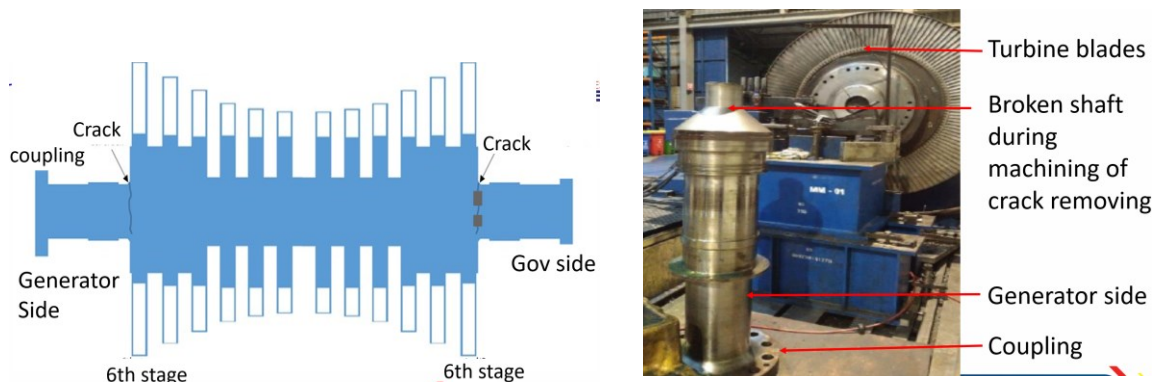
As per shown in Figure 10, rotor repair includes crack removing by machining the crack and re-welding to the original size diameter. Therefore during machining through the crack on the generator side, the crack was deep enough to the center of the shaft, resulting the rotor shaft broken into two different pieces. Rotor weight is 22 ton.

Figure 10: Rotor crack both at end side of 6<sup>th</sup> blades, both in generator side and governor side. Right picture is a broken shaft after machining to remove crack.

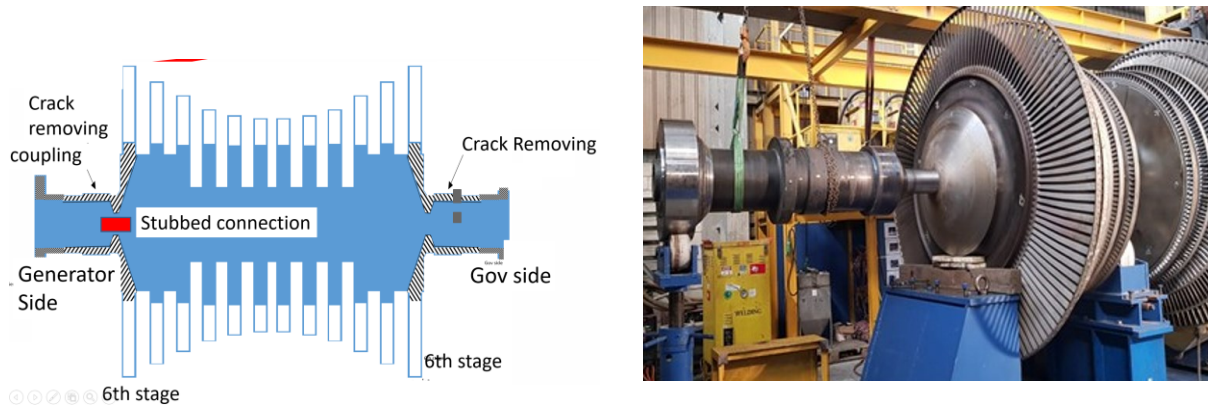
Figure 11: Rotor crack both at end side of 6<sup>th</sup> blades, both in generator side and governor side. Right picture is generator side after stubbing.

As per illustrated in Figure 11, the stubbed connection rotor to include removing the 6<sup>th</sup> turbine blades then followed by building up the whole disks to avoid placing heat affected zone (HAZ) in this high stress area. Weld material used was 12% Cr Stainless steel with addition of Nickel and Molybdenum alloy. This weld material will improve the corrosion and erosion resistance properties, as well as mechanical properties.

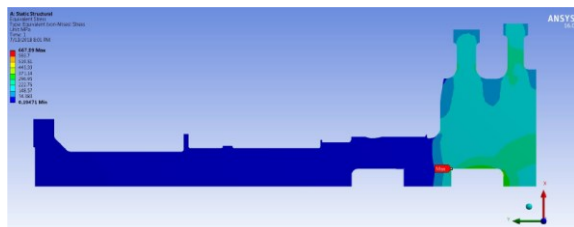
Figure 12: Finite element analysis on stubbed rotor connection. Red color shown the critical area of stubbed material.

The load results show a Von Mises load peak stress 667 MPa at the critical area shown in the red notch of Figures 12 & 13. This stress value is still secure, since it still below the permitted peak stress value in the rotor design (2 times rotor yield strength of 2 x 567 MPa).

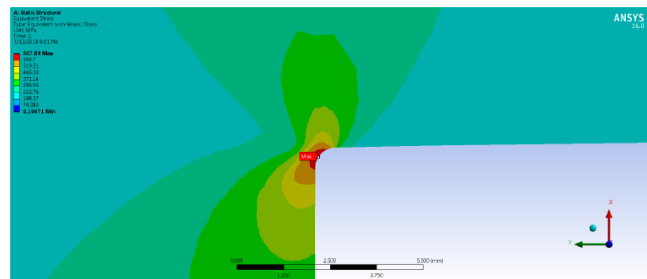
Figure 13: Zoom in of critical area on the stubbed area.

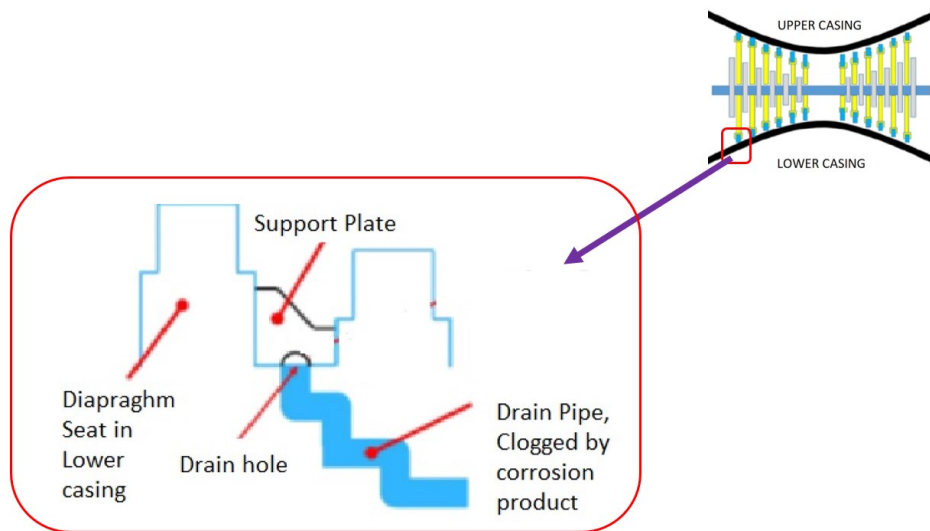
To construe the original cause of the crack on the turbine based on the information that most of corrosion product found was located at the lower casing Turbine. This corrosion may be caused by the presence of condensate in this area. The product of corrosion to block the hole of the drain catcher, cover up and clogged up the drain line of lower casing. The presence of acid condensate and accumulation of corrosion product lead to further accelerate the corrosion in the area of the lower casing. As per illustrated in Figure 14, the drain hole to release condensate was blocked by corrosion product.

Figure 14: Drain hole of Darajat Power Plant, Turbine's Lower casing clogged up by the corrosion product.

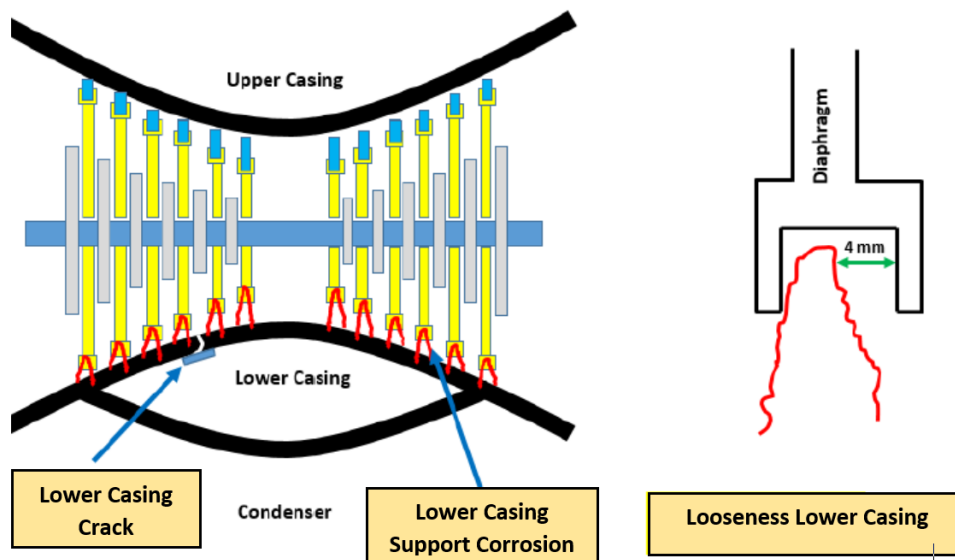
When condensate was not able to be drained, where the condensate has low pH, then the corrosion will expand to the area surrounding, to include corrosion in the sitting of lower casing diaphragm. Eventually, corrosion wear will lead to loosening of the diaphragm. In the worst condition, the steam may also flow through the area gap on the wear of sitting diaphragm area. If this is the case, then combination between loosening diaphragm and leak flow of steam may cause vibration on turbine. Abnormalities of turbine vibration may cause cracks on some areas of the turbine rotor, in respect with concentration of pressure or mechanical turbine load. Figure 15 is showing a diagram to figure out the mechanism of diaphragm looseness (4 mm) due to severe corrosion, that leads to an unbalance situation.

Figure 15: Diaphragm looseness (4 mm) due to severe corrosion, that leads to an unbalance situation.

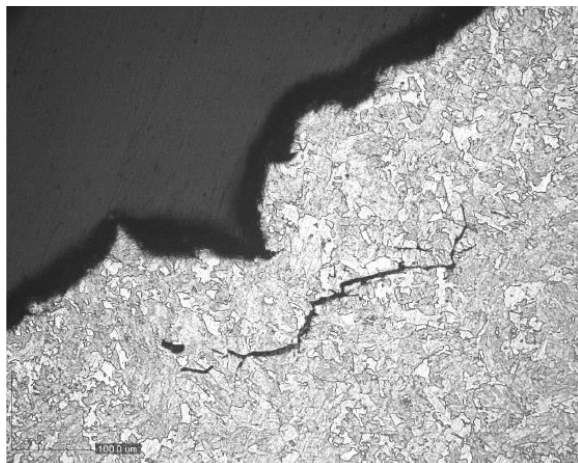
Hydrogen sulfide  $H_2S$  is a common gas in the geothermal steam. In some cases, the presence of high hydrogen can lead to SSC. SCC is the growth of crack formation in a corrosive environment. It can lead to unexpected sudden failure of normally ductile metals subjected to a tensile stress, especially at elevated temperature.

This SSCC is recognized by a microstructural branched crack shape as shown in Figure 16. To construe the original cause of the crack on the turbine based on the information that most of the corrosion product was located.

Figure 16: Micro structure from a branched crack at rotor.

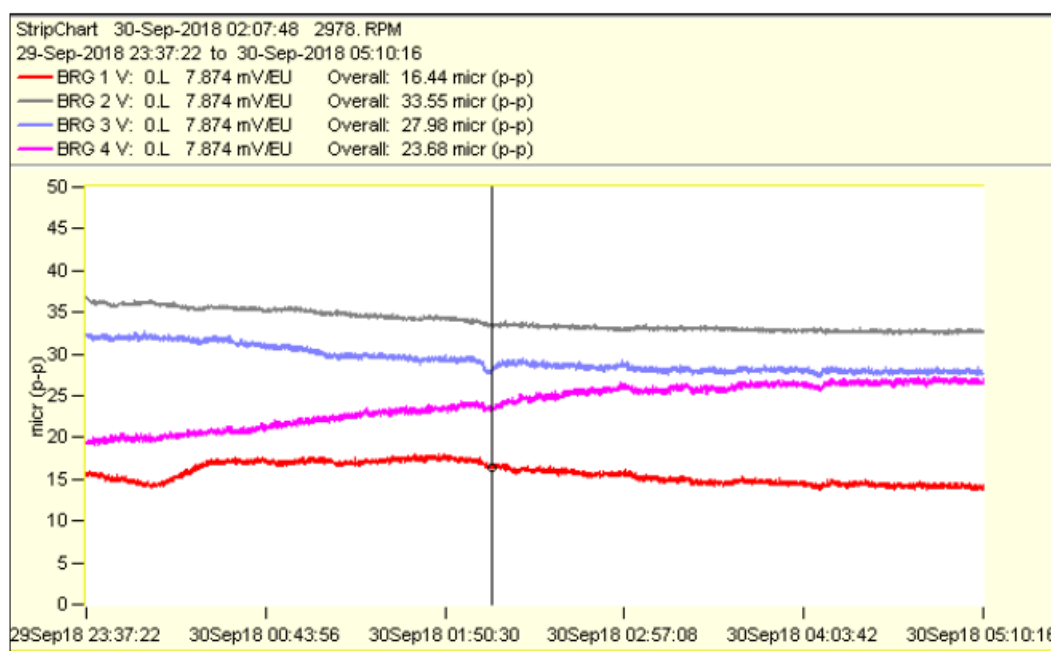
Successful turbine unit 1 rotor repair via stubbing and welding was monitored in its operational condition. Since August 2018 until May 2019, the unit 1 performed a satisfying conditions, especially in vibration sensor as displayed at Figure 19.

Figure 17: Vibration at 55 MW of Darajat Unit 1 after rotor repair via stubbed welding method.

Overall, operational performance of Darajat Unit 1 after repair process shows a distinguish result. The maximum load reaches 55 MW and up until now, its equivalent available factor (EAF) reaches 95% value. The quality rotor repair also being guaranteed up to 10 years by the workshop itself.
