## **Operation Challenges of Ageing Geothermal Power Plants Gn. Salak 180 MW and Kamojang 140 MW – West Java, Indonesia**

Indra Jaya, Hanafi Nur Rifa'i, Sugeng Triyono, Budi Wibowo

PT. Indonesia Power, Centennial Tower Fl. 7 & 8, Jl. Gatot Subroto No.Kav. 24-25, Jakarta, Indonesia 12930

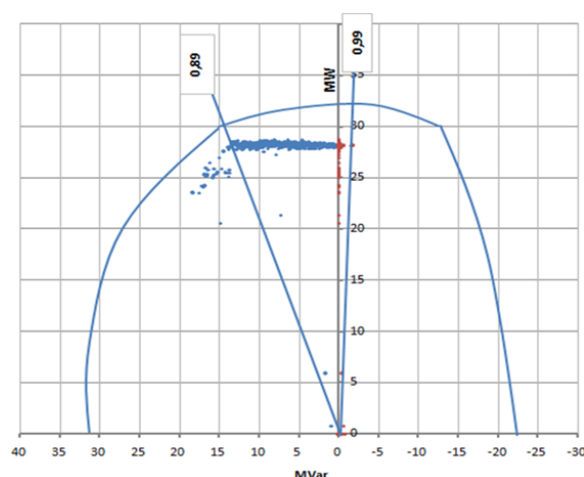
**Figure 1: The capability curve of the generator, showing many operation events beyond the safe operation curve.**

It was concluded that the operation Kamojang unit 1 with MVAR out of normal generator capability curve would impact on overheating condition on the generator, leading to potential damage on generator insulation. In summary, the damages generator of Kamojang Unit 1 can be summarised as follows:

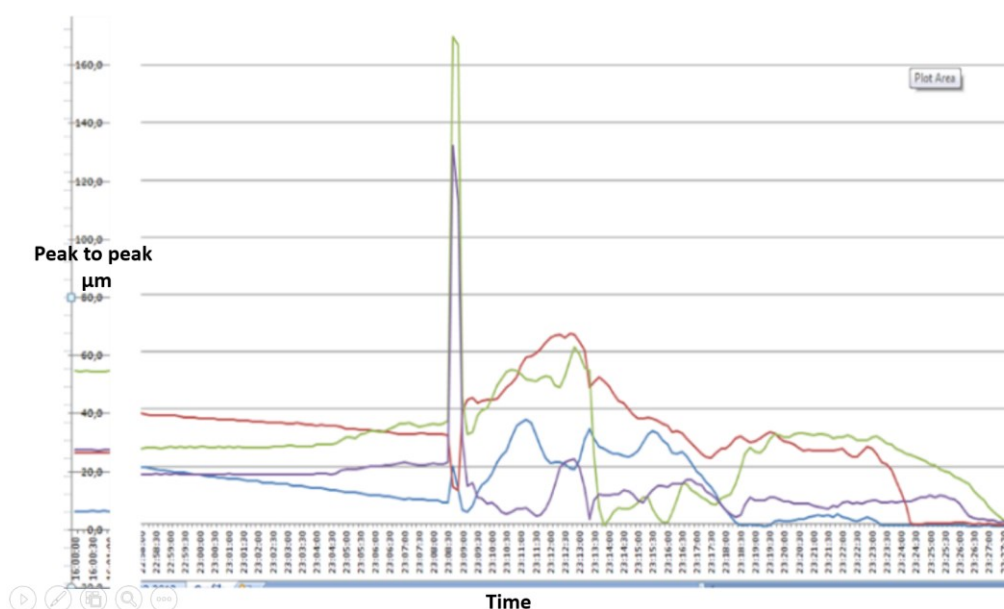
To ascertain the recorded value of high bearing vibration, the turbine then is rotated of 400 rpm. The result: there was an indication of noise/vibration and a turbine was stopped again. Figure 2 is shown the event recorder graph to conclude the signature of the generator rotor ground fault then followed by the appearance of high vibrations on the bearings.

**Figure 2: Vibration of generator bearing during turbine trip.**

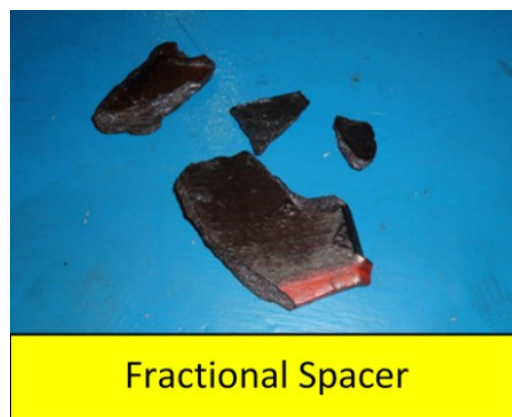
Further thorough investigation during Kamojang Unit 1 stop, during the dismantling of the rotor generator, it was founded splinter insulation material in the coupling side generator. This foreign material was thought to be a fractional spacer that originally installed between the coil end rotor (turn to turn coil). This chunk of a broken spacer as per shown in Figure 3, was suspected because of spacer material deterioration after years of operation. It was concluded that the broken spacer was due to thermal effect or probably excessive temperature rose occurred on the coil end rotor.

Figure 3: Vibration of generator bearing during turbine trip.

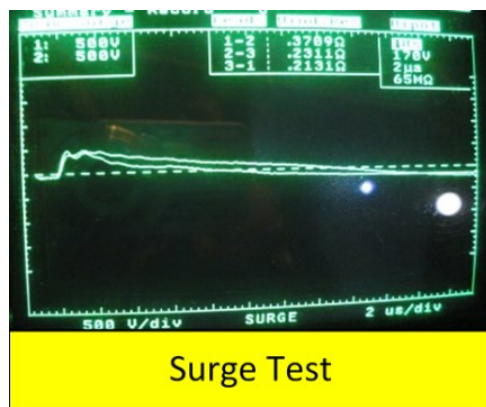
To ascertain the root cause of abnormality parameters, further surge testing was done. As per shown in Figure 4, the graph in the screen was the result of a surge comparison test on Pole-A and Pole-B winding rotor with 500 V DC injecting voltage. The two graphs did not coincide, which indicate the rotor coil imbalance between pole-A and pole-B.

Figure 4: Vibration of generator bearing during turbine trip.

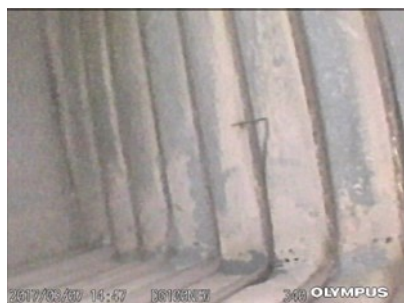
Figure 5: Borescope of end winding, end winding in a dirty condition

During the thorough investigation on Gunung Salak unit 3, the rotor generator was pulled out for visual inspection, as per Figure 5. It was founded foreign materials contaminants in the rotor winding. The contaminants were hard bonded with rotor winding, and cannot be cleaned by a vacuum pump, as well was not able to be cleaned by the typical chemical, electric motor cleaner. Finally, the mechanical cleaning was the only option needed by brushing or gouging contaminants to remove from rotor material.

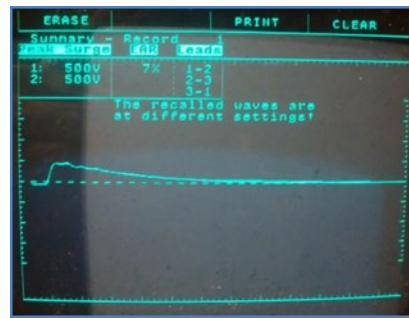
Figure 6: Surge test, the results of the surge test on the generator (EAR 7 %)

The result of a surge comparison test as per Figure 6 shown on Pole-A and Pole-B winding rotor with 500 V DC injecting voltage. The two graphs do not coincide so that the rotor coil in pole-A and pole-B occur imbalance. Results: 7% EAR indicates short inter-turn (Standard Normal EAR <5%).

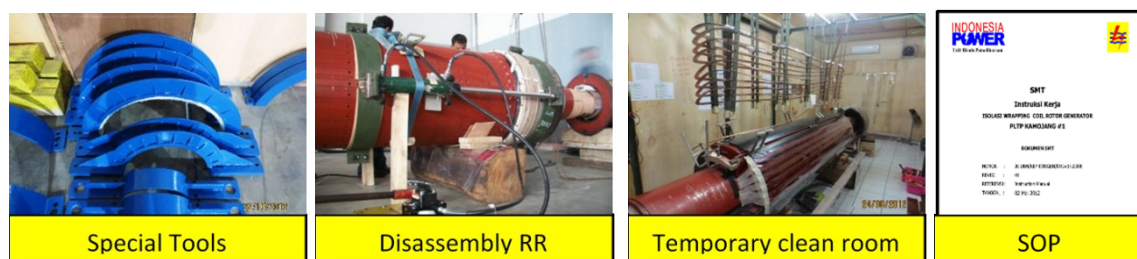
Figure 7: Preparation special tools, proses disassembly retaining ring and make a temporary cleanroom.

The step by step recovery preparation, as among others to the mobilisation of generator rotors to workshops. In some cases, it is needed to do manufacturing special tools, then followed by preparation of SOPs and work methods, and then finally making isolating rooms to avoid any unnecessary dirty dust inside the room.

In case of Kamojang Unit 1 repair, knowing that the geothermal environment contains a lot of H<sub>2</sub>S sulfuric acid gas which will oxidise the generator rotor coil, the generator rotor repair will be carried out at the workshop in Bandung. The step by step work preparation is shown in the following figures.

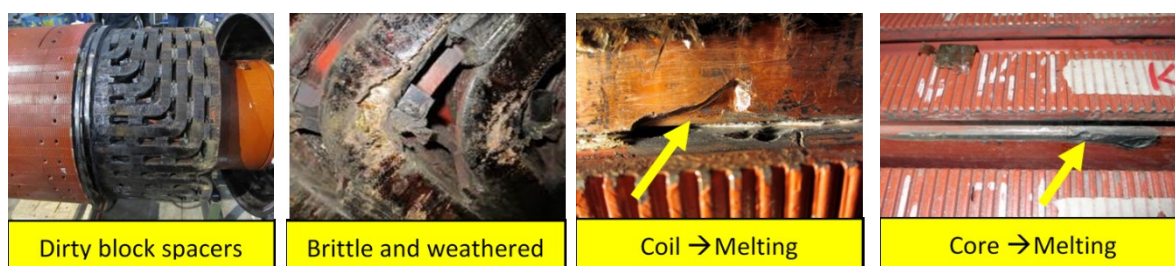
After dismantling the retaining ring and wedge rotor generator, a coil was founded to be melting. Dirty block spacers are characterised by carbon in the area. Insulation is brittle and weathered. Figure 8 shows these rotor visual conditions after the dismantling.

Figure 8: Fact-finding of ground fault rotors and condition of the end winding that dirty & brittle.

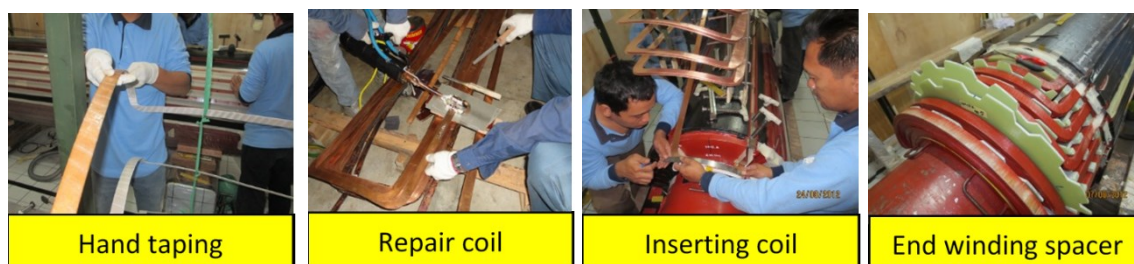
Figure 9: Process repairing of the rotor generator.

After investigation of damage, cleaning parts of the rotor generator, then re-installation was carried out. The procurement of insulation material was done parallelly while cleaning process of generator parts, as shown in Figure 9.

- Repair damaged coil parts.
- Hand taping (re-insulation) coil.
- Inserting coil.
- Installation of End winding spacers & wedges.

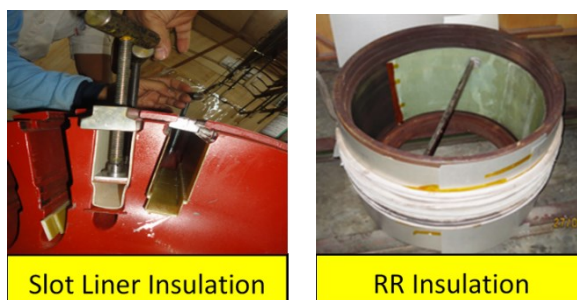
Figure 10: Preparation insulation material (slot liner and retaining ring) before being to do the assembling of slot liner and retaining ring and coil and retaining ring.

- Insulation for the slot liner, both for type and dimensions adjusted to the rotor voltage rating.
- Insulation retaining ring, with heating to see endurance on temperature.

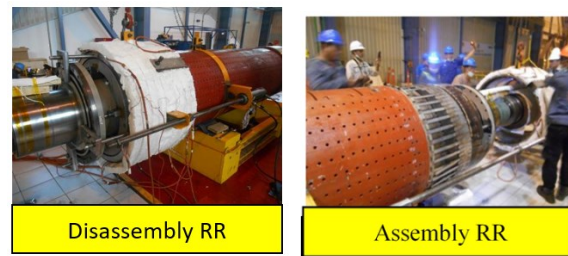
During the dismantling of the rotor generator, visual investigation to assess damages of the generator, as per Figure 11.

**Figure 11: Process disassembly retaining ring to do visual checking.**

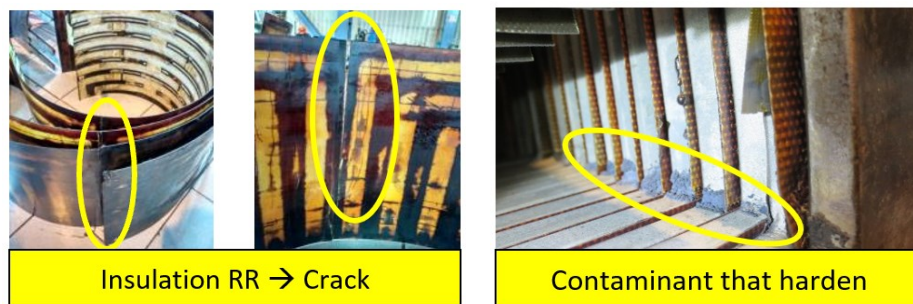
After dismantling the retaining ring, cracks were founded in the insulation. The cause of short inter-turn was founded in contaminants that hard sticky bonded at the end winding generator coil, as per figure 12.

**Figure 12: Retaining ring insulation in crack condition, possible due to ground fault and harden contaminant due to inter-turn short.**

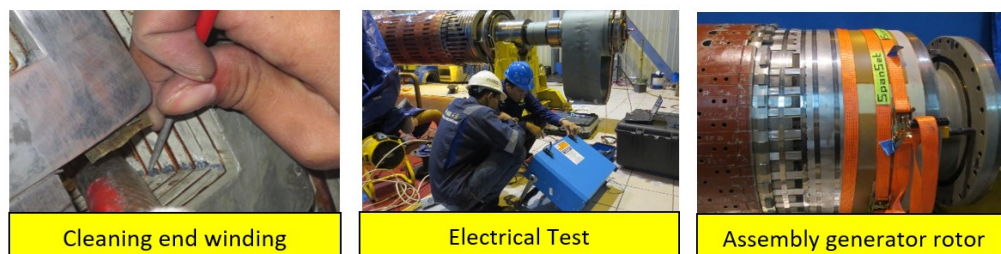
**Figure 13: Cleaning hardens the contaminant, electric test and assembly new retaining ring insulation.**

- Repair damaged coil parts.
- Hand taping (re-insulation) coil.
- Inserting coil.
- Installation of End winding spacers & wedges
- Electrical testing
- Assembly the generator rotor.
