The main challenges in operation and maintenance of geothermal power plants

Sæmundur Guðlaugsson

On Power Bæjarhóls 1 110 Reykjavík

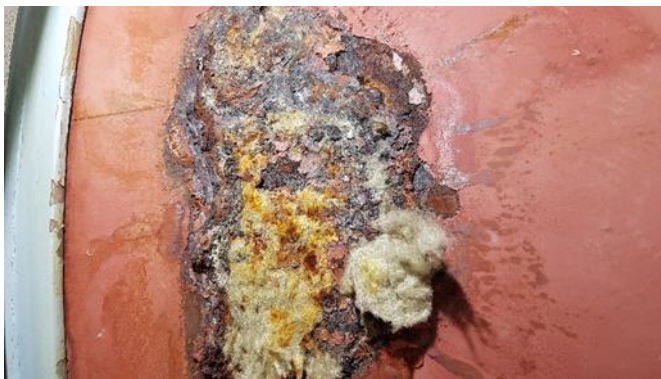
Corrosion can occur in piping systems, especially in locations where the temperature is around or below 100°C. The carbon steel piping systems at Hellisheidi and Nesjavellir are insulated with rockwool. If a leak occurs the rockwool insulation can absorb the moisture and create ideal conditions for corrosion. To prevent this cladding is kept in good condition, and in some high-risk areas aluminum coating is applied to the pipes. A corroded pipe from ON Power's piping system can be seen in Figure 2.

Figure 2: A corroded pipe from ON Power's piping system.

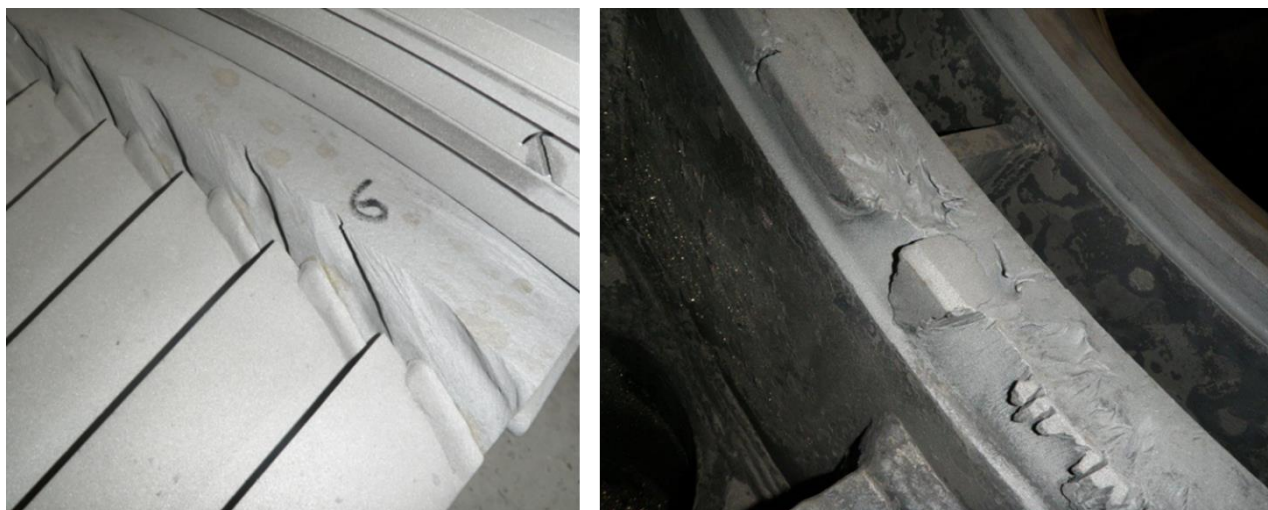
Erosion corrosion can occur in control valves for boreholes, in pipe bends close to boreholes, and in turbines. The erosion corrosion close to boreholes is often due to high flow rates or because the borehole was prematurely put online, too soon after drilling. Erosion corrosion in turbines happens because the steam is moving through the turbine at a high velocity while going beyond the saturation point, thus getting wetter while it travels through the turbine unit. The steam collides with precipitated water droplets and causes erosion corrosion (Morris & Robinson, 2015). This process cannot be eliminated. It takes place in several places in the turbine unit; among those are the diaphragm, the rotor, the turbine casing and assembly surfaces. In the diaphragm the erosion corrosion takes place on the assembly surfaces, between the blades, and in the seat for the casing.

In Figure 3 a highly eroded casing seat can be seen. Noticeably, there is old welding repair work made with 309Mo alloy in the seat and that part has not been eroded away in the same way as the surrounding material of the seat. This example clearly confirms the importance of choosing the right metals for equipment construction in the first place, especially in critical places like the casing seat of the diaphragm.

Figure 2: Erosion corrosion in turbine; between blades in the diaphragm (left) and in the casing seat for the diaphragm (right).

The erosion corrosion in the turbine mainly occurs where there is a pressure difference between sections and where the steam flows at a high velocity through the turbine. This happens because turbines in geothermal power plants are operated at fairly low pressures; the Hellisheidi power plants has turbines operating at pressures as low as 7 bars and close to saturation. During energy extraction, with such a low pressure and close to saturation, the steam will inevitably condense to some extent, forming water droplets. These water droplets are the main reason for erosion corrosion in turbine parts. In both Hellisheidi and Nesjavellir many modifications have been made to the system in an effort to avoid these problems. Holes have been drilled between the diaphragm through the casing to collect condensate which is subsequently lead to the condenser.

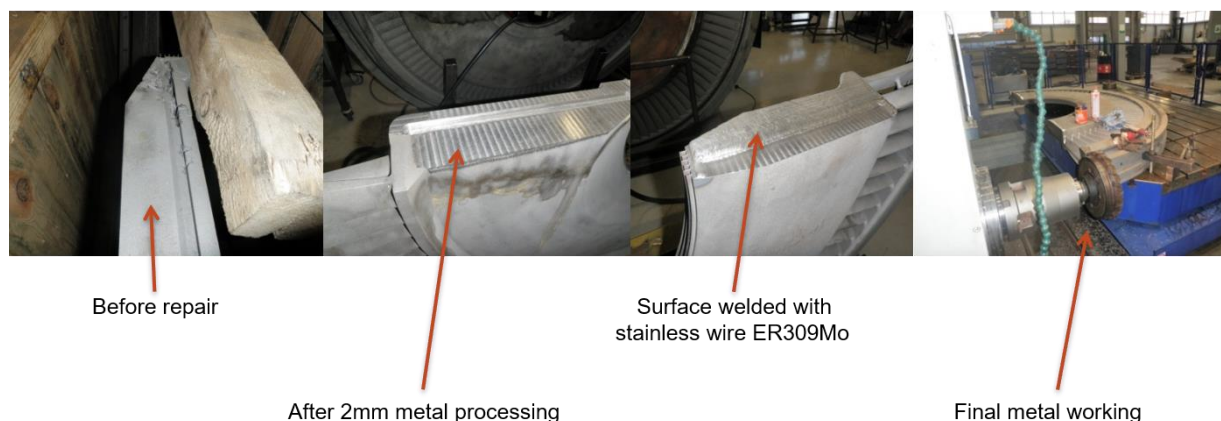
Figure 4: Assembly surface repairs in diaphragm.

To deal with the problems listed in the previous section several repair techniques have been developed in our workshop in Hellisheidi, in cooperation with our contractors. This is in addition to the mitigation techniques applied that were discussed above, such as the acidification of geothermal water in the heat exchangers to prevent scaling, the careful selection of boreholes for mixing of geothermal fluid to prevent scale formation in the turbine, and the aluminum coating of critical parts of the piping system to prevent corrosion. The repair techniques covered here deal with erosion corrosion in the diaphragm, the casing, and the rotor. In the case of the diaphragm the assembly surfaces have been rebuilt with 309Mo alloy over a nine year period with very good results. There has been no observable erosion on the assembly surfaces with five years of operation from the time they were repaired (Figure 4).

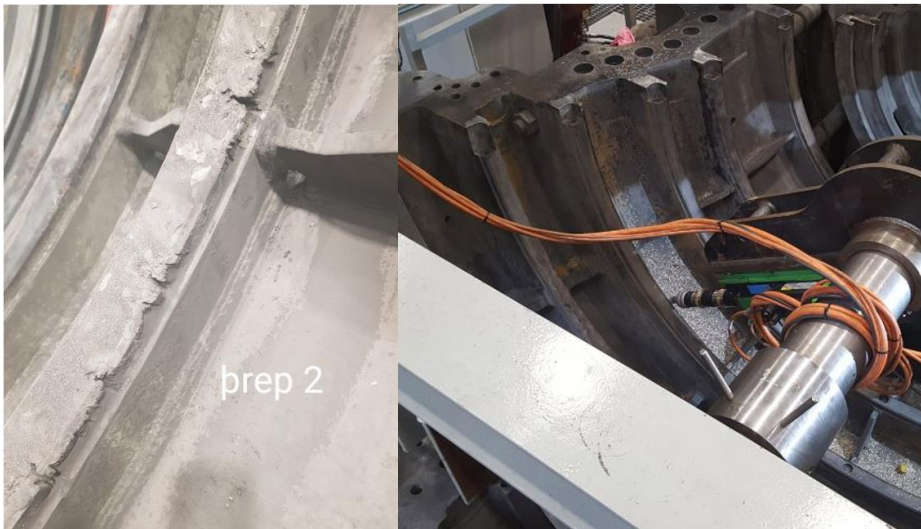
The casing seat for the diaphragm is prone to corrosion due to the leak of wet steam between the steps of the turbine. This type of erosion is present in steps one to four of the turbine, and the damage needs to be repaired because it creates a path for the steam to go through the turbine, eventually going through the casing to the engine area. In cooperation with ON Power's workshop contractor a machine to repair this critical area has been developed. The general concept of the machine is to enable repairs on the eroded area in the same way erosion in the assembly surfaces has been repaired. The machine removes about 2 mm of the welded area and then the

Figure 5: Diaphragm seat repair.

seat is welded with 309Mo. The machine is carefully aligned with the rotor so that the seats for the blades will be exactly perpendicularly to the rotor once machined.

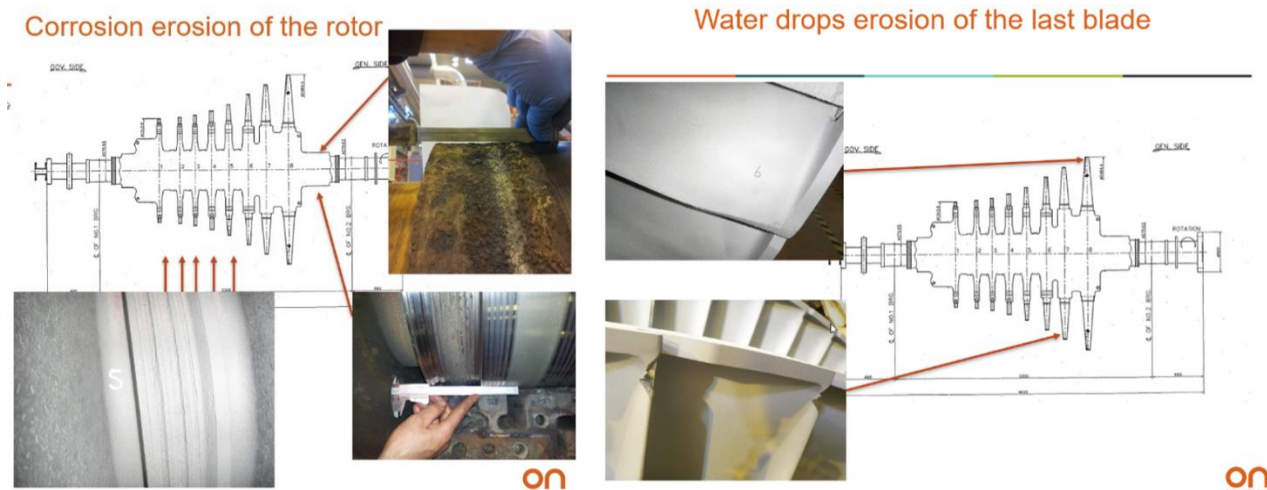
Geothermal turbine rotors need regular maintenance due to erosion corrosion, especially in areas where there is a pressure difference, like in the gland seal area. The rotors at the power plants have been repaired after twelve years in operation due to erosion in the gland seal area and after fifteen to eighteen years in operation a blade repair was necessary due to erosion corrosion caused by water droplet formation on the blade edge. The major affected areas have been in the first two steps, which have required a complete rebuild with 410 NiMo alloy while the later steps are more intact although we still see erosion corrosion in the blades for all steps. The erosion corrosion takes place in balancing holes and the area close to the blades. Originally all repairs on the turbine rotor and blades were sent out but since 2014 a turbine workshop has been operated in the Hellisheidi Power Plant. Up until now, seven rotors have been rebuilt in cooperation with the workshop contractor, Deilir.

Figure 6: Turbine rotor corrosion erosion and water drop erosion on rotor blades.
