## Refurbishing the Wellhead Master Valves from IDDP 1 for the IDDP 2 Well at Reykjanes.

**Keywords:** Geothermal, IDDP 1, IDDP 2, Expanding Gate Valves.

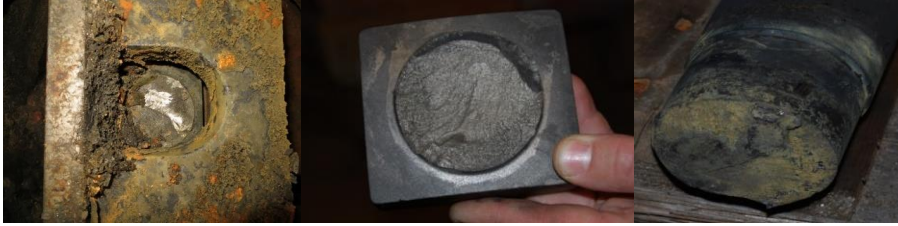
Figure 2: Broken parts of the stem. From left to right: Broken stem shown in gate when dismantling the valve, broken bottom part of stem after cleaning, end of broken stem.

Both valve stems were broken as described above. A failure analysis study of the fracture was made by S.N. Karlsdóttir (Karlsdóttir, 2013). The results from the failure analysis showed that the fracture is a brittle failure with a possible contribution from hydrogen embrittlement and Sulfide Stress Corrosion Cracking (SSC).

The material of the broken stems is 17 – 4PH (UNS S17400). According to the NACE MR0175/ISO 15156-1 standard 17 – 4PH stainless steel (NACE MR0175/ISO 15156-1: 2001(E), 2001) is not recommended above 316°C (600°F). A possible cause of the valves getting stuck is thermal expansion mismatch effects. The valve body material WC6 has a lower thermal expansion coefficient than the ss 410. Thus, during heating in open position with the expansion gate wedged open, the temperature of the fluid heats up from around 200 to 450°C, the difference in the expansion of the stainless-steel gate and segments and the valve body is approximately 1,0 mm creating immense forces and jamming the gate and segment. Combining a stuck gate and a damaged or a brittle stem material is a likely way to a disaster.

corrosion resistance is also very important, and only materials conforming to NACE MR0175 – ISO 15156-3 were considered. The main materials considered were highly alloyed nickel alloys and cobalt alloys. A decision was made to obtain stems made from Inconel 725. When asked for alternative stem materials, TIX could not deliver. The new stems of Inconel 725 were fabricated by Texas Honing inc. in Houston, a PCC company. The hydraulic cylinder valve actuators were made by a local workshop in Iceland. A stem packing rings of graphite and carbon fiber were used in the stuffing box and high temperature grease (SL -HT 1000) injected into the stuffing-box lantern ring. Figures 5 and 6 show the refurbished wellhead master valve from IDDP 1 for the IDDP 2 well at Reykjanes, Iceland, and a drawing of the valve stem machined for the IDDP 2 wellhead valve.

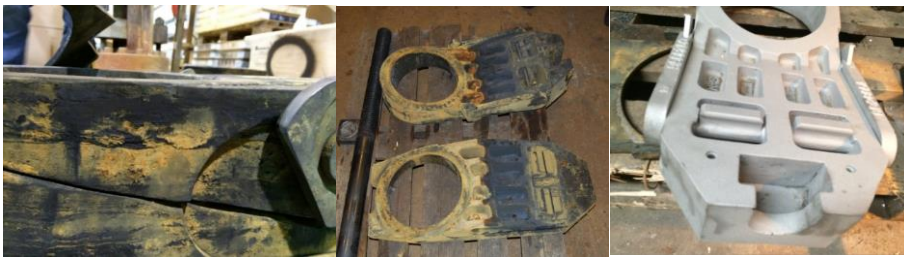
Figure 3: Gate and segment. a) Gate segments showing distortions b) Back side of gate and segment c) Gate after sandblasting.

The gate and gate segments in both valves were also distorted (fig. 3), and when the valve was operated, that is, opened or closed, the mechanism (levers) for directing the gate and gate segments to a proper position was stuck. The seat skirts were also distorted, probably because the mechanism for directing the gate and gate segments to a proper position had gotten stuck.

Galling on the contact faces on the back sides of the gate and segment may also have contributed to the stuck gate. Experience from high temperature steam power plants indicates contact surfaces in steam valves are prone to galling. The 410 stainless steel has been reported to have a very low galling resistance (Review of Wear and Galling Resistance of Stainless Steels, 1978). Furthermore, the lubricity of steam and brine at high temperatures is very poor. Besides, most lubricants are washed out by superheated steam.

New gate segments and gate seat skirts were ordered from TIX, the valve manufacturer. These parts are again made from type SUS 410 stainless steel as no other option was possible from the manufacturer. The seat and gate faces are Stellite 6 clad as standard, but additional requirements were made, that is, having the contact faces on the back side of the gate and segment Stellite 6 clad as well. New seat skirts of the same SUS 410 material were used as before. For the broken valve stems the 17 – 4PH could not be used based on the failure analysis and previous analysis. Some materials of similar strength as 17 – 4PH were considered. Also,

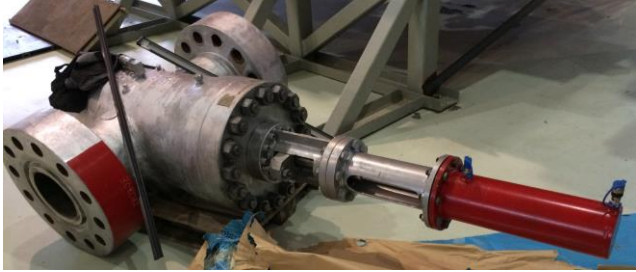
Figure 4: Refurbished valve prior to installation on the IDDP 2 wellhead.

One valve was installed on the IDDP 2 well in January 2017 after cementing a 7" sacrificial casing and installing an expansion spool. The valve had a temporary valve stem made from SAF 2507 duplex made by a local workshop. After installing the Inconel 725 valve stems, both valves were installed on the wellhead in September 2019, prior to flow testing the well. The valves performed flawlessly during the flow test in 2020.
