Casing failure analysis and proposed repair for well OW-740A in Olkaria Geothermal Field

Nahashon Karanja Nzioka, Kristinn Ingason and Málfríður Ómarsdóttir.

Kenya Electricity Generating Company (KenGen), Olkaria Geothermal Projects,

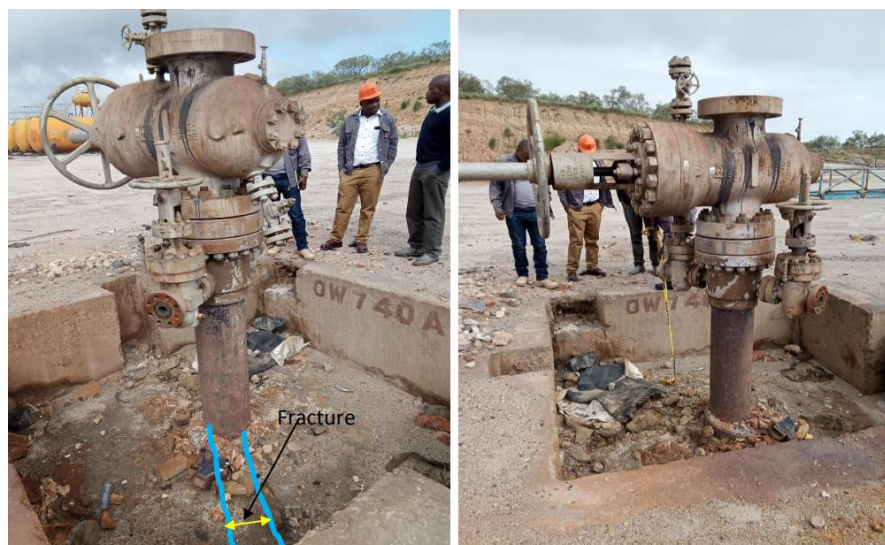
This leakage increased in quantity over time, to the point that fumaroles developed at the well pad in the areas surrounding the cellar and it was threatening to be uncontrollable if it was left uncontained (see Figure 3). It was at this point that a quenching operation was recommended to lower the wellhead pressure and investigate the cause of the steam leakage. Quenching was done on the 8th of August 2019 at a rate of 25 l/s using a high-pressure triplex pump cementing unit and after 4 hours the well was successfully killed. Continuous pumping was allowed so that a logging operation could be conducted. The multifinger caliper survey conducted suggested that the casing had parted at various locations i.e., 187 m, 198 m, and 318 m.

FIGURE 2: Situation at well OW-740 at the initial stages of steam leakage development (July 2019)

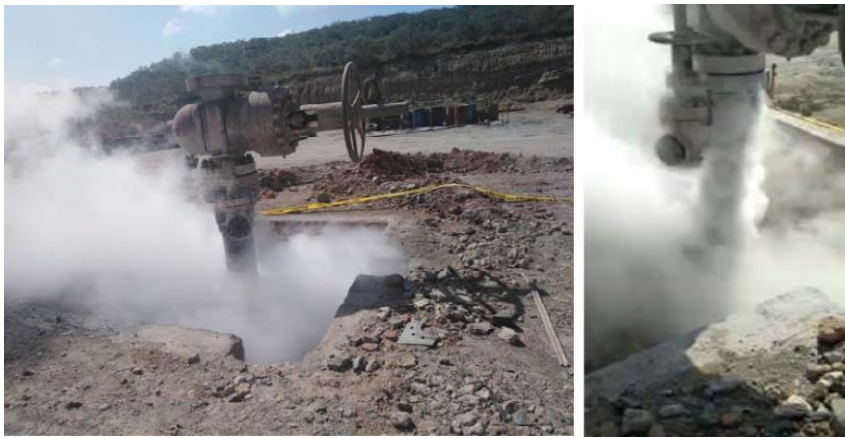
FIGURE 3: Steam leakage at later stages of development.

After the survey, the well was let to discharge vertically to avoid pressure build-up. Furthermore, an additional containment measure of conducting a squeeze cementing operation was done to try and seal the conduits that transmit steam to the surface. This was done by welding in place two halves of the 20" casings, then pumping through a valve to squeeze as much cement slurry as possible while the well was discharging. The cement slurry pumped during this operation was about 4 m³. This process is described in Figure 4 below. After this squeeze cement job, leakage between the casings stopped including steam that was escaping between the fractures.

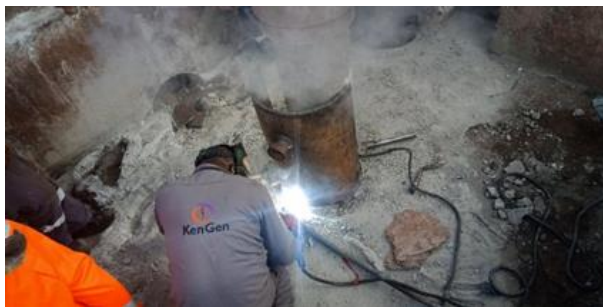
1. Welding the containing casing in place

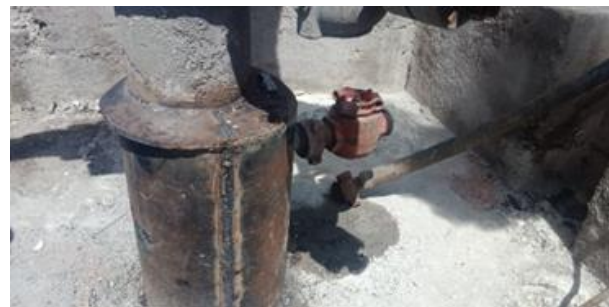
2. Welded casing ready for the squeeze operation

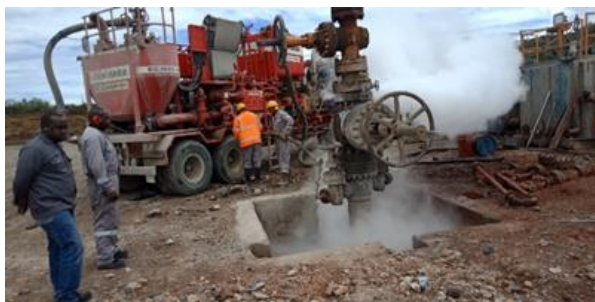
3. Conducting the cementing squeeze operation

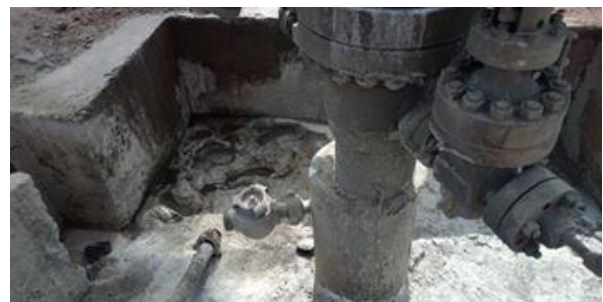
4. After conducting the squeeze operation and pumping 4m³ of slurry

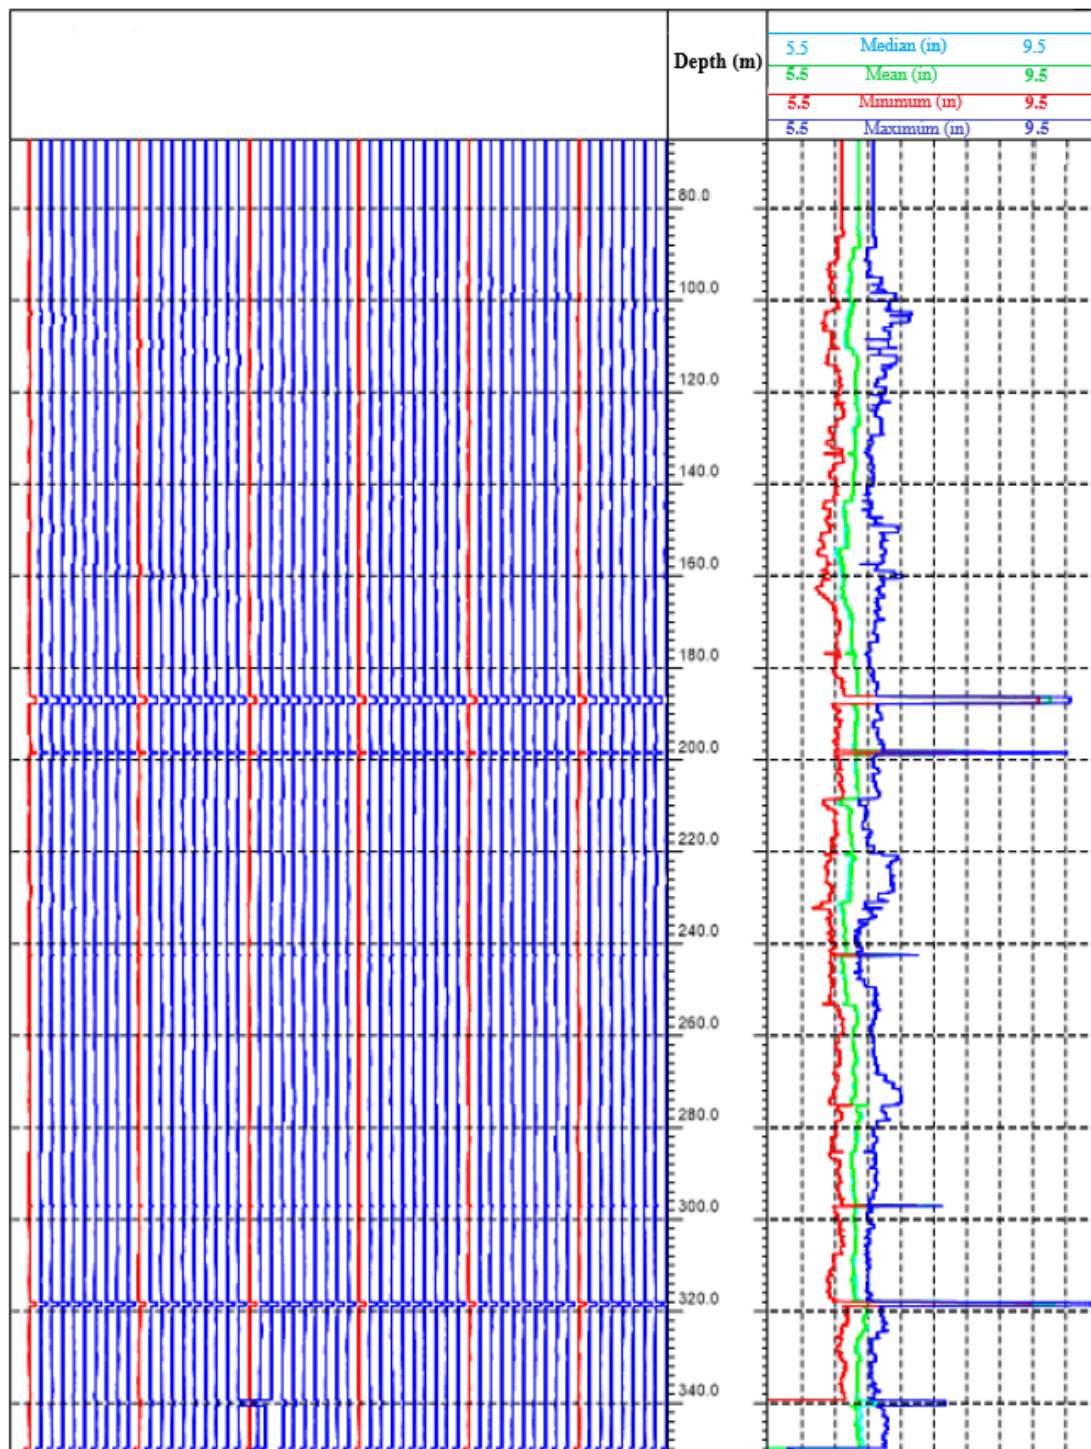
FIGURE 8: Full range calliper results.

The survey shows three locations where the casings have parted. These are at 187 m, 198 m, and 318 m depths. The full extent of these damages is presented in the expounded view in Appendix A and B.

The parted casings at 187 m and 318 m depths seem to indicate a perfectly circular increase in internal diameter that may be attributable to the parting of casing. The breach at 187 m is the widest suggestive of a typical casing failure which may be due to sudden thermal stresses caused by quenching the well suddenly. The casing breakage at 318 m is likely to be responsible for the provision of passageways of steam departure from the well and possible conduits of steam to the crevices leading to the surface. The casing breakage above are inside the anchor casing and should not cause steam leakage out of the well unless the anchor casing is broken as well.

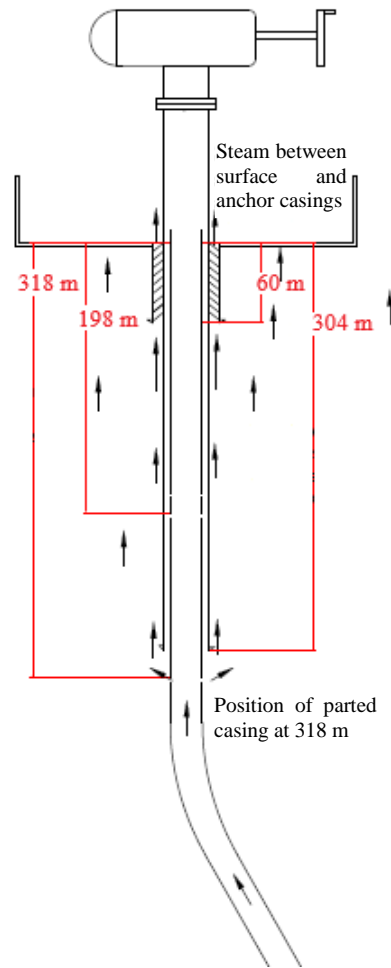
Due to parted casings, the flow of steam to the surface is perceived to flow as shown in Figure 9 below. With time this flow between the surface and anchor casings intensified and grew in magnitude as steam found its way to the surface.

FIGURE 9: Possible flow of steam in well 740A due to the parted casings

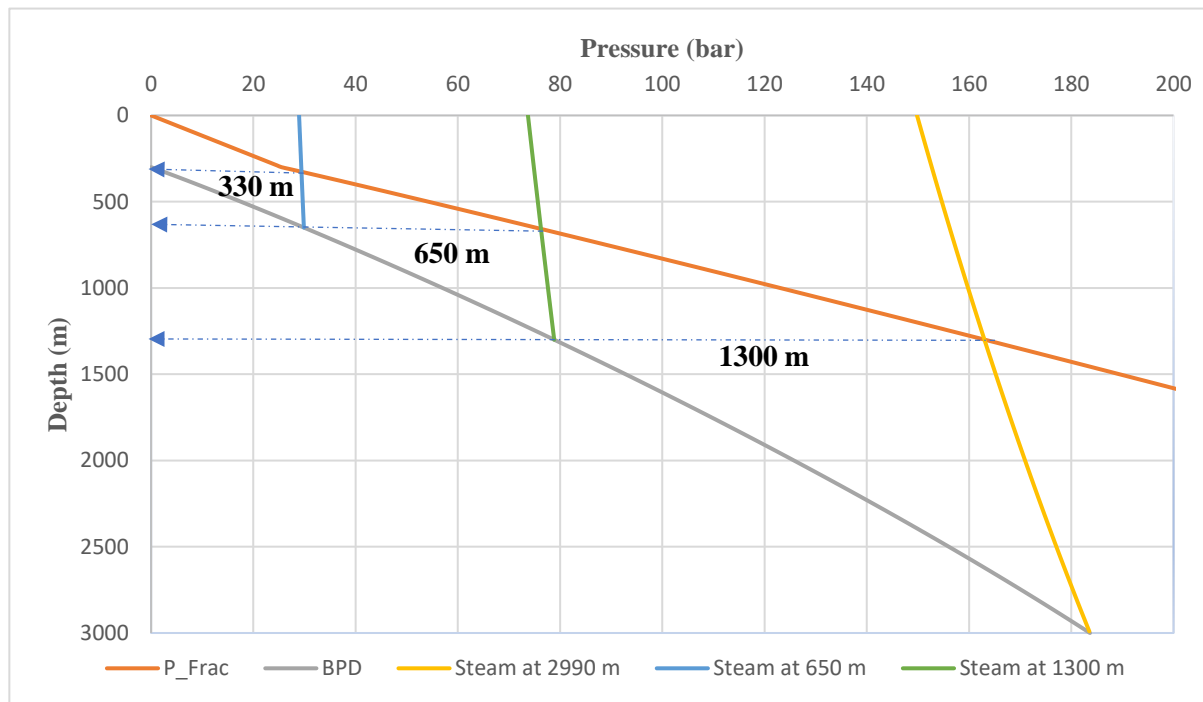
Since the well was drilled to 3000 m RKB, which is about 2990 m measured depth from the surface, the casing sets for the various casings vary from the actual casings depths used in well OW-740A as presented in table 4 below. The conclusion is that assuming the BPD the casings depths do not comply to the African code. This deviation is though not the cause of the failure in the well.

FIGURE 10: Redesigned casing set depth using the African code of practice (the dotted line shows the intersection of pressure and formation pressure curves)

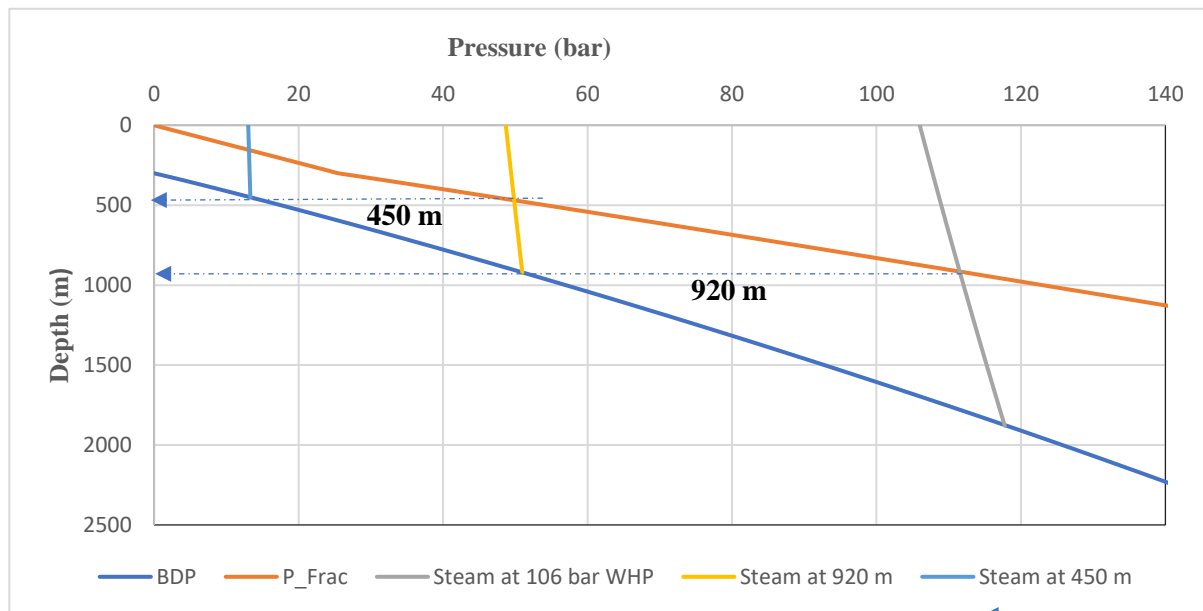
FIGURE 11: Design of the casing depth from the known WHP of 106 bar_g (the dotted line shows the intersection of pressure and formation pressure curves)

From this plot, we see that the minimum casing depths for the production, anchor, and surface casings are 920 m, 450m, and 100m. The comparison with actual setting depths is as shown in table 5.

From this analysis, we can deduce that the production casing was set at the appropriate design depth. However, the plot also shows that the pressure in the well at 318 m where the casings have failed, is way above the containment pressure of the formation.

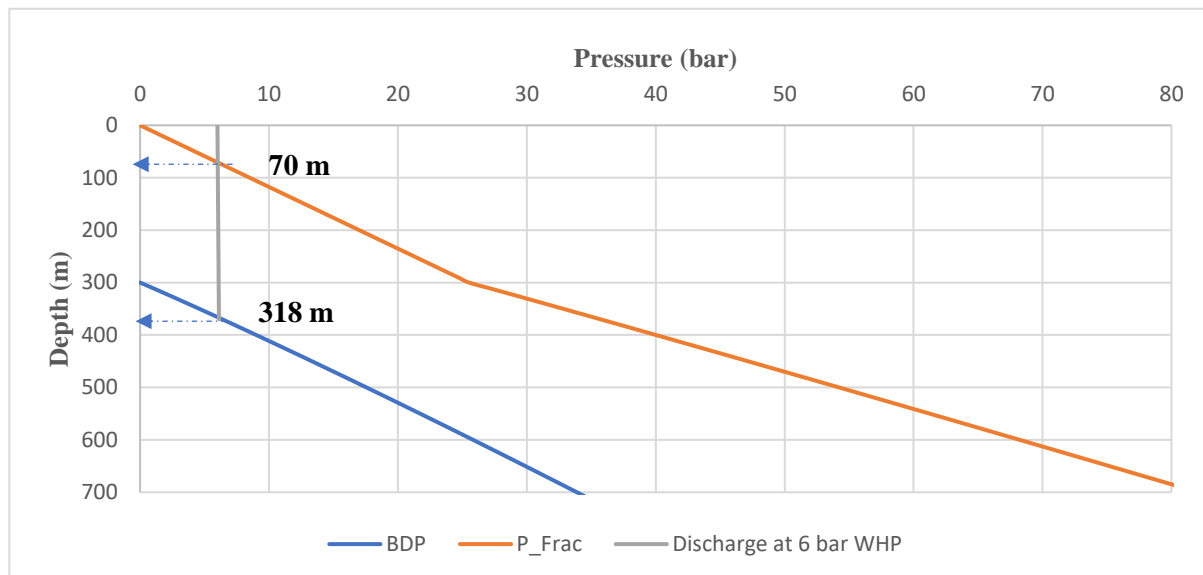
FIGURE 12: Pressure at the parted casing relative to the containment pressure of the formation (the dotted line shows the intersection of pressure and formation pressure curves)

From the plot, we see that the minimum depth that the formation can contain this pressure is about 70m. Therefore, the point where the casing has parted, 318 m, the rock has enough containment strength to sustain the discharge from the surface. It is however not strong enough if the well is shut in.

Currently, the well is under vertical discharge. We have seen from Figure 12 that it is safe to let the well discharge as this does not pose any danger to the surface equipment as the pressure exerted at the parted casings is well below the containment pressure of the formation. Our aim for choosing a workover intervention is to choose a method that is realistic and will enable us to save the well for future production of steam. From the discharge tests, we saw that the well has the potential to produce up to 8 MW_e at a steady pressure of 5 bar. Therefore, the best intervention must keep in mind ways of not compromising the production of this steam to get a return on investment.
