Canby's Geothermal Laundromat

Dale Merrick

A small community cooperative installs a non-coin operated Laundromat to save money and upgrade equipment. Retrofitted gas-fired 55-lb industrial laundry dryers receive energy from a geothermal district heating system to dry domestic laundry.

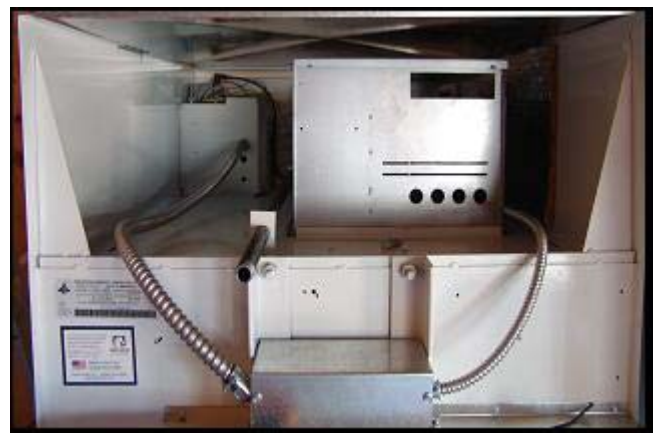
Figure 7: Gas Dryer before retrofit

After removing the gas unit from the dryer, it was obvious that a larger opening would need to be made to allow the

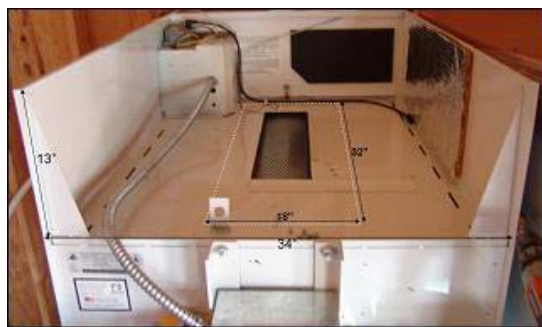
Figure 8: Target size of new opening

maximum air flow through the coil and rotating drum. Figure 8 shows the small original opening and how much larger it needed to be. A plenum was then mounted over the enlarged opening with a hot water coil as shown in Figure 9. A control valve was installed on the return header which is connected to a controller in the buildings mechanical room. This in turn is monitored by the district heating system's DAS software. The retrofit per dryer averaged about \$1,800 including the coil, plenum, control valve, fittings and copper supply and return lines. This cost is largely dependent on the price of copper which has been extremely volatile in the last few years. This equipment was purchased in June 2008. The simple payback for the new equipment and dryer retrofits is under 3 years considering cost of machines (\$35,000), retrofits (\$9,000), and the current price of propane (\$2.33/gal) at an average usage of 7050 gallons per year.

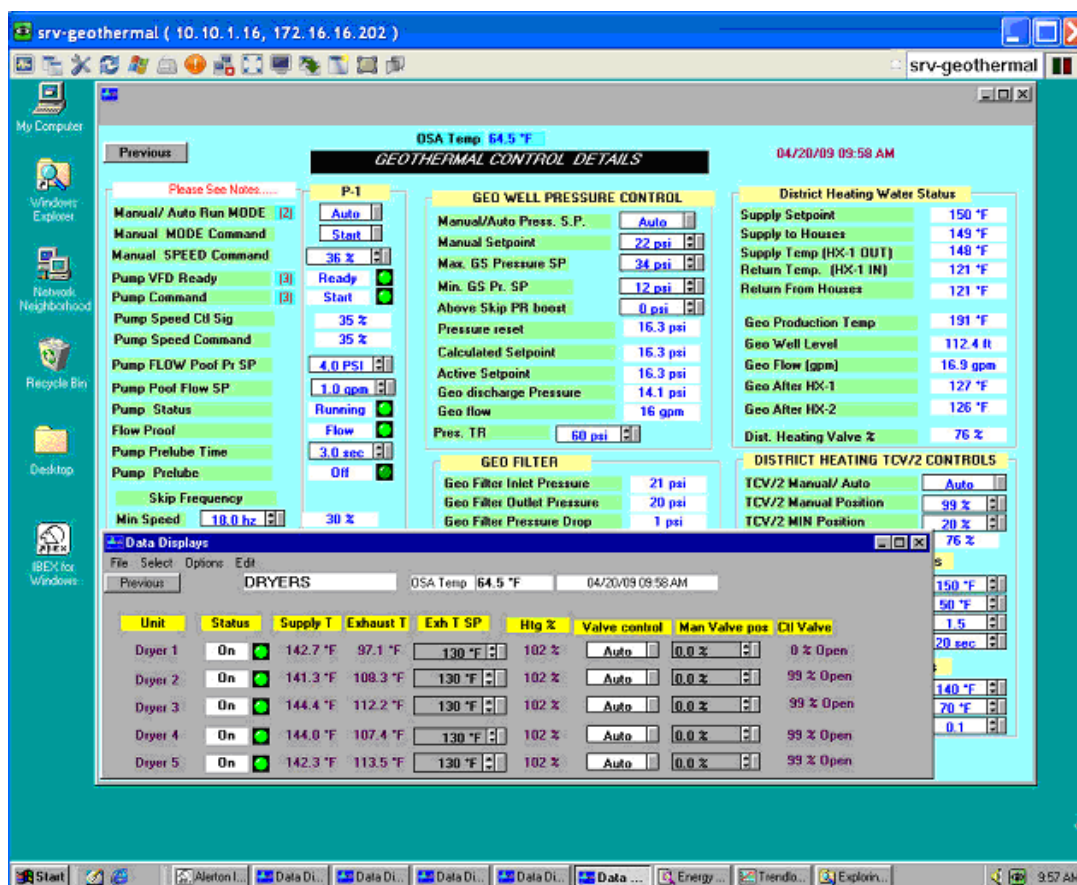
Figure 10: Dryer Monitoring on Desktop

Figure 10 on the last page shows dryer and district heating system performance. The light blue and green dialog box shows overall system conditions and the grey dialog box shows the retrofitted dryer performance. Design supply water temperature is 150°F and is manually set to meet that requirement. The supply air temp to the dryers exceeds the design temperature of 140°F. Temperature probes are placed both after the hot water coil and the exhaust duct to monitor dryness of the laundry. If the exhaust temperature exceeds the exhaust temperature set point (EXT T SP), the control valve would close and limit energy to that dryer. At this time, the EXT
