Calcite Inhibition Systems Tubing Recovery

Keywords: *Calcite Inhibition System, Geothermal, Well Intervention, CIS Tubing Recovery, Solenis, Acidising.*

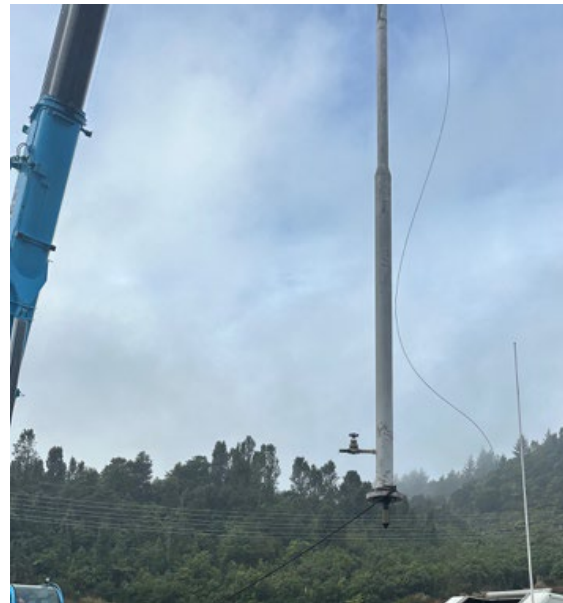
Figure 1: Successfully Retrieved CIS Tubing

Chemical treatment commenced with the wireline team maintaining the required tension on the tubing and constantly monitoring weight. After the first batch of treatment fluid was pumped the tubing showed no signs of being displaced but once the second batch was about to commence we noticed a weight change and the team could begin to pull the tubing out of hole. Water was flushed into the wellbore to displace acid and we pulled the tubing free with a fully intact sinker bar.

With the tubing out of hole the stimulation section of the job commenced without a hitch. Post stimulation PTS runs showed injectivity was back to better than completion test and the camera showed clean casing around the stuck point area and historical scale formation. With the well back on line and feeding the station the production was back to over 100%. The CIS tubing was reinstated and functioning well at the start of production.

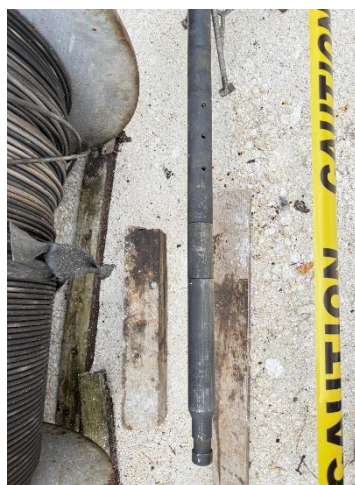
Figure 4: Recovered sinker bar

During the first treatment batch, at slow controlled rates we observed movement. After approximately 2 hours and 15 minutes, a change in CIS weight was observed, indicating that the tubing had begun to move. Following this, the treatment injection was continued using an increased flow rate. Upon completion of this, fresh water was flushed through the system to displace residual chemicals, after which the tubing was successfully pulled out without resistance up to the nozzle assembly.
